Confidential Reporting Of Structural Failures And Lessons Learnt

NEWSLETTER

A PUBLICATION OF INDIAN ASSOCIATION OF STRUCTURAL ENGINEERS

July – September, 2022

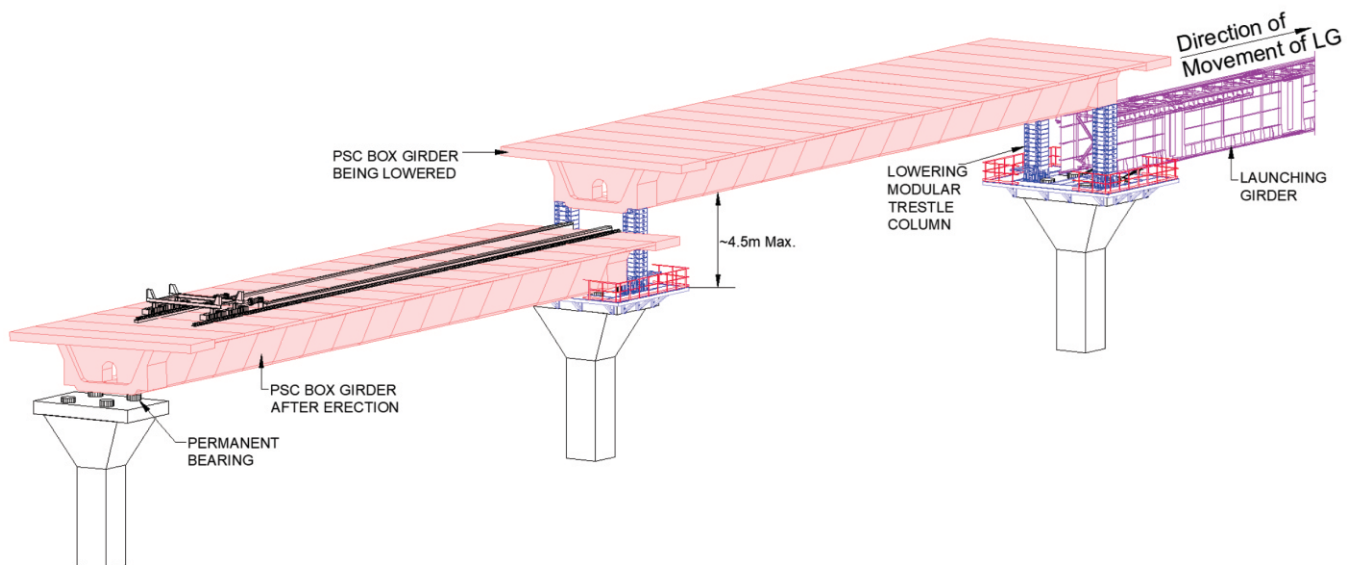
TYPICAL SKETCH SHOWING LOWERING ARRANGEMENT OF PSC BOX GIRDER

After the successful erection of a couple of spans in this bridge, failure occurred when one of the spans was being lowered. The incident occurred in the middle of the night when the lowering operation was being undertaken by the executing agency. It was reported that while lowering the span, one of the hydraulic jacks failed which triggered the failure of other adjacent jacks resulting in instability and fall.

The reporter found that the launching/lowering operation adopted in this project is NOT commonly in practice for highway bridge construction. The lowering scheme was found to be highly vulnerable to any jerks or mechanical failure of hydraulic jacks. The modular trestle used for lowering the span was neither connected at the top nor at the base and was not braced in any direction. The reporter could not find the checks for the stability of the trestles for the safety aspect during lowering.

- a) The scheme of lowering of PSC girder provided in this project was not a commonly used launching system. All stakeholders (i.e, the executing agency, the design consultant and the approving agency) should have exercised extra diligence in finalizing the scheme of erection. Stability checks for the temporary works during construction must be performed. The performance of any erection scheme and structural adequacy of the proposal should be ascertained prior to its finalization.

In most of the Erection and Launching schemes, it has been observed that the various components are not designed for lateral loads caused by wind and earthquakes. Lateral loads should not be ignored even though it is difficult to implement the safety measures, which require proper anchoring and /or bracings of the structure. The components forming part of the launching and erection scheme are required to be shifted after each operation to the next location. Anchoring and then de-anchoring is a time-consuming process and there is a tendency to ignore the safety measures. At the design stage itself, these should be designed and checked by the proof consultants and supervision authorities. The implementation of these measures has to be enforced during the construction stage by adhering to the SOP and Method Statements approved. Suggestions are given in para "Lessons learned" are very useful and should be implemented. Finally, the concept of Temporary works like Launching Girders and lowering of 900t full span superstructure by 5m over the pier cap requires much more engineering input than seems to have been applied. Also, overcrowding over the pier cap should have been avoided.

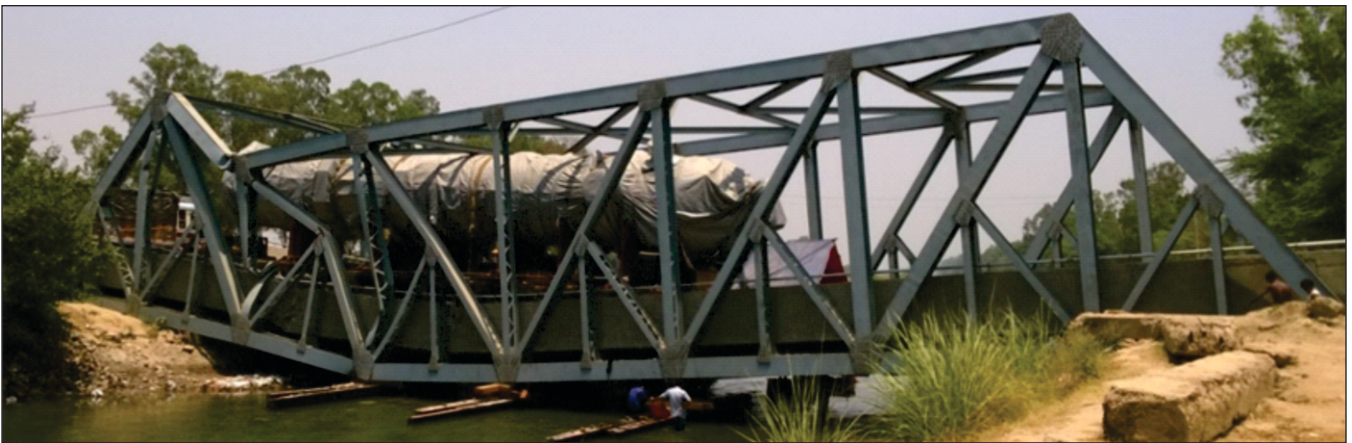
Fig. 1 : View of the Collapsed Bridge Over Canal

The failure has occurred apparently due to the buckling of compression members, which was caused due to the passage of the OWC vehicle carrying GVW of 305 MT having axle configuration shown in Fig 3 on the bridge designed for IRC Class A/70R.

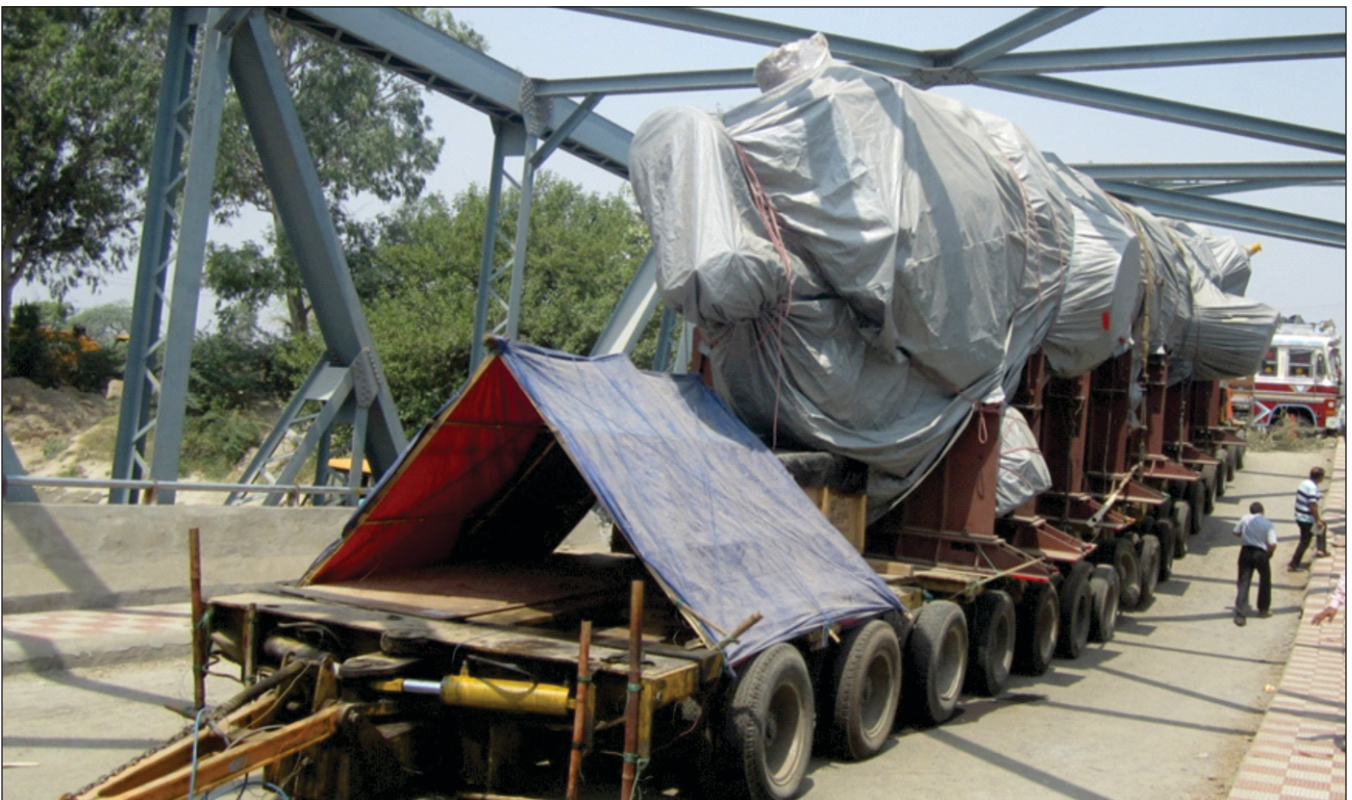
Fig. 2 : View of the OWC/ODC Vehicle on Collapsed Bridge

In this case, the transporter tried to deviate from the allotted route as he could not pass the vehicle with 6.0 m height through a ROB with 5.5 m clearance and moved the vehicle carrying GVW of 305 MT over this affected bridge designed for IRC Class 70 R/ Class-A loadings. The bridge failed instantly with the vehicle on it and settled by more than about 2m at the 3/8th nodal point from one end of the bridge. Due to the shallow depth of the canal bed from the soffit of the bridge, the bridge did not collapse completely and stood in its position with the consignment trapped inside.

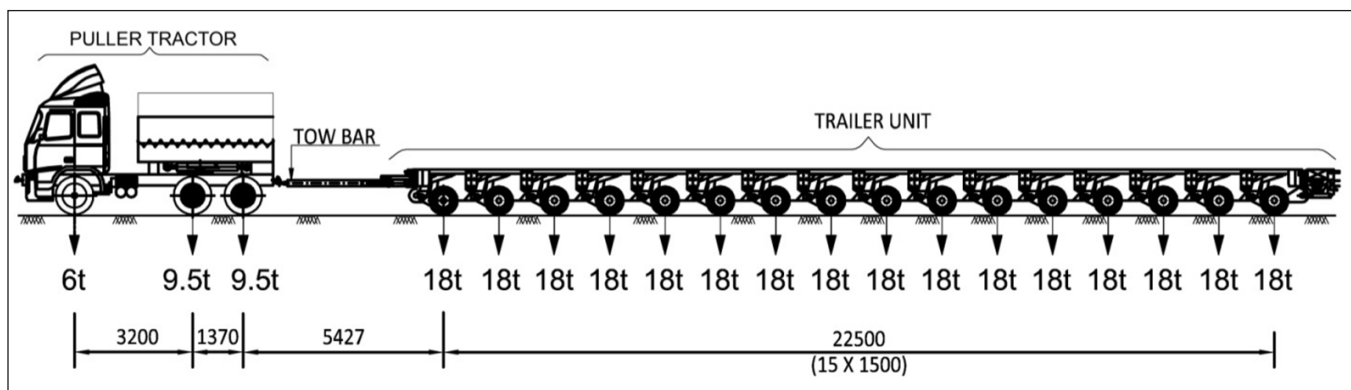
Fig. 3 : Axle Load Configuration of OWC/ODC Vehicle

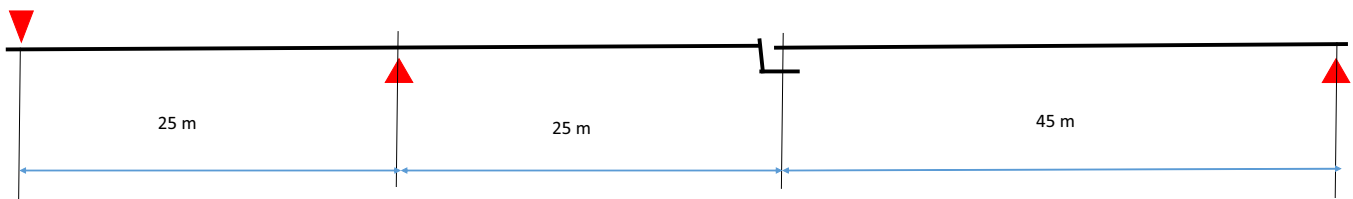
A crucial concrete bridge, 95m long, linking two major towns collapsed one fine day after serving for only 12 years. Six people got injured in the tragedy. Fortunately, there was no casualty. The structural scheme and the span arrangement for this bridge were unique. It was a 2-span bridge having span lengths of 25m and 70m. The structural scheme comprised of a simply supported PSC box girder span of length 45m, which was supported on an Abutment at one side and was made to rest on overhanging cantilever span from the other side. The 25m end span on the other side is made continuous over the intermediate pier and is made to overhang by 25m to support this 45m simply supported span. Expansion joints are provided at the two abutments and the articulation point. The sketch below explains the details. The photograph shows the bridge immediately after failure.

The reporter informed CROSFALL that scrutiny of the GFC drawings post-failure revealed that there was a mismatch between the design requirement as given in the design calculation and the GFC drawing regarding details of prestressed anchor cables which is the root cause of the failure of this bridge. As per the design requirement, 6 Nos U-shaped 6T13 cables were needed. However, the draughtsman noted the requirement as 6 Nos 6T13 cables and showed only 3 U-shaped cables of 6T13 in the drawing interpreting one U-shaped cable as two cables. It is clear that the actual stress in the prestressing cables was double the design value. Probably there was enough margin in the stress due to which the bridge survived for 12 years. However, with time, due to stress corrosion, coupled with high relaxation losses in prestressing steel and lack of maintenance, this sudden failure occurred, in which the whole bridge was lost.

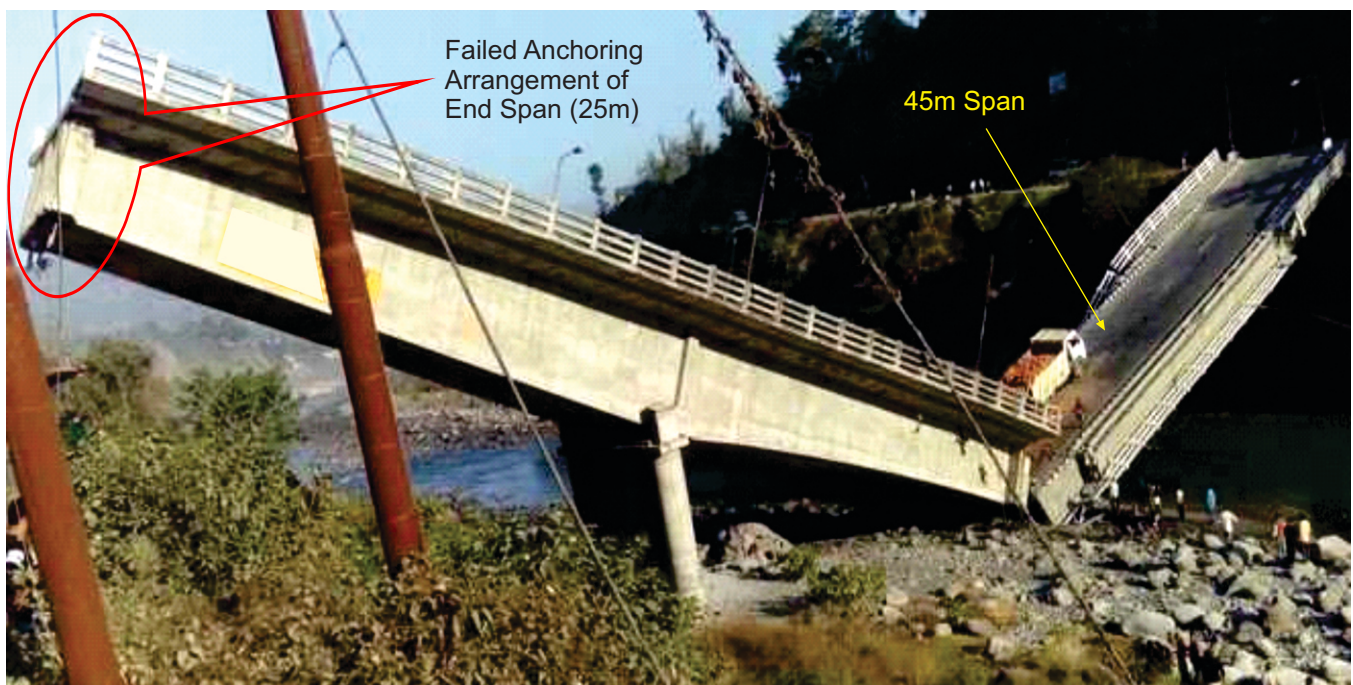
It is obvious by looking at the structural scheme that the abutment at the end supporting the 25m end span is subjected to an upward reaction from the anchor span, unlike a conventional deck which gives a downward reaction. It is understood that the deck was anchored to the abutment by using prestressing cables, which were provided between the abutment and deck, to carry this upward reaction force.

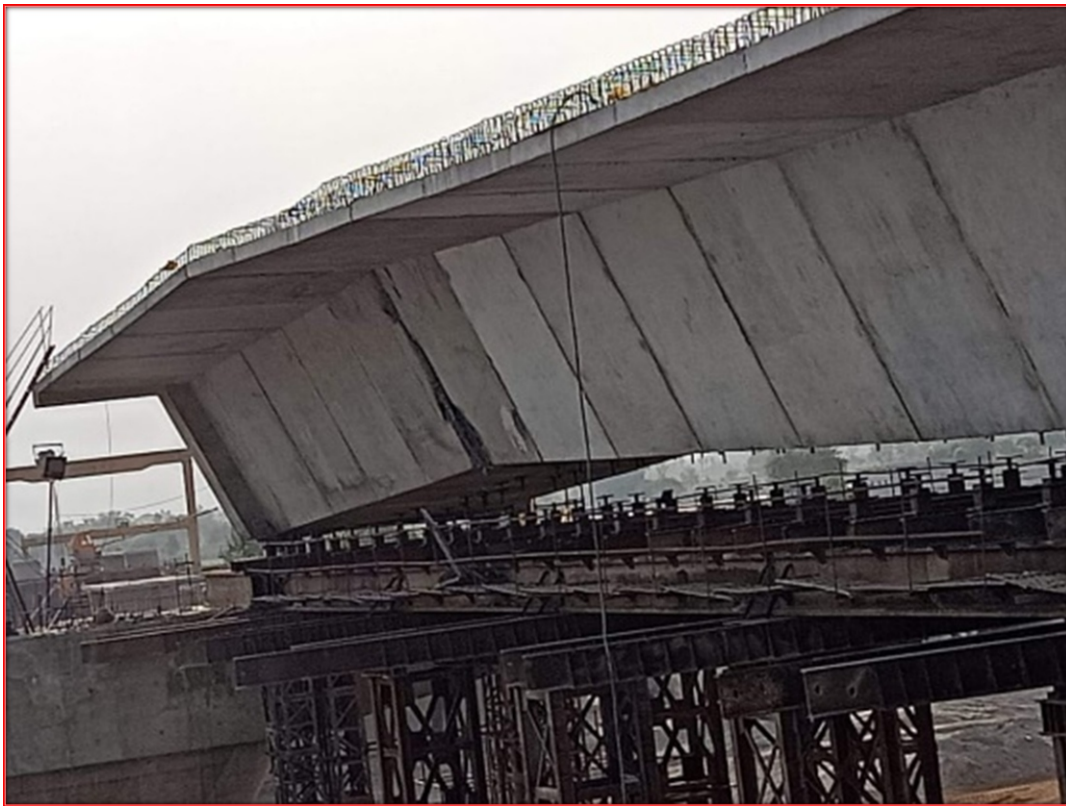
This case pertains to the failure of a prestressed concrete segmental box girder span during the prestressing operation. The span hogged up during the last stages of prestressing, as can be seen from the photograph given in Fig. 1 below:

Fig. 1 : Photograph of the affected span

In view of the above, it was concluded that the PSC box girder failed due to a variety of reasons such as poor-quality control, bad workmanship, and improper reinforcement detailing in the blister block. The quality of coarse aggregates and fine aggregates was not up to the required specifications. All the remaining precast segments yet to be erected were rejected. Later, the source of the aggregates was changed, and quality & workmanship standards were improved for the new segments which were erected without any problem during the prestressing operation.

- i) Adequacy and acceptance of cube test results alone do not ensure good quality concrete and design strength. Apart from strength, it is important to ensure the quality of concrete in terms of durability criteria. Quality of concrete should be ensured for the structural components being cast by following an approved design mix, ensuring the quality of raw ingredients and water as per specifications, and ensuring proper cover, reinforcement placement, and thicknesses of various components. Curing is a major factor in achieving the desired concrete strength which should be ensured.

- iii) The designer should develop detailed drawings properly, especially where there is reinforcement congestion, and increase concrete dimensions suitably to ensure proper space for concrete to go in. Thicknesses specified in design codes are minimum and the designer should increase these at points of reinforcement / cable congestion.
