## FROM THE DESK OF THE PRESIDENT

## REPORT No. CF-46

# Design & Construction Challenges Faced in well Foundation of a Railway Bridge & Remediation

# Failure of False Steining of Well Foundation during sinking Process

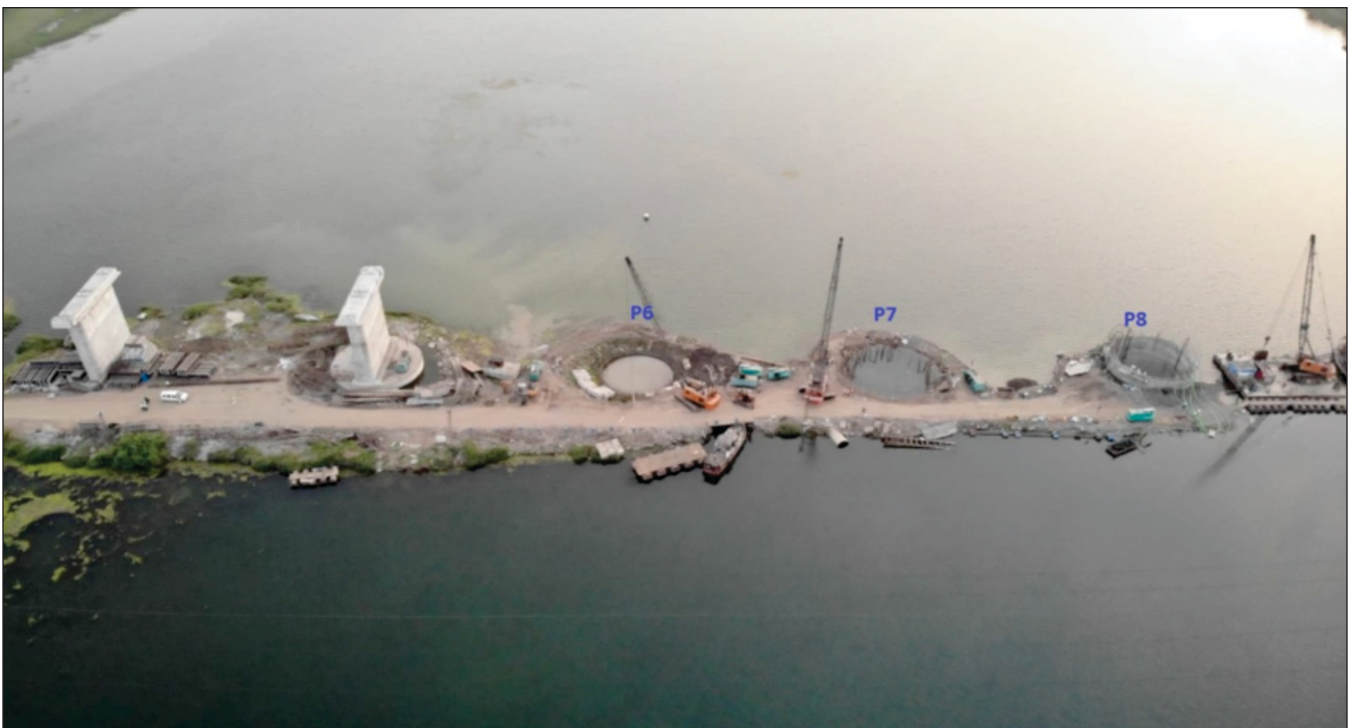
**Photo-1** : View of Foundations affected due to presence of hard strata

Contractor was finding difficulties in sinking of some of the well foundations in the main river zone (i.e. P6 to P9). These foundations were passing through predominantly soft disintegrated rock/soft rock/conglomerate. As per the Good For Construction drawings, these wells were to be sunk 9m below the maximum scour level, but the cutting edge of these wells were ranging from 0.44m to 5.44m below the maximum scour level. As a solution to the problem, contractor claimed that the strata in this zone is in-erodible and hence these foundations can be redesigned as 'open' foundation, with minimum founding depth of 2.5m below scour level. In case the strata is erodible (as was originally considered in design), the foundation has to be taken down and embedded in the substrata for a depth of at least 1/3rd the depth of scour, which works out to more than 9.0m below the scour level. Photo 2 shows view of the dredge hole where attempt is being made to cut through hard strata. Photo 3 shows the dewatering arrangement in the well to ensure dry condition at cutting edge level, to enable workers to go down and facilitate sinking operation.

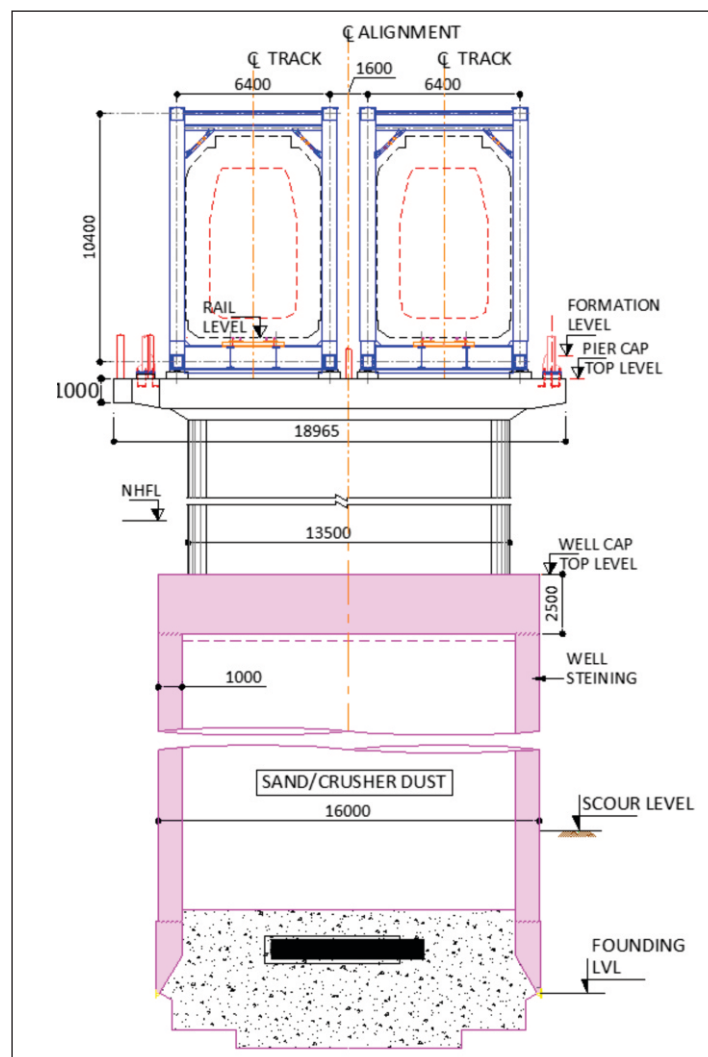
Fig. 1 : Typical Cross Section showing Pier and Well Foundation Dimensions

- b) Provided steining thickness of 1.0m for 16m diameter well foundation appears too less and not justifiable from following considerations:
  - i. As per Clause 1.2 (b) of the IRS Manual for Well Foundation, the steining thickness should be sufficient to enable sinking without excessive kentledge and provide adequate strength against forces acting on the steining, both during sinking and service. This clause is violated.

- ii. Clause 708.2.3.1 of IRC:78 recommends a minimum thickness for well steining, by using a simplified formula ( $t_{\min} = K.d.\sqrt{l}$ , where  $K=0.03 \times 1.1$ ,  $d=16\text{m}$  and  $l=19.2\text{m}$ ) works out to 2.31m, as against provided thickness of 1.0m.

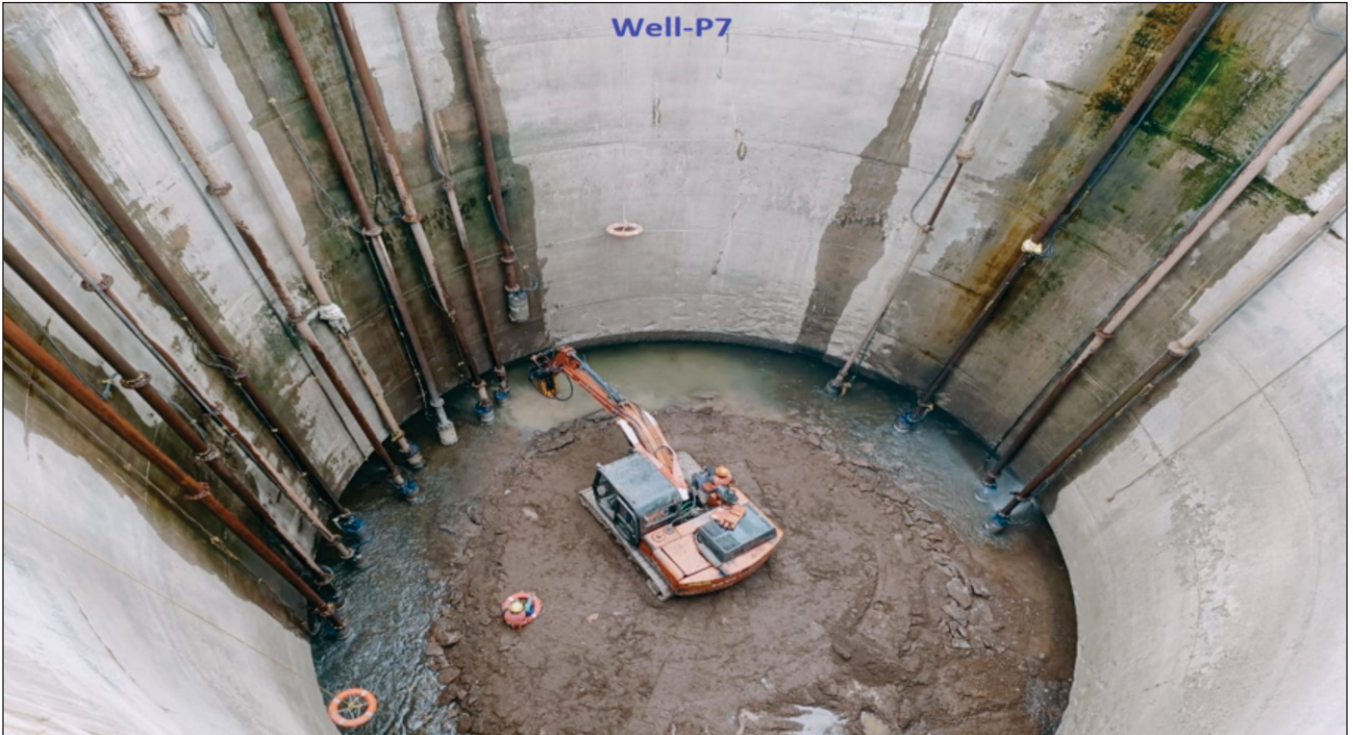
**Fig. 2 :** View of the dredge hole for well P7 where attempt is being made to cut thru' rock. Pumping-out of water is simultaneously done to ensure dry condition for ease of working

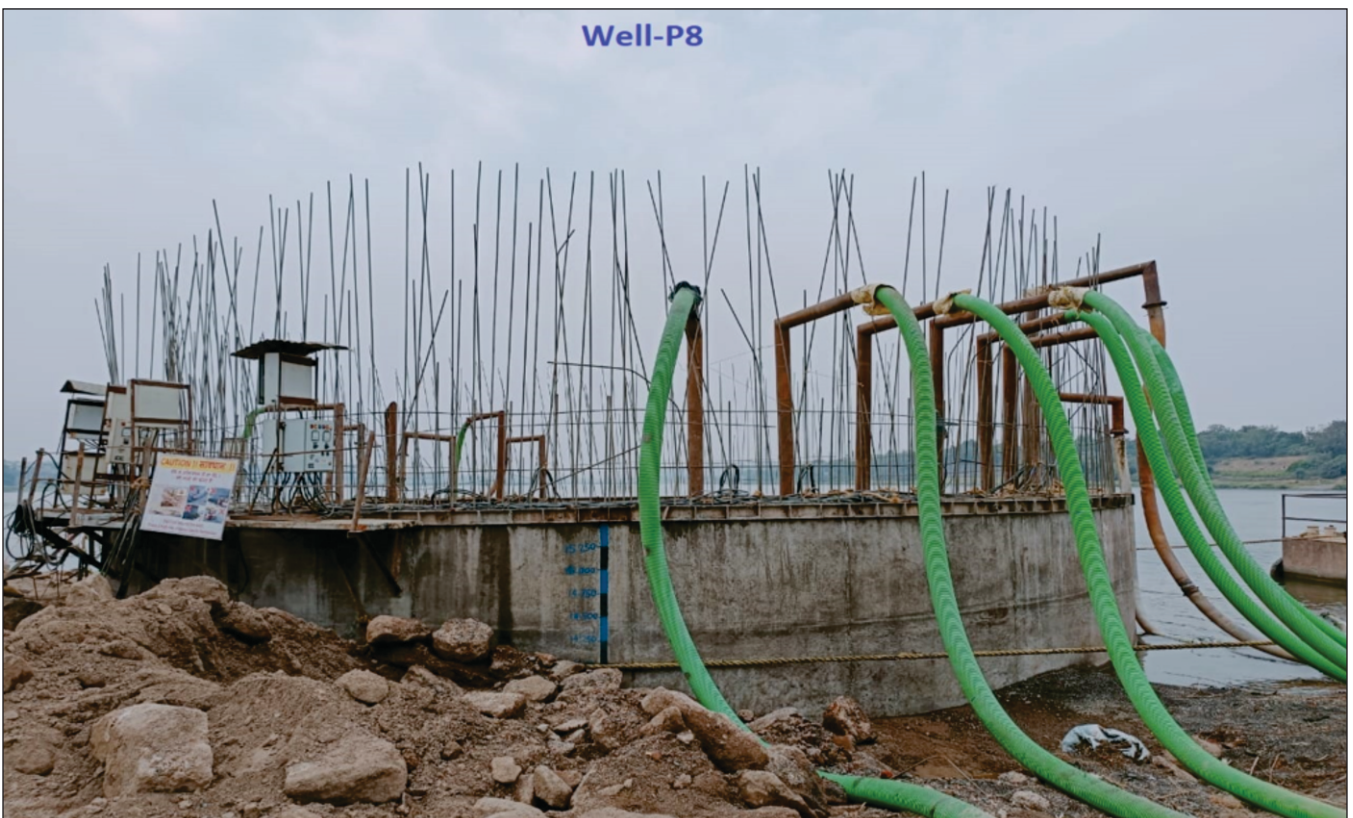
**Fig. 3 :** View of the Well from top showing arrangement of pumping to dewater

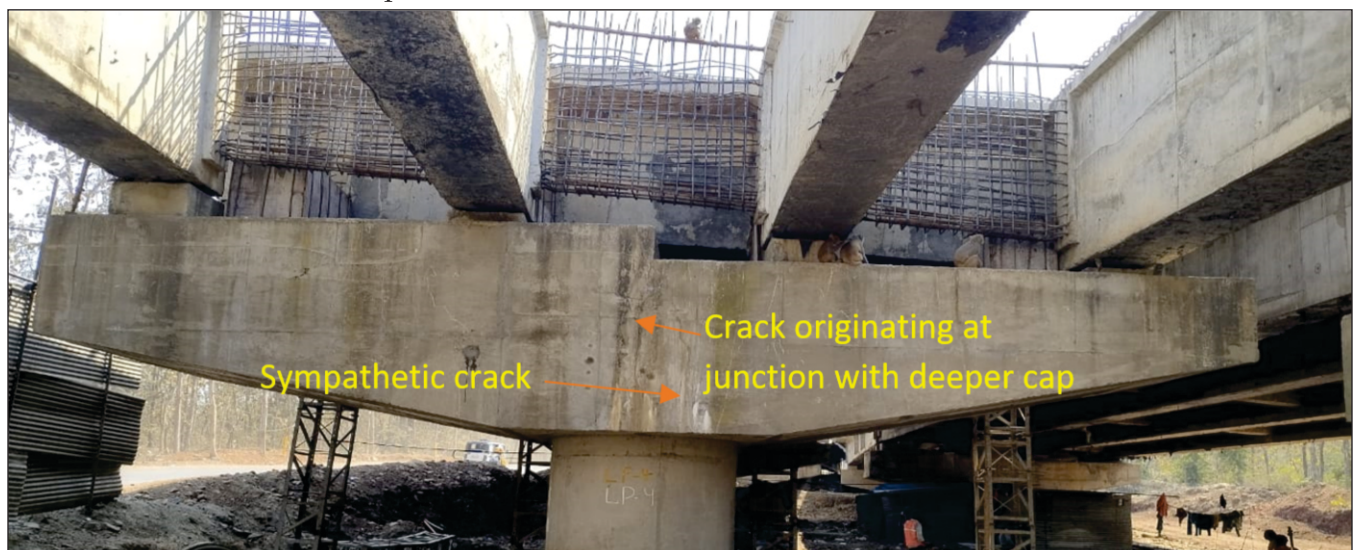
Photo 1

Construction up to pier cap level progressed smoothly. Work up to pier cap level was completed in almost all the piers. Simultaneously Psc girders were cast in the casting yard. After readying 2 spans, A1-P1 and P1-P2, precast girders were brought to site and erected by crane from one side. Study of actual erection sequence indicated that placement sequence was haphazard. After placing them on bearing, next inspection indicated substantial cracking in pier caps at the junction with pier. Cracks were noted at all three locations A1, P1, P2. See photo 1.

It is noted that every crack originated at the junction of raised pier cap and progressed substantial downwards almost vertically except in one case it was slightly inclined. There were sympathetic cracks sometimes parallel to the main crack or sometimes at an angle. At this stage a thorough investigation of cracks was necessary recording widths and depths of cracks. A complete diagram of crack patterns, their extent as on the day, widths and depths should have been noted, however it was not done. Cracks developing in pier caps just after placing girders is rather unusual as at this stage pier caps are loaded to less than 25% of total load. This should have alarmed the concerned.

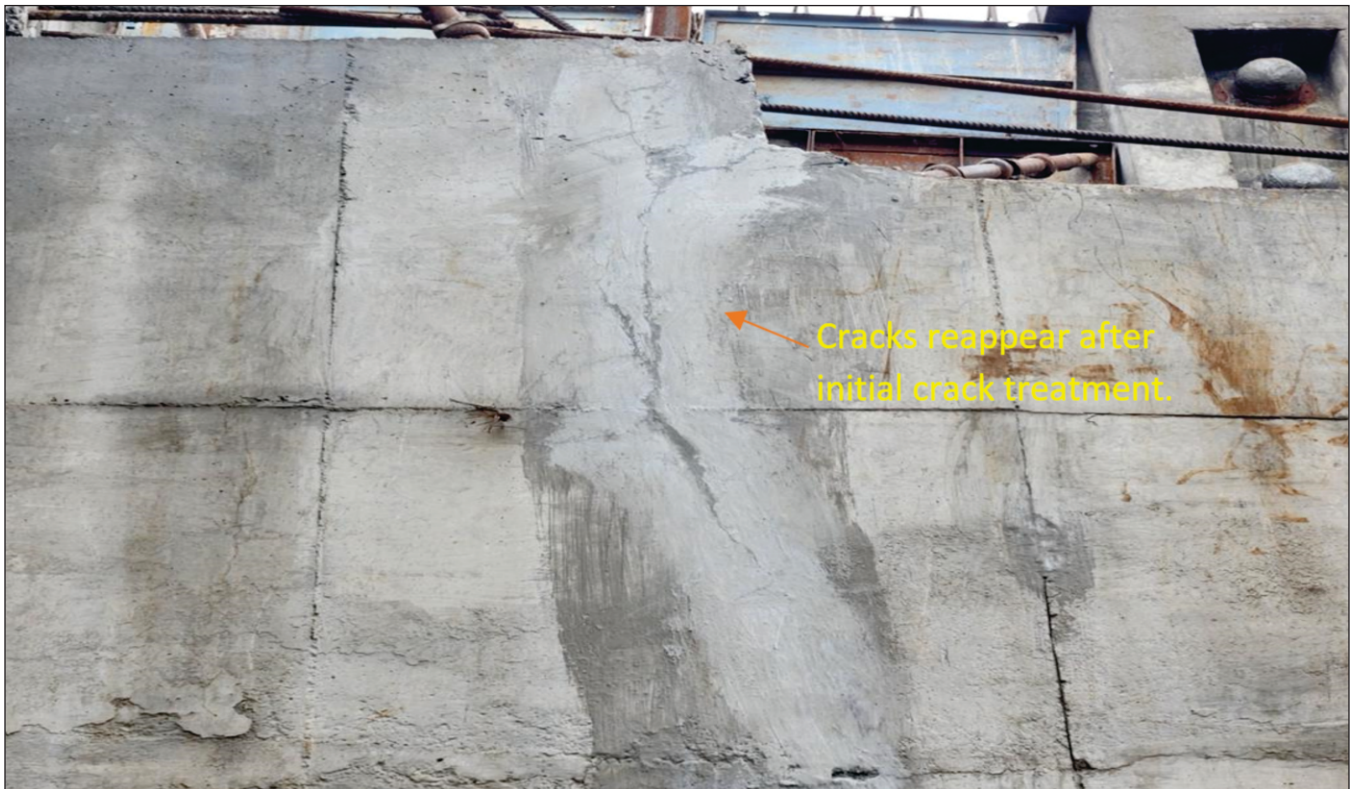
Photo 2

## Such Cracks were seen on Every Pier Cap where Girders were Erected

All the drawings prepared by design consultant were approved by Proof Checker. Initial inspection by them did not lead to any clues. It was decided by them to fill the gaps with epoxy based crack fillers and observe. However, cracks reappeared, see photo 2. Rechecking of calculations was done by the same group of engineers which had done designing/checking initially.

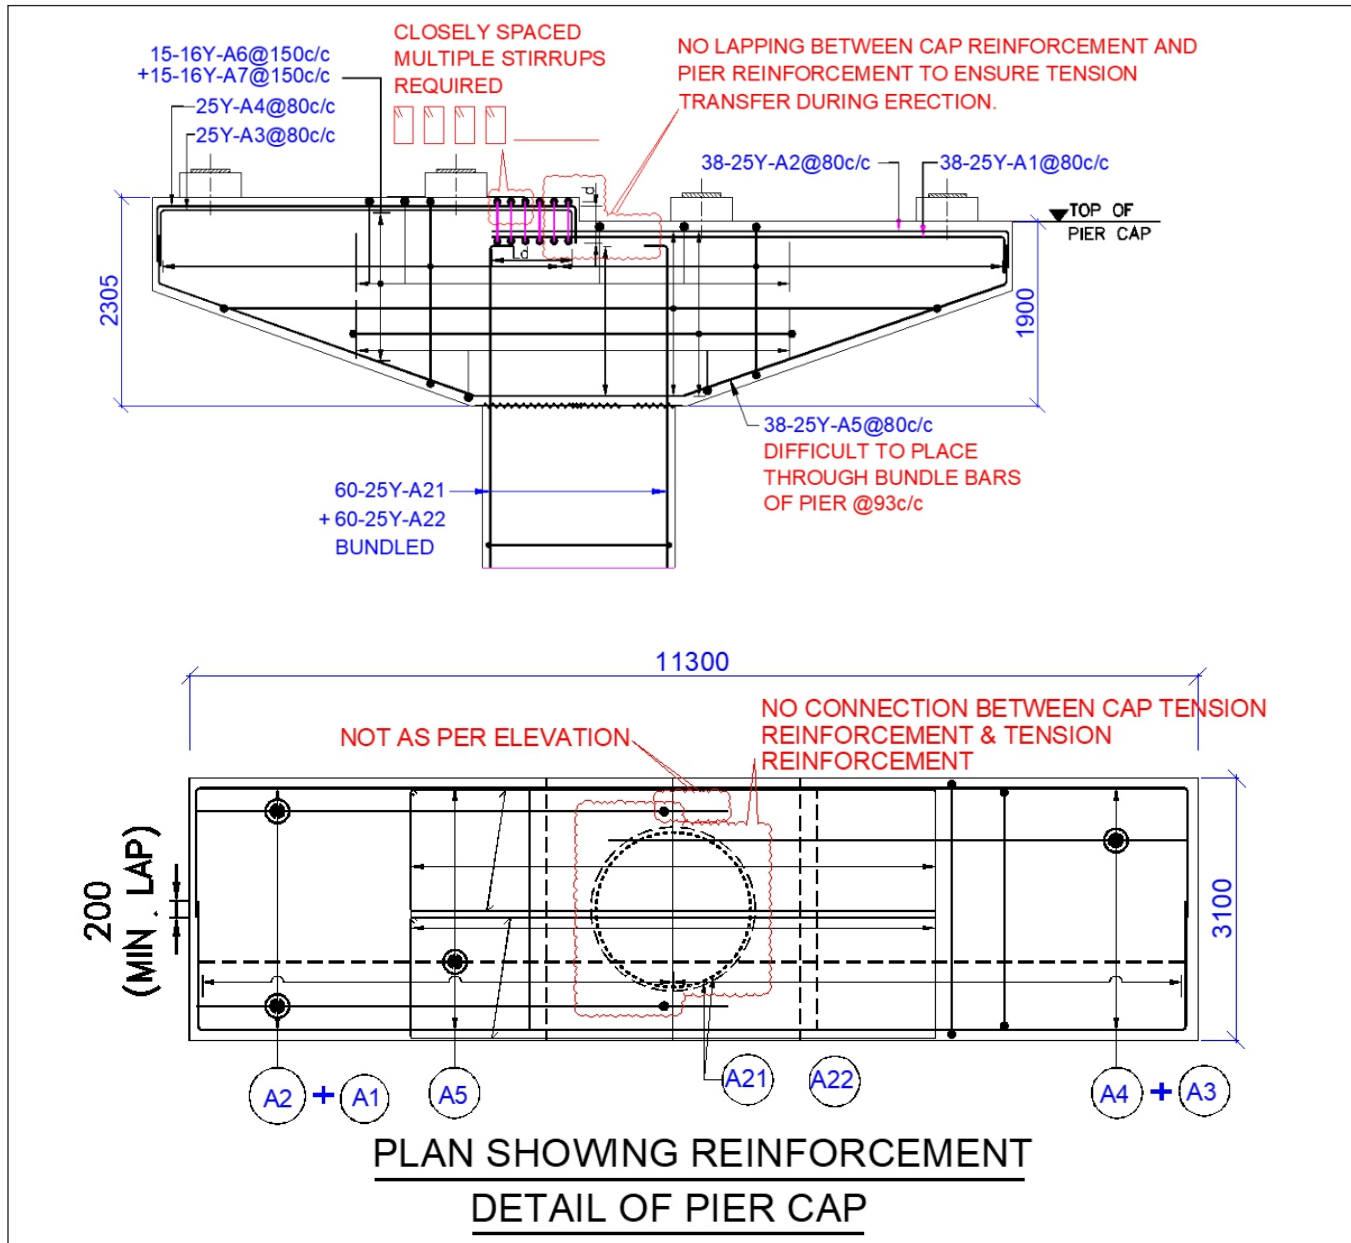
Sketch 3

Reinforcement details of pier cap are shown in sketch 3. Reinforcement provided on both sides of cantilevers is same and worked out on basis of smaller depth. So increasing the depth of pier cap was purely for functional reason and not to achieve any economy in reinforcement.

- d. Some other difficulties in placing bars are shown in Sketch 3. This must have been tackled locally. However bottom bars are nominal.
- e. Camber could easily be restricted to 2.5%, giving a design vehicular speed of over 45 kmph adequate in a city environment. This would have eliminated the need for raising the pier depth by 405.
- f. Alternatively depth of pier cap structurally could be maintained same throughout so that main tension reinforcement is taken through. Additional concrete depth to cover for restricted pedestal height, could be provided with nominal steel. In this case lapping/continuation of pier reinforcement up to and into main cap reinforcement was easy (See sketch 4).

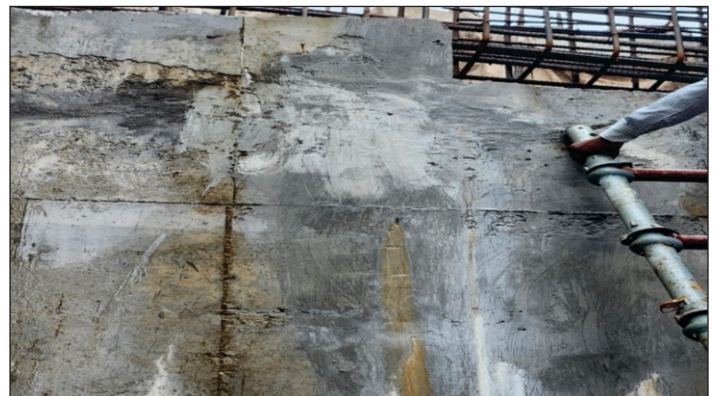
Photo 3

- Though concrete strength results were confirmatory to design, general condition of concrete did not look good. See Photo 3. This however would not have led to cracking.
- Main top tension reinforcement on two cantilever sides of pier is in two layers each and separated vertically by 400 mm which means there is no direct transfer of stress

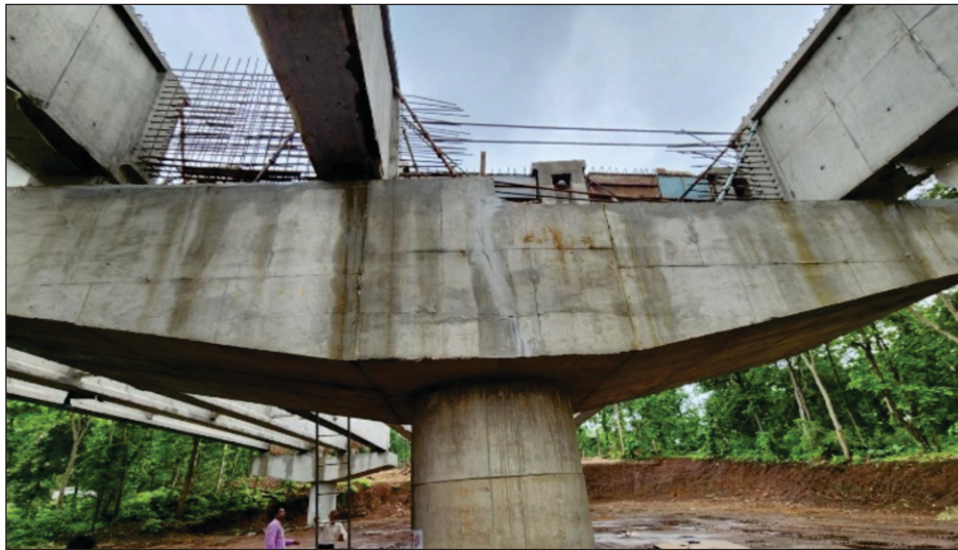
Photo 4

- c. During erection phase there was imbalance in placements of girders see photo 4.

The resulting moment generated in cap was therefore transferred to pier. The pier reinforcement was stopped well short of pier cap tensile reinforcement (see mark up on the Sketch 3). Pier reinforcement did not extend/ lapped with cap tensile reinforcement. This led to cap cracking immediately after placement of girders. This happened when girders on raised pier caps were placed. There was no path for stress flow from reinforcement in cap to reinforcement in pier.

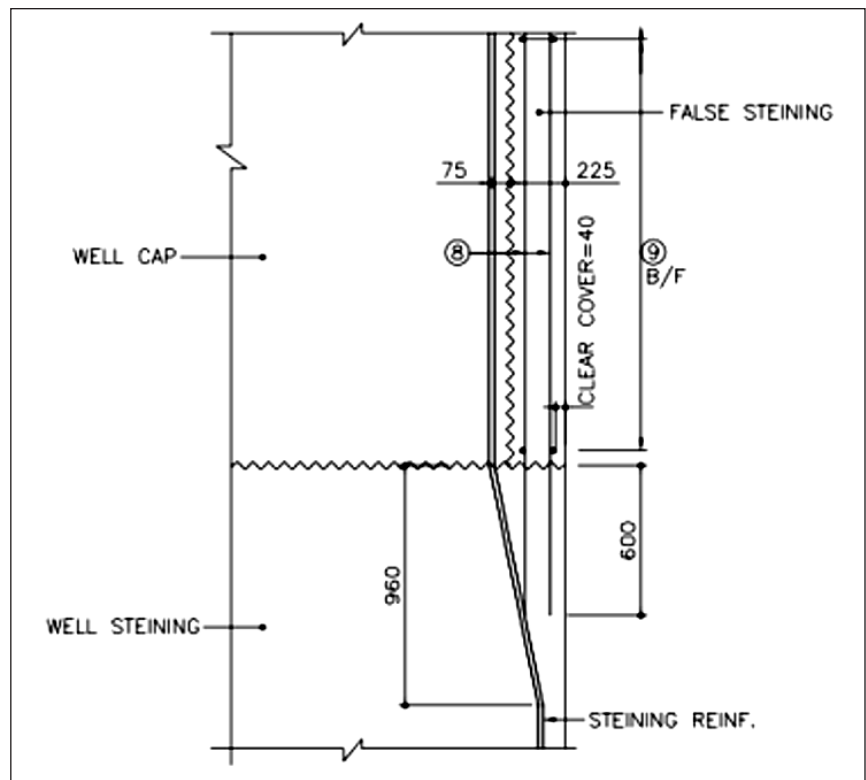
- Reinforcement detailing of the steining top and false steining as per GFC drawing is shown in Fig. 3.
- Failure occurred at the interface between the well steining and false steining (Fig. 4 & Photo-1).

Fig. 3 : Reinforcement Detailing of False Steining

- The reinforcement provided in false steining was anchored inside the well steining by 600mm (Fig. 3).
- The reinforcement for the well steining was improperly positioned and placed 200 mm away from the inner face of the false steining (Fig. 5). Which further makes the section weak in tension.
- The presence of cracks indicates possible poor concrete quality and workmanship, which may have contributed to the distress.

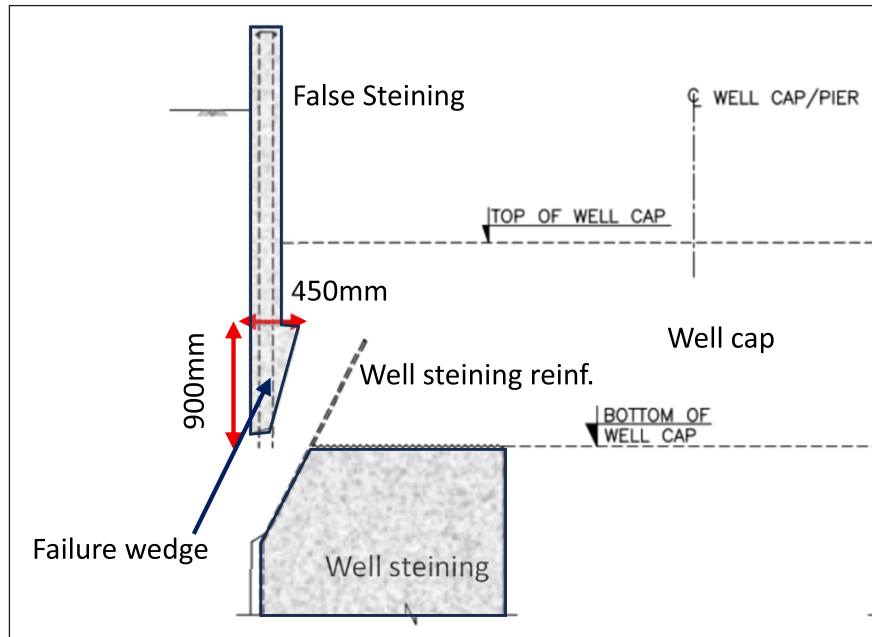
Fig. 4 : Sketch showing failure at junction

- c) A wedge-shaped portion of concrete, approximately 450 mm wide and 900 mm deep, came out from the outer edge at the top of the well steining as shown in Fig. 4.
- d) Few vertical cracks were visible in false steining, which creates doubt about concrete quality (Photo-2).
- e) The cover to outer vertical bars of well steining from inner face of false steining was noted as 200 mm instead of 75mm, shown in GFC drawings (Photo-3 & Fig. 5), which indicates poor workman ship.

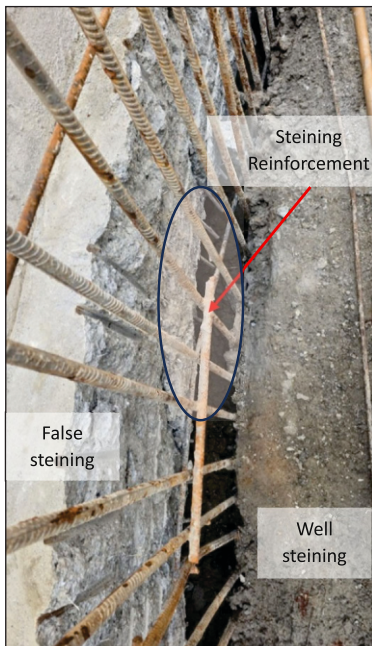
Photo - 01 : Actual site picture at failure location

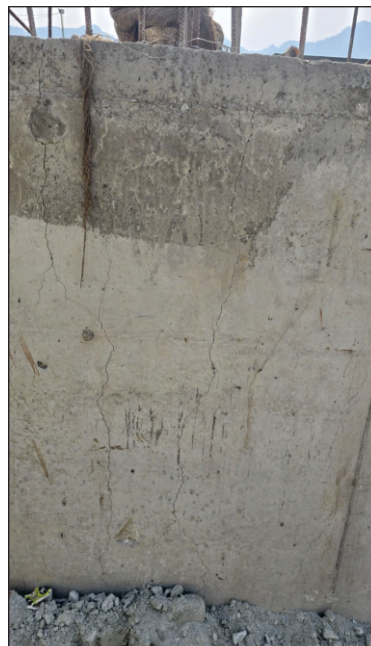
Photo - 02 : Cracks in false steining

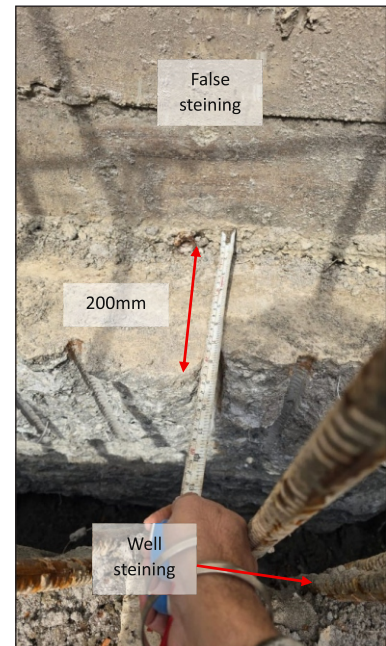
Photo - 03 : Cover to outer vertical bars of well steining is 200 mm instead of 75mm

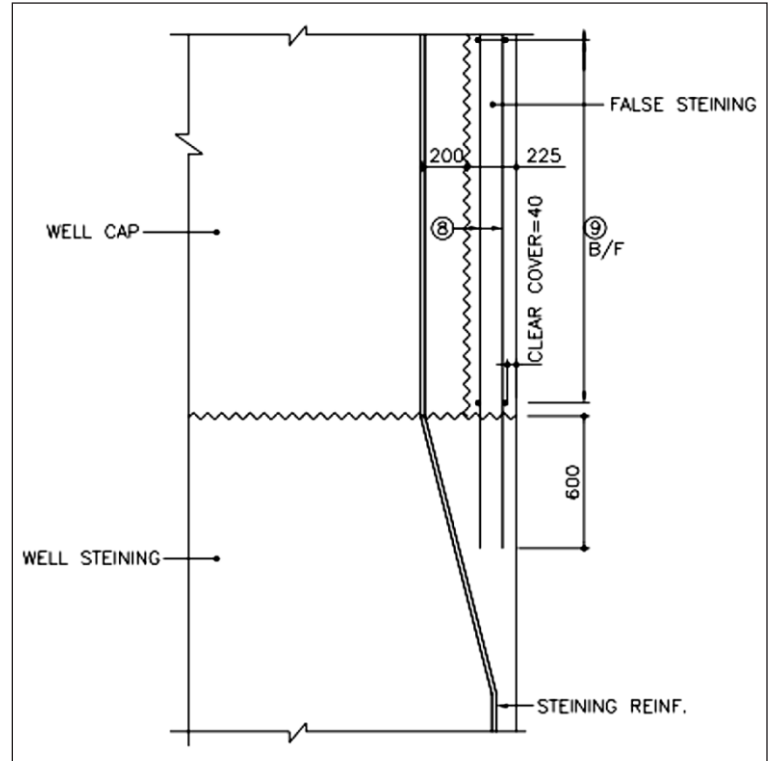
Fig. 5 : Detailing at junction of false steining well (As per site)

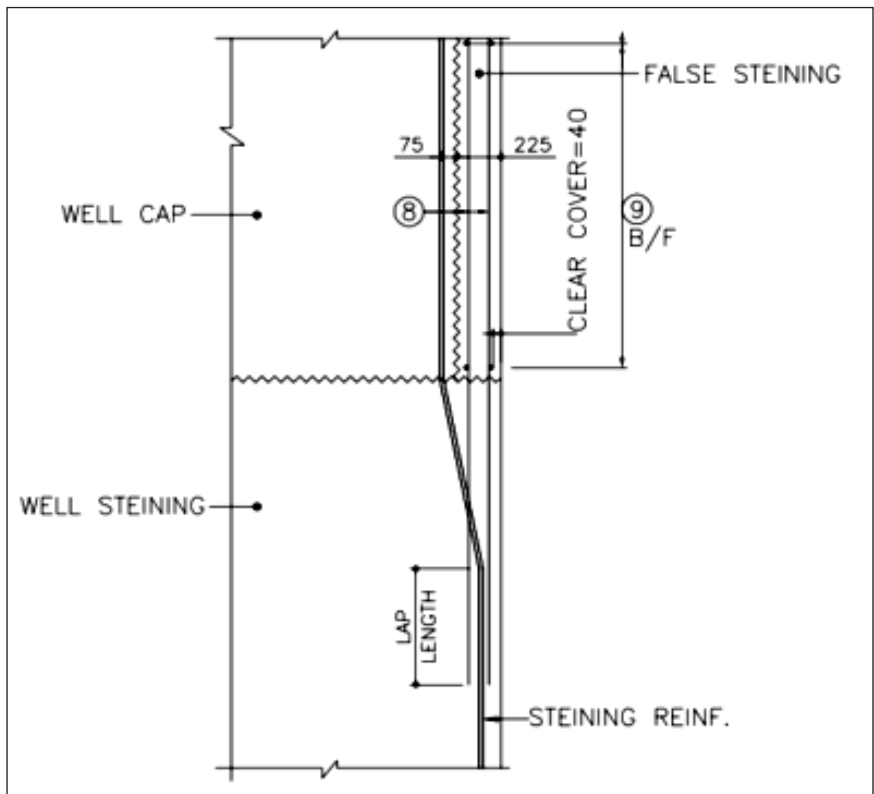
Fig. 6 : Improved detailing at junction of false steining

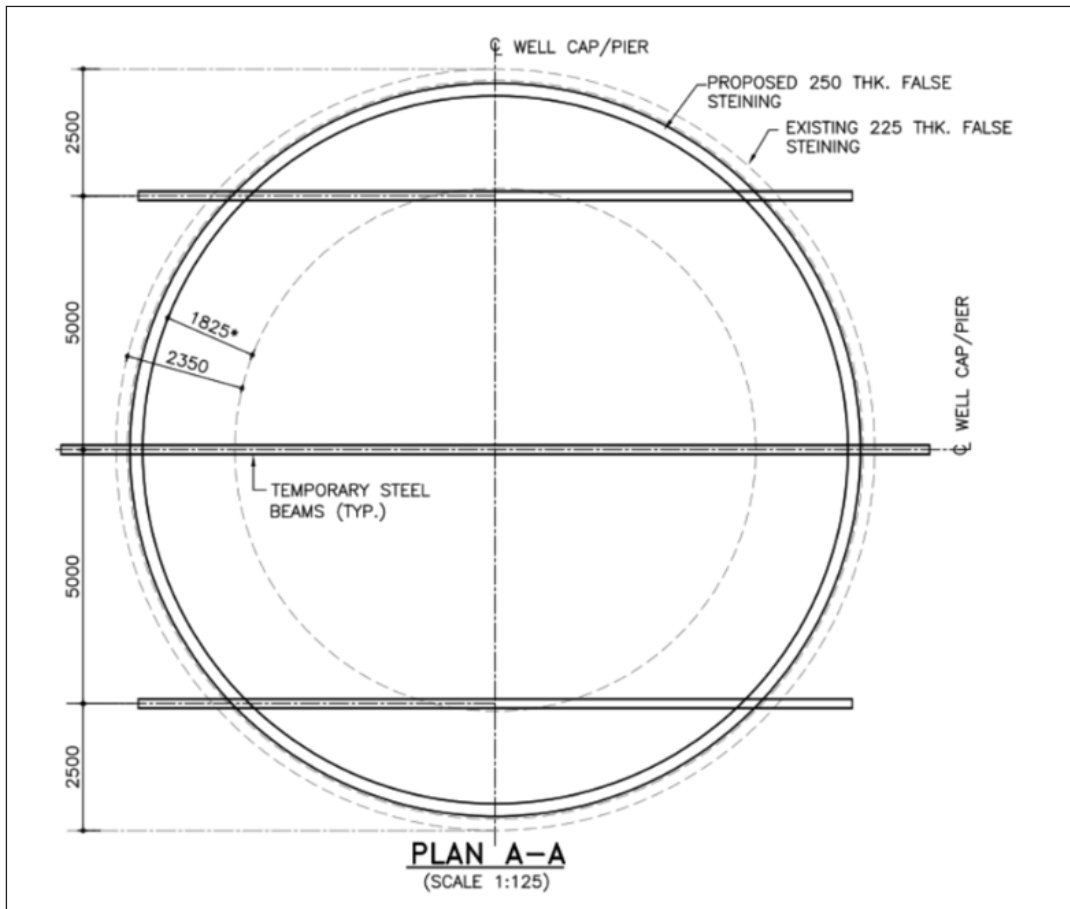
Fig. 7 : Temporary supporting arrangement for the distressed false steining

- Provide temporary support to the distressed false steining using suitably designed steel beams resting on sandbags at ground level (Fig. 7 & Fig. 8).
- As excavation around the well/false steining is not feasible due to site condition, exposed reinforcement of well steining at the failure location shall be protected using Conbextra GP2 grade concrete or its equivalent to prevent corrosion in future.
- Construct an additional layer of false steining inside the existing (distressed) false steining, with reduced height,

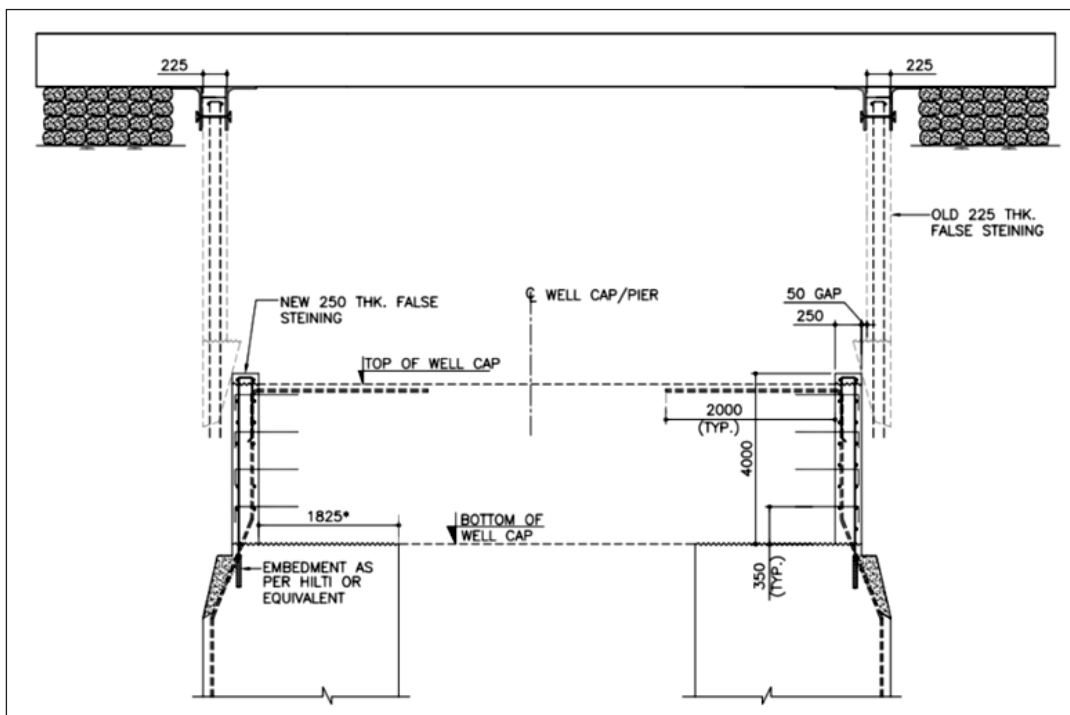
Fig. 8 : Sketch showing repair method

to prevent soil from escaping through the gap formed between the distressed false steining and the well steining (Fig. 8).

- d) Refer Fig. 8 for proposed repair strategy
