Confidential Reporting Of Structural Failures And Lessons Learnt

NEWSLETTER

A PUBLICATION OF INDIAN ASSOCIATION OF STRUCTURAL ENGINEERS

JANUARY-MARCH, 2024

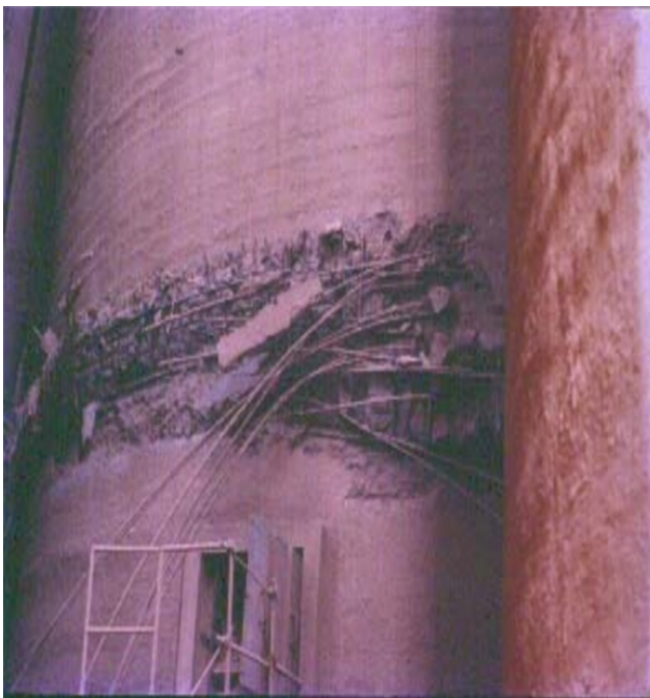
Fig 3 : Crushed Concrete

There was crushing of concrete noticed at a height of about 7 meters. Tilting of silo occurred slowly in all taking about 25 minutes. The direction of the tilt kept on changing and the silo finally leaned along the line bisecting the packing plant and adjoining silo at right angle and got supported on the latter.

Detailed investigation revealed that during construction of this silo, when the height of 7 meter had been reached, the shutters got stuck up. There was interruption of more than a month in concreting operations at that stage. It appears, that sufficient precautions were not taken to ensure proper continuity of wall. The concrete at that level remained weak. Joints are source of weakness and need to be treated properly to achieve same quality of the concrete. Though the silo was in operation for a year or so, it was never filled full. The failure occurred only when it happened to be full.

The failure of the Silo no. 3 when it was in use, filled with cement, due to the local crushing of concrete at an improperly treated construction joint puts a sharp focus on the needs for proper treatment of construction joints before proceeding with further construction. Slip form technique was abruptly halted at 7m when the shutters got jammed and insufficient/incorrect treatment of this construction joints before resuming further construction leading to the crushing failure of the concrete at this location at a later time.

Rehabilitation of the silo was carried out in mid-eighties when facilities for investigation were very limited. Reasons for failure of the silo were analysed by the engineers and designers of the cement plant. It is gathered from them that the quality of concrete in particular zone of the silo might have led to this mishap. In conclusion it may therefore be said that quality of concrete should essentially be maintained in all parts of the structure during the construction.

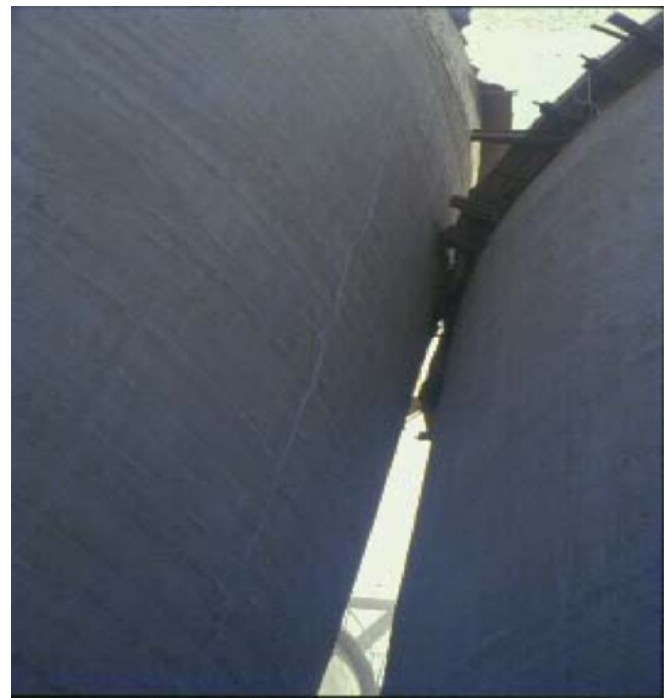
Fig 4 : Tilted Silo

Out of four silos, silo no.3 as shown in the above figures was in operation for about an year. This silo however was not used for full capacity. After a year in 1985, when the silo was being filled to almost full capacity, it got tilted by two meters and leaned upon adjoining silo which was full with cement at the time of the accident. But for the support from adjoining silo, the silo no. 3 would have collapsed resulting into a major accident. Fig No. 3 & 4 shows the tilted silo.

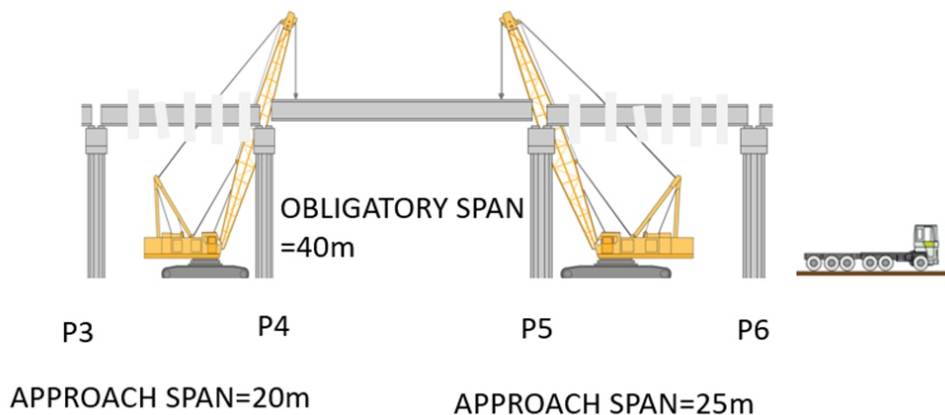
Fig 2 : Erection of Obligatory Span

The pier cap during the construction phase shown in FIG2 is subjected to shear, flexure as well as torsion. It was concluded that the missing torsion check and required detailing of reinforcement for the same was the reason for the appearance of the cracks. It was decided to check the provisions in IRC Codes for construction stage which is discussed in the next section.

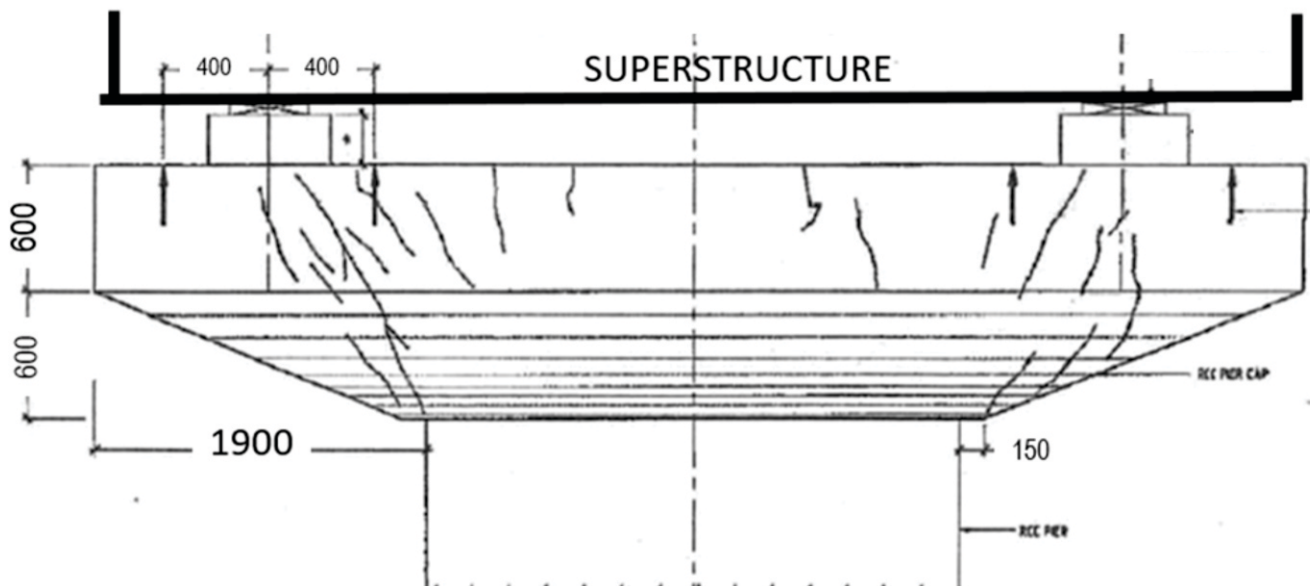
Fig 3 : Cracks in Pier Cap at P4 as Seen from Obligatory Span Side After its Erection.

The pier caps P4 and P5 showed cracks upto 0.4mm , FIG-3, before the last operation of erecting spans P3-P4 and P5-P6 could be started.

The design of pier caps was checked, and it was concluded that during service condition the design was meeting the provisions of the code IRC 112. The design of pier, piles and pile cap were checked and found to be in order for the service stage as well as this particular construction phase, FIG2. However the design check of pier cap for this construction phase was missing in the designs and was taken up for further study.

- a) The check for torsion in pier caps in service as well as construction stage is essential, and so also the detailing of the reinforcement.
- b) Crack width check needs to be introduced as part of the SLS check during construction stage along with recommendations of the limiting crack width in IRC112.
- c) In IRC6, changes in Table B-3 should be made to be in sync with (b) above.

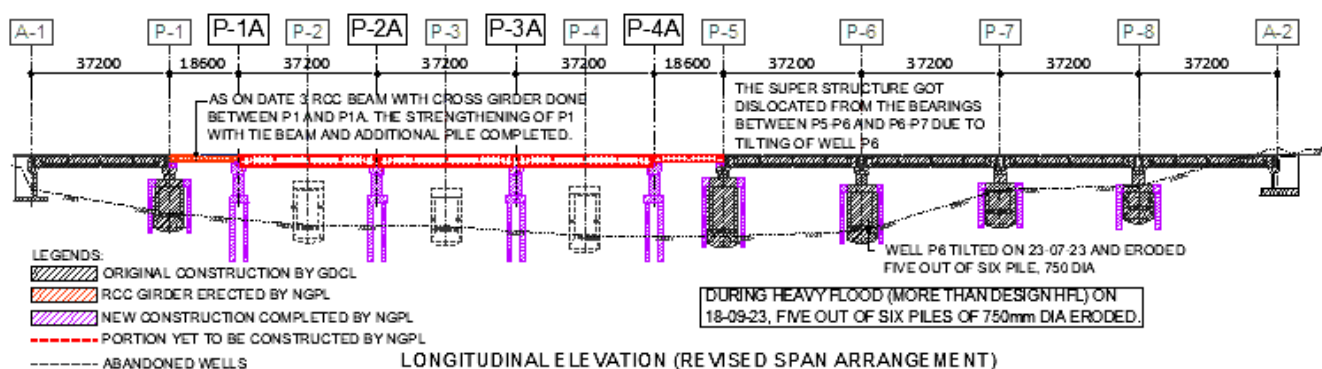
Fig. 2 : Span Arrangement of the Bridge as per Revised Design

- g) During the monsoon season in 2023, Well P6 tilted significantly towards upstream. The tilt is visibly about 20 degrees. The spans resting on this foundation shifted, tilted, and also got dislodged from bearings. Though these spans did not get completely dislodged from the top, but were hanging in a precarious position at the time the reporter visited the project site. The water level at the time of this incident was reportedly much below the design HFL. The 750mm diameter piles surrounding the well P6 were reportedly not visible after this tilting of the well. These piles either broke due to the tilting of the well foundation or got uprooted from the base itself. The exact position of these piles was unknown. It was reported that the ring piles constructed surrounding other wells were intact and no damage was visible. It was also reported that the flood level in this monsoon exceeded the design HFL by about 600mm to 700mm. The water marks in pier cap indicated that the it has touched the top of sloping portion of pier cap.
