REPORT No. CF-37

Failure/Distress of Post Tensioned I Girder during Prestressing and Lifting Operation

Impact of Ignoring Hydro-morphological Effects of Mighty Rivers in Planning of a Bridge – A Case Study

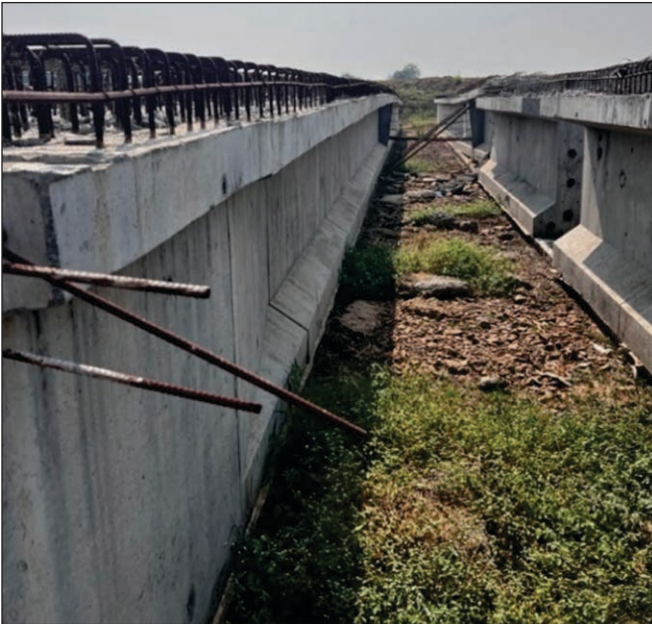
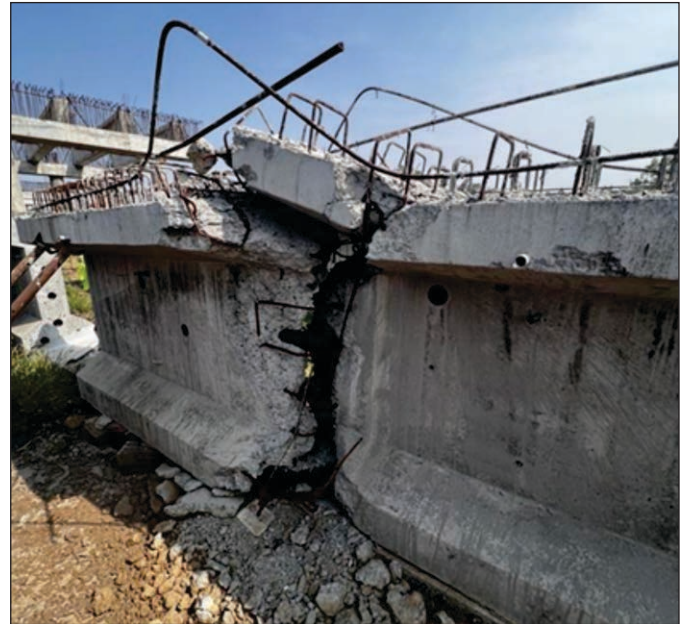
The RCC girders were erected in position and did not show any distress. During stressing of the PSC-I Girders, it was noticed that the girders hogged more than 250mm at the mid span. Post-stressing the girders failed due to concrete crushing.

3. Probable Causes of Failure

Drawings suggest that all cables shall be stressed when beam concrete is 28 days old with minimum concrete strength of 45MPa. The design calculations indicate that the girders were actually designed for a concrete grade of M50. At the time of stressing, the actual concrete grade, as per core test was found to be less than 30MPa

Compressive Stress:

As per the design calculations, The maximum compressive stress at the bottom of the girder during lifting is 22.23MPa.

Permissible limit of compressive stress during construction is $0.48F_{ck} = 0.48 \times 30\text{MPa} = 14.4\text{MPa}$.

It is pertinent to note that from the photographs, the girder was cast on the ground with multiple support points along its length. There should have been removed prior to prestressing so as to mobilise the dead weight of the girder cast against excessive hogging deformation during prestressing. The stressing operation appears to have been done without the benefit of this Dead Load to counter the second order moment due to hogging deflection.

Construction Stages: Attention should be paid to construction stages, especially when implementing integral type arrangements of precast PSC-I girders. Stressing all cables in a single stage can make the girders vulnerable. Consider staged stressing of the tendons to reduce the risk of excessive deflections and concrete crushing.

L/D Ratio: Ensure sufficient depth during construction and stressing when the composite section is not active.

Monitoring and Testing: Regularly monitoring and testing the of concrete strength and girder performance during construction is important to detect and address any issues promptly.

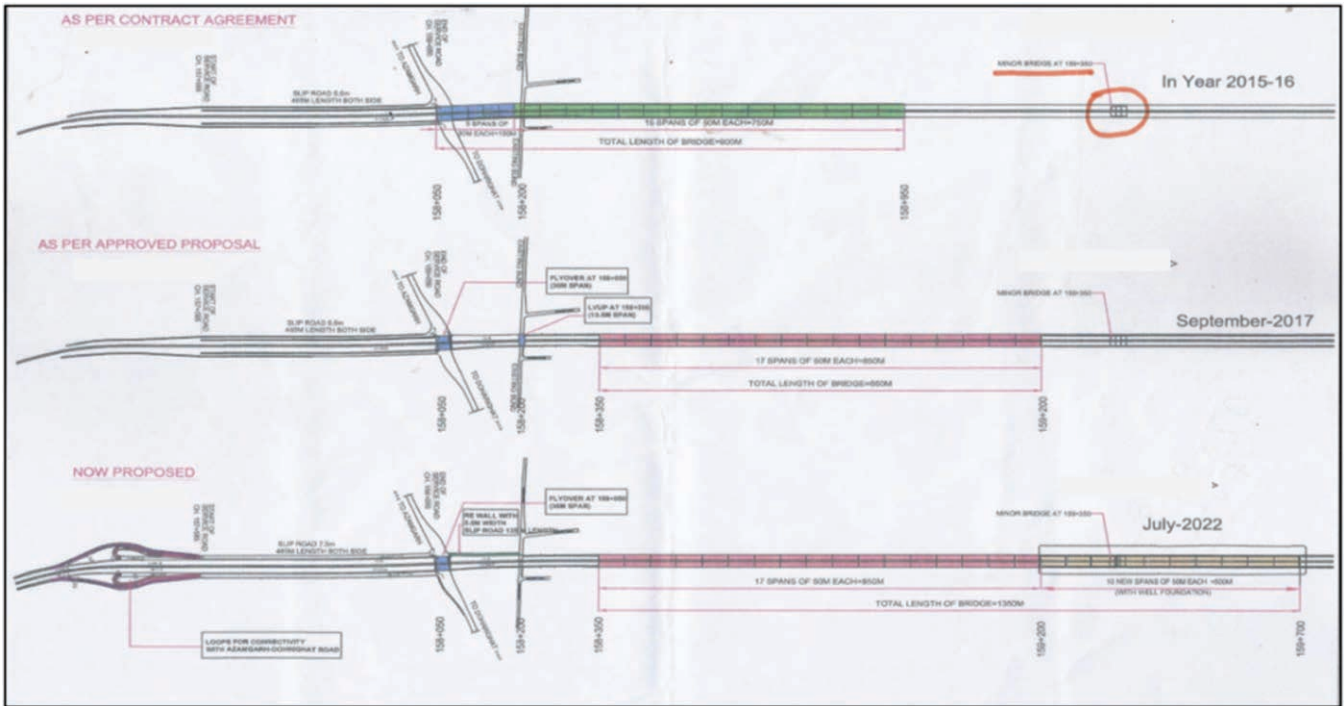
Fig. 1 : Showing the changes in bridge location, and length with passage of time

- b) *Year 2015-16* : As per the original Contract Agreement, the bridge proposed as per the DPR was with a span arrangement of 5x30.0m + 15 x 50.0m forming a total length of 900m. The bridge start point on the right bank was at chainage 158+050, which was about 200m behind the existing guide bund. Reason for extending the bridge length beyond the right guide bund was essentially to fly over a cross road close by.

- c) *Year 2017* : When the construction started on ground, it was realized by all stakeholders that the bridge position do not cater to the requirement of the stream, which was already flowing more towards the left bank of the river. While guide bund was provided in the right bank, the left bank was left unprotected. After much discussion between all stakeholders, it was decided to shift the bridge by 300m towards the left bank, provide a separate flyover for the cross road and provide an LVUP over the bund road. The bridge length was reduced from 900m to 850m with span arrangement of 17 x 50m. Reduction in bridge length is apparently to adjust for the cost variation and avoid contractual variation in price.

- d) *Year 2022* : Mid-way into the construction, unexpected changes were noticed in the nature and direction of the river flow. The mainstream of the river was shifting towards the left bank at a rapid pace. This compelled the authorities to extend the bridge length by another 500m. 10 spans of 50m each was added. The revised bridge length was 1350m with span arrangement of 27 spans of 50m each, as against 900m envisaged in the original contract.

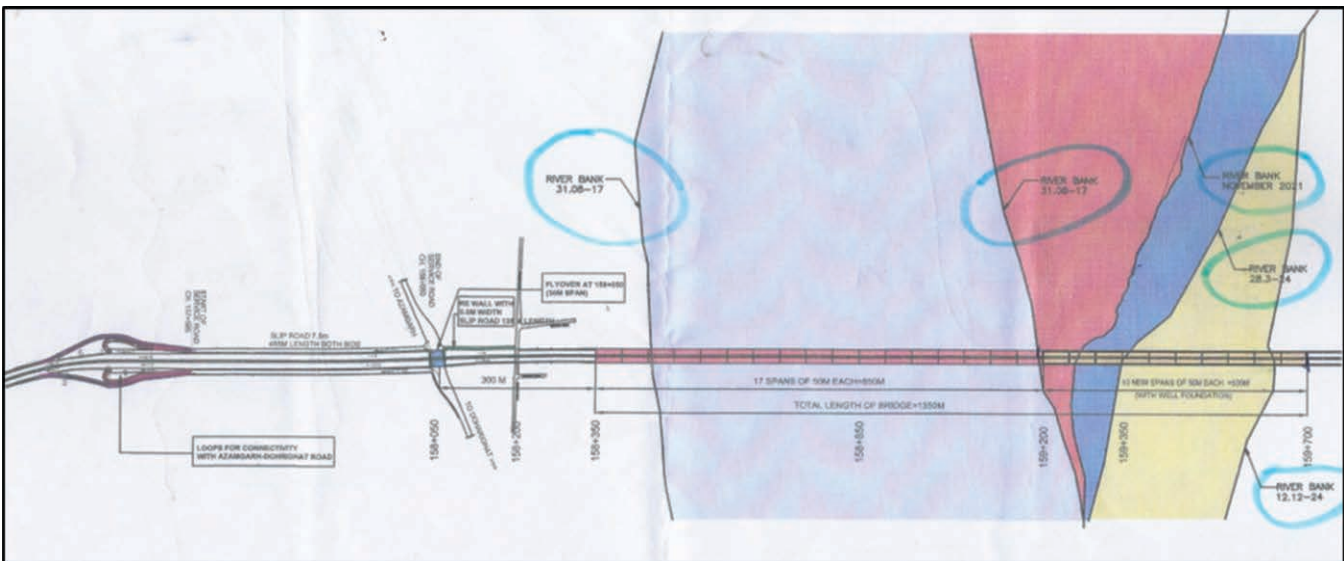
Fig. 2 : Showing Shifting tendency of river towards Left Bank side during previous years

- e) *Year 2024* : The bridge construction was completed and opened to traffic. Meanwhile the river further shifted towards left bank, cutting the banks close to the bridge. The river was flowing primarily towards the left bank.

- g) Lack of river protection in the left bank of the river threatens erosion of bank, including the approach embankment of the bridge. There is fear that the approach embankments of the bridge may get washed away unless some protection measures are taken on priority to protect the left banks, on both upstream and downstream of the bridge. The authorities were alarmed by this strong possibility and sought opinion from a team of experts to mitigate the problem.

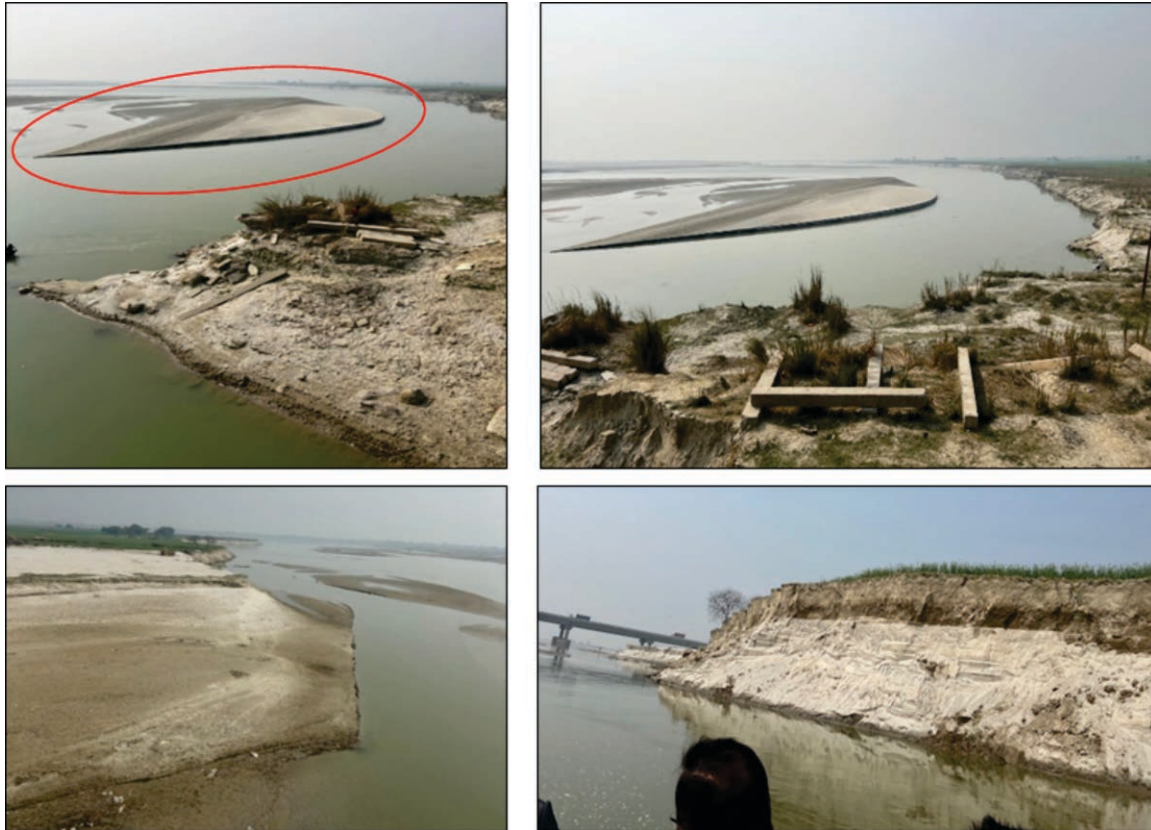
Fig. 3 : Showing Shifting tendency of river towards Left Bank side during previous years (Alarming situation w.r.to shifting during March.2024 to Dec.2024)

a) The expert team noted that on the upstream side of abutment (A2), the river has shifted beyond the abutment location by more than 50m in a period of less than one year, creating an island between the active channel and present bank of the river. Plate-5 shows some of the photographs of u/s side of riverbank. Fig. 3 shows some of the photographs taken from left bank abutment showing cutting of embankment towards the left bank (both U/S as well as D/S side), endangering the bridge approaches.

- c) Considering the present situation, where the river is eroding the unprotected left banks close to Abutment A2, the following short term (Immediate) mitigation measures to be taken on priority to protect the immediate approach embankments of the bridge so that the corridor remains functional post this years monsoon.

- i. To complete the balance construction activities of launching apron, slope protection works of the Abutment (A2) i/c slope of approaches, on priority as per the available Good for Construction Drawing (GFC).

- ii. To remove / clean the construction debris from the riverbed which was lying around the piers which block some portion of the river flow.
 - iii. To monitor during monsoon, the depth of actual scour at all piers in order to ascertain that the scour levels are still above the design scour levels of piers. Based on ground level / riverbed level profile @50m interval in upstream / downstream from the abutment (A2) indicates that the depth of erosion is around 7m to 8m at the time of inspection of the bridge. From the shifting pattern of the river, it appears that it may hit upon the approach to abutment (A2) in future if adequate river training works are not carried out timely.

- iv. There are existing flood embankment guide bund (top width about 5m to 6m with slope pitching) and impervious spurs (top width about 3m/4m, length about 150m, spacing about 200m with slope pitching) on right bank, near abutment (A1). In absence of any detailed studies, similar arrangement (with different length and spacing of the impervious spurs (repelling / deflecting / Sedimenting) may be provided on left. The tentative length of protection suggested (based on site visit) is :

- For a length of 1040m on the U/S side of Abutment A2
 - For a length of 250m in downstream side of Abutment A2This measure can be planned and implemented at the earliest. All relevant river training activities as remedial measures shall be carried out in the light of IRC:89-2019 "Guidelines for Design and Construction of River Training and Control works for Road Bridges" & Section 2500 of MoRTH Specification for Road and Bridge Works (Fifth Revision)

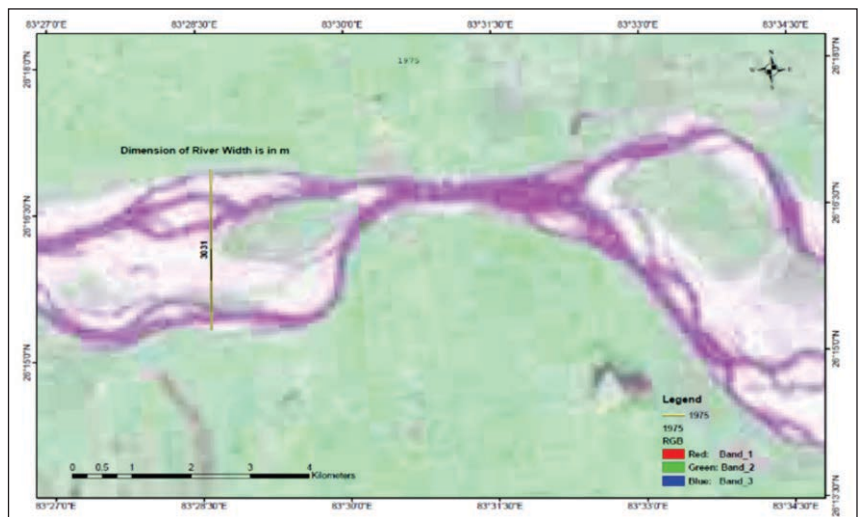
Fig. 4 : Showing Shifting tendency of river towards Left Bank side during previous years (Alarming situation w.r.to shifting during March.2024 to Dec.2024)

- b) On downstream side of left abutment A2 the river is moving curvilinearly creating back flow towards abutment and finally inclined towards center of river at a very large distance. Plate 6 shows some of the photographs of d/s side of riverbank.
- c) With the shifting of river towards A2 side, no major adverse effect of scour (based on the scour measured by the contractor) was noticed on adjoining piers.
- d) The slope pitching & Launching Apron on the A2 side was only partially completed and the team observed that this pitching work was of sub-standard quality not done as per standard specifications (Plate-1 (a & b) above).
- e) Based on local inquiry, it was confirmed that the river is extensively meandering in nature, and it was flowing 200m away from the present location of A2 in the year 1975 which is further confirmed through review of old satellite imagery as shown in Fig. 4.
