It gives me great pleasure to present the July-September 2025 issue of CROSFALL, IAStructE's flagship newsletter dedicated to the confidential reporting of structural failures and the dissemination of lessons learnt.

Report No. CF-40 : Cable Stayed Bridge - Failure during Construction.. **02**

Report No. CF-41 : Failure of Approach Embankment of A Major Bridge on National Highway during Monsoon **05**

Report No. CF-42 : Cantilever Bridges with Short Suspended Spans – A failed experiment of the past : A Case Study..... **11**

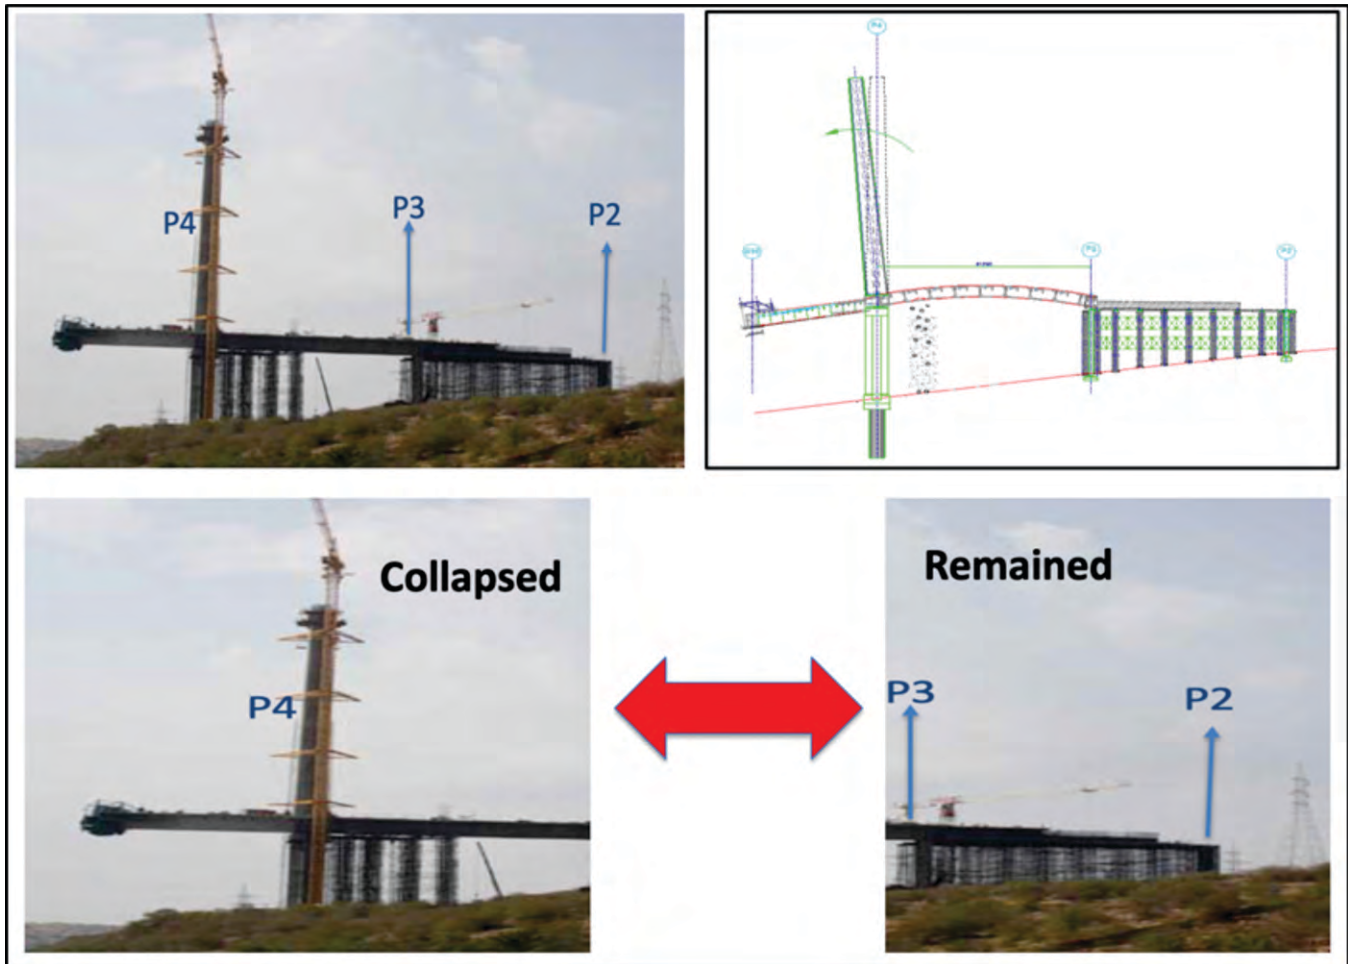
Fig.1 : Collapse mechanism of cable stayed bridge under construction

As per the eye witnesses report, the cantilever decking started drooping (Fig.1 right top) and simultaneously pylon on top of the pier P4 was tilting towards the river. The form traveller was sagging towards downstream (D/S) side in transverse direction, the pylon and cantilever together as a rigid body was rotating downwards till the cantilever along with form traveller hit the ground. The other eyewitness at the same time standing on the downstream side near the span P3-P4 observed that around 1/4th the span of P3-P4 towards the P4, the concrete dust and falling of pieces was observed following a breaking sound. The mapping of the debris (Fig.2 (a) &(b)) later revealed that the cantilever span was found upside down with its form traveller end near the P4 and the pylon with the span P4-P3 catapulted in to river by around 100 m. Half cast span P2-P3 was dragged on to the pier P3 by around 3 to 4m before being separated from the span P3-P4.

As per the report, change in the sequence of construction, poor quality of workmanship in counterweighing back span P3-P4, stabilising arrangement at the base of pylon P4 resting on guided spherical bearings and mechanical failure of the form traveller could be the probable causes of failure (Fig.1 & 2).

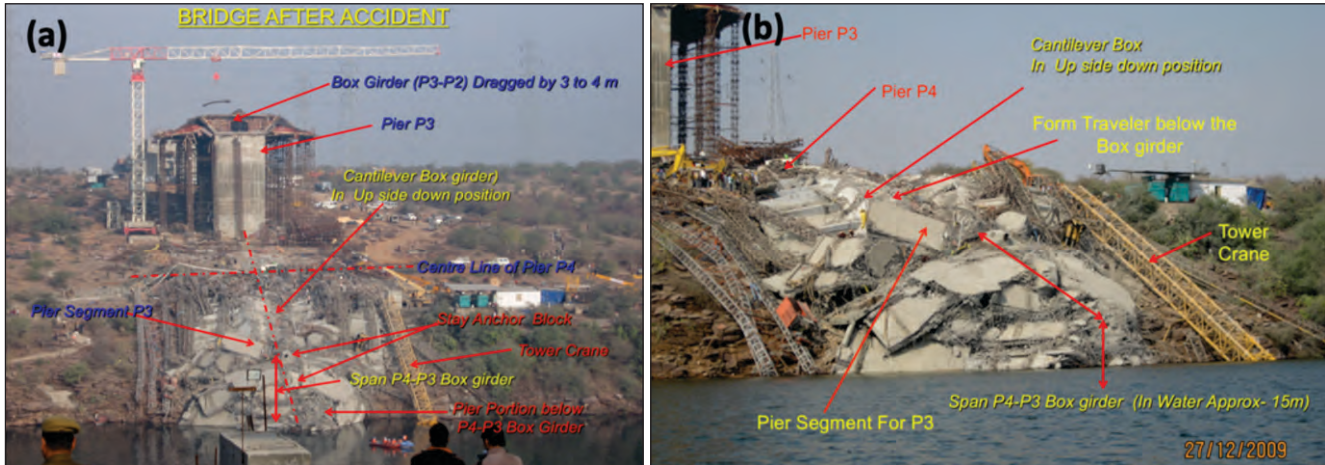
Fig.2 : (a) &(b) Mapping of the debris after the collapse of the bridge

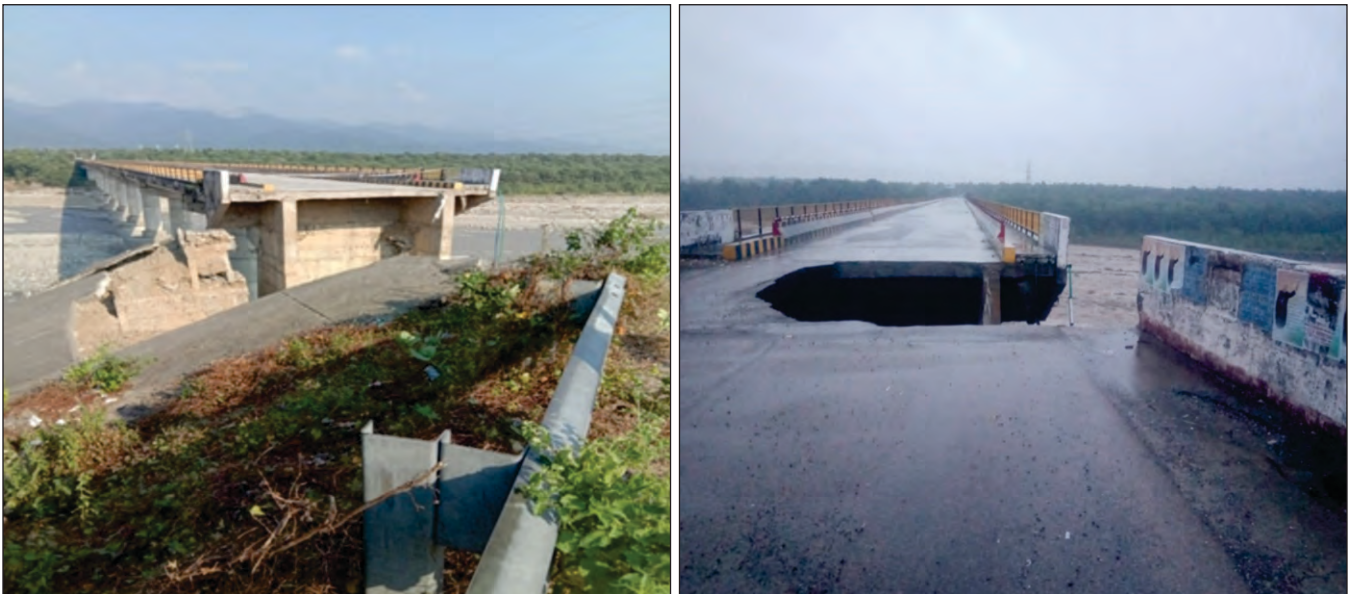
This case study is about Major Bridge constructed over a National Highway. Overall length of the bridge is 373.75m resting on well foundations. It is a Two-Lane bridge having footpath on either side. During heavy rainfall in the month of September 2024 part of embankment behind one of the Abutment (A1) has been washed out causing traffic disruption on this route. At that time traffic was diverted through another existing roads causing immense inconvenience to the road users. Considering the importance of this major bridge to remain always accessible, Authority decided to adopt proper restoration works, which calls for the inspection by the Structural Engineer. The purpose of the visit was to determine the condition of bridge and its protection works at site by assessing its existing site conditions, based on which the measures to be taken in selection of appropriate repair and/or rehabilitation works. Fig. 1 shows the photograph of the approach road behind Abutment A1 of the bridge.

Fig. 1: Approach Road behind Abutment A1

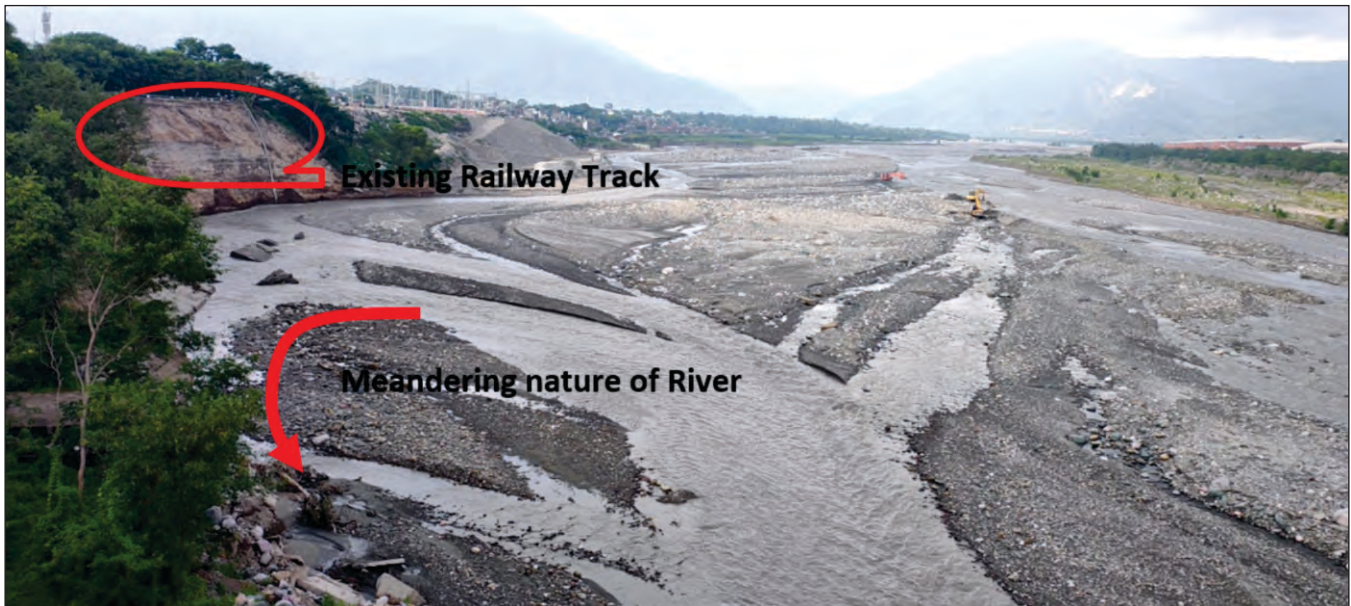
During site visit it was observed that the Bridge is located in meandering zone of the river (Refer Fig.2). These bends form due to unequal erosion and deposition along the riverbanks. Due to its meandering nature outer bank of the river is getting eroded enormously due to high velocity of water there, while inner bank accumulates sediments due to lower velocity. Due to its repeated embankment erosion almost in every monsoon, presently the Abutment A1 of the existing bridge is almost located into the main stream, obstructing the natural flow of water, leaving its approach embankment dangerously.

Fig. 2: Meandering nature of River causing Embankment Erosion on Up Stream Side on Outer Embankment

The flow towards the right bank is eroding the outer embankment on both the upstream & downstream sides of the bridge for a substantial length. Moreover it was observed at site that towards the downstream side of the bridge, illegal mining activities are happening, which is not far away from the bridge site. The visiting Team also got the information that during monsoon in the Year of 2021 similar mishaps happened there. May be some temporary restoration measures were taken at that time, which was incapable of providing any long-term solutions. It seems the high velocity river water is eroding the outer embankment repeatedly in each monsoon leaving the embankment dangerously and posing a threat to the existing bridge. The embankment erosion caused by the high velocity river water has already reached an alarming situation (Refer Fig.3 & 4). Other than embankment erosion there are other issues of general erosion of river bed, scouring in and around bridge foundation etc. Moreover on the upstream side near to the bridge, existing railway track is there which is running very close to the eroded outer embankment of river.

- v. To push main current away from the outer bank of the river, Groyne to be constructed at upstream side by properly investigating the site as well as by conducting proper hydrology analysis. The Groynes are required to divert the flow from the point of attack; thus protecting the river embankment from onslaught of water current.

- vi. Guide Bund is to be constructed as Bank Protection measures on both upstream & downstream sides along the river for at least 100m length, taking advice from Technical Agency. Guide Bunds are required to confine and guide the river flow without causing any damage to the bridge and its embankments & approaches.

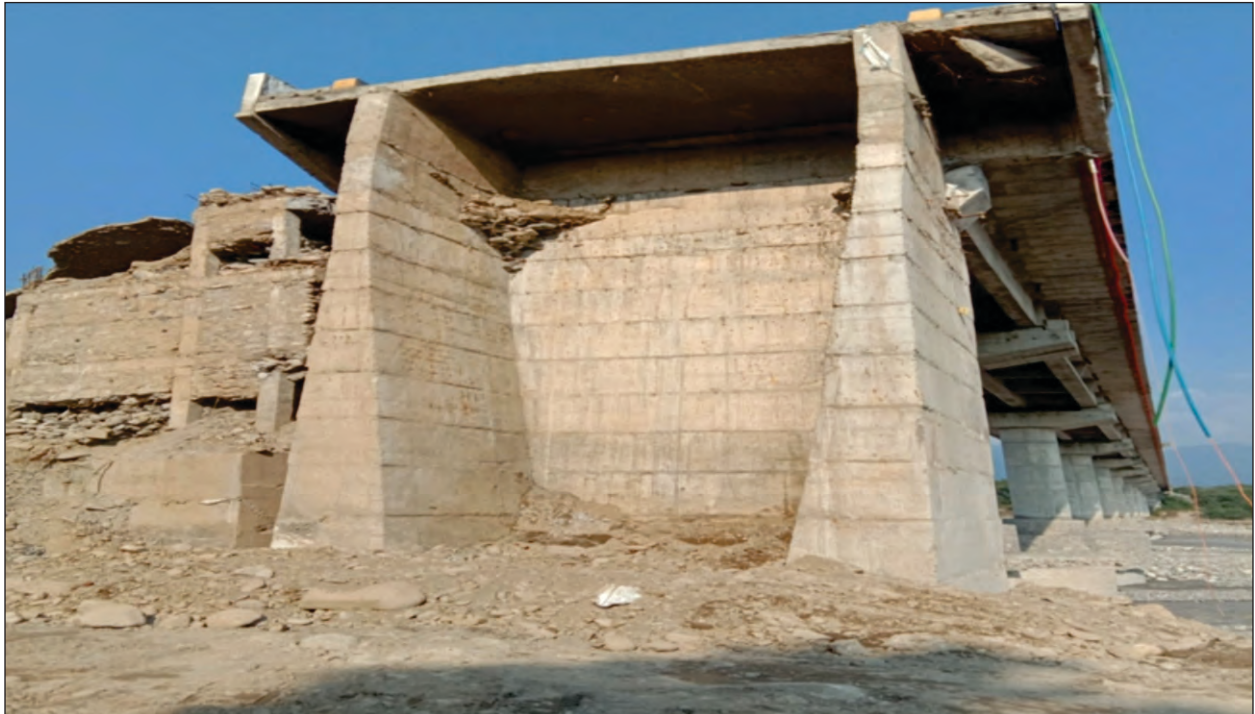
The main problem, as stated earlier, is that the approach road behind the Abutment A1 has been washed away during heavy rains disrupting the traffic on bridge. Temporary works, which was adopted partially in the Year 2021, was also got washed away. Probably at that time some immediate temporary measures had been taken at site to restore the traffic on this route as soonest possible, which didn't address all the issues.

Fig. 3: Wash out Portion of Approach Road behind Abutment A1

- i. Looking into the flow pattern of River additional span is required behind Abutment A1 towards the Approach side. The number and length of span should be decided by the Technical Agency after thorough investigations considering the meandering nature of the river. Any short term solutions, like back-filling the embankment and open the road for traffic, will not serve long term solutions.

- ii. Technical Agency need to review the original design of the bridge as the behavior of the bridge is getting modified, specially the Abutment A1, which will eventually become the Pier due to addition of new span. Design of this Abutment alongwith its foundation needs to be checked.

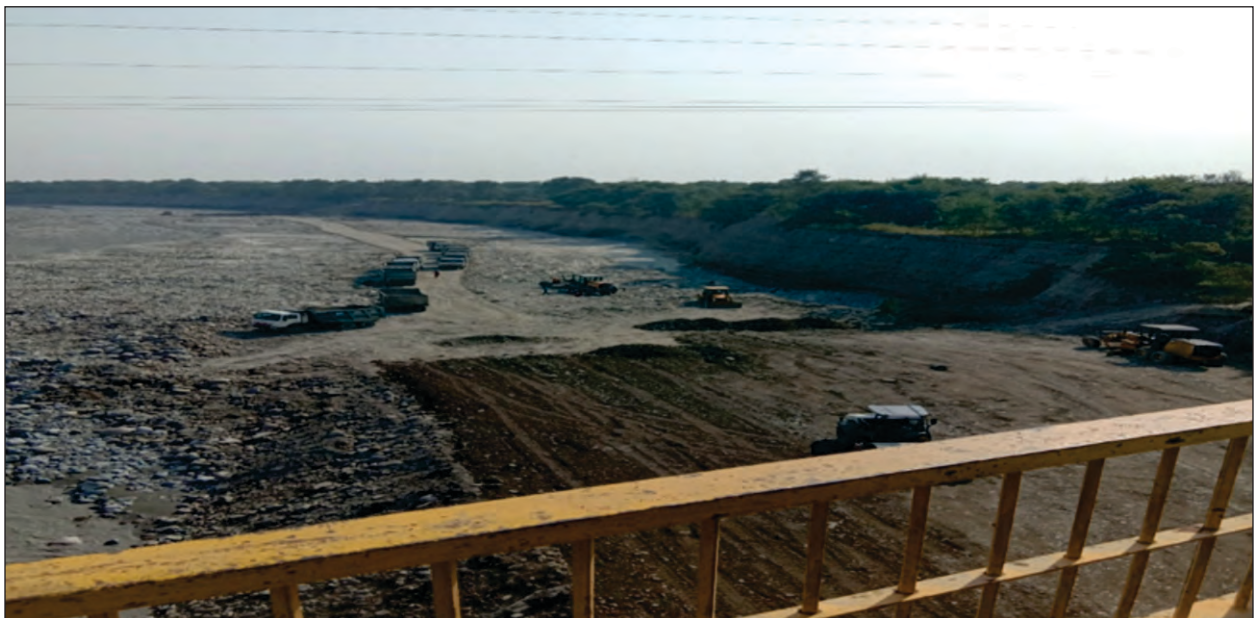
Fig. 4: Embankment Erosion on Down-Stream Side

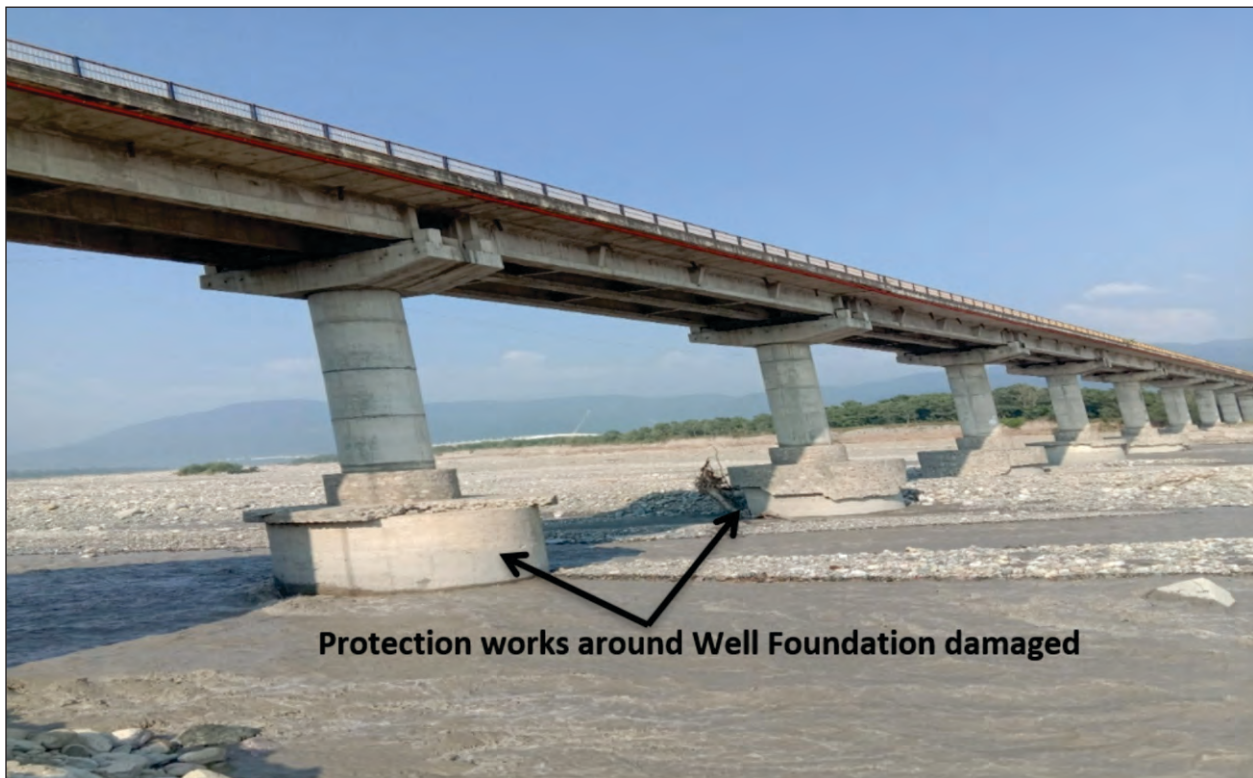
Fig. 5 : Exposed Well & Well Cap due to Scouring

- vii. As stated earlier severe scouring has been observed in and around Pier Foundations. To arrest the further propagation of scouring proper protection works are required in and around the Pier Foundations (Refer Fig. 5).

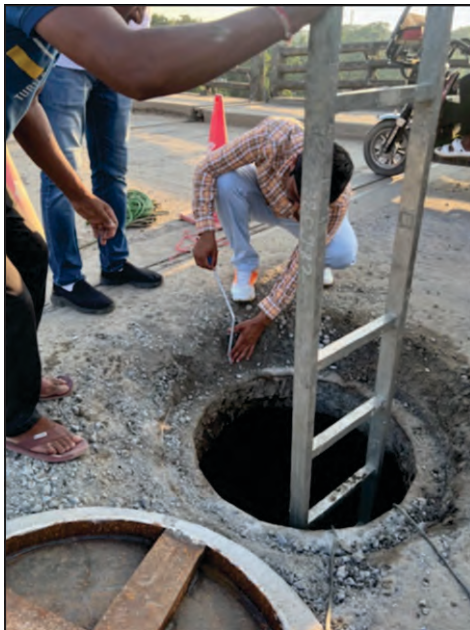
(Photo 1)

- (a) It is noted that the wearing coat for the entire deck has failed. There has been overlay done number of times over the existing RCC wearing coat. Measurement carried out at site revealed that the increase in wearing coat thickness ranges from 40mm (minimum) to 100mm (Refer Photo 1 & 2). This increase in overlay has resulted in an increase in the dead load over the bridge, which is undesirable.

Photo 1 : Checking excessive overlay thickness at deck, near man-hole

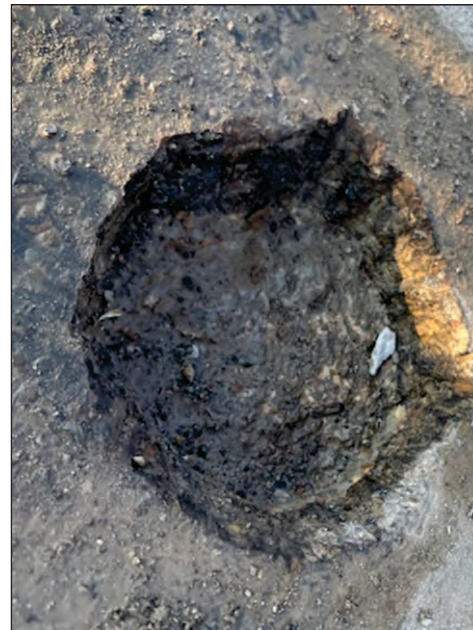
(Photo 2)

Photo 2 : Checking overlay thickness at deck, over pier location

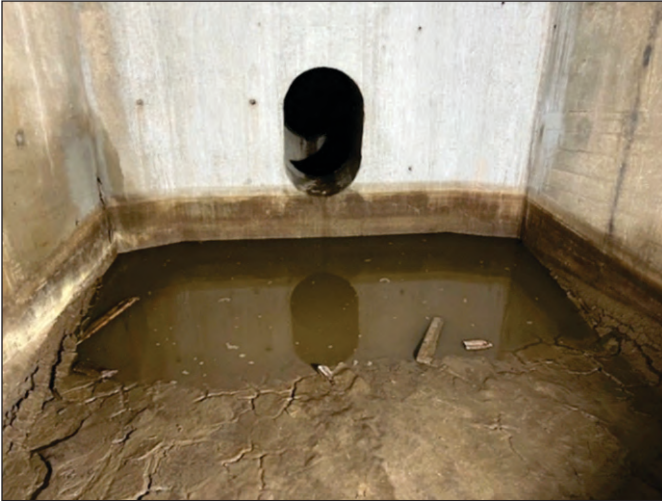
(Photo 3)

- (i) The inside of box girder is not clean. It has layers of mud all over. There is also accumulation of water in some part of the box girder (Refer Photo 3 & 4)

Photo 3 : Accumulation of Water inside Box Girder; **Photo 4 :** Accumulation of Soil Layers inside Box Girder

- b) The bridge should be relieved of some unwanted dead loads, which is lying inside the PSC box girder. Close inspection of the box girder (at two arms) on 6th October 2024 revealed that the box girder has layers of soil and mud throughout the length. A portion of the box girder from inside is also found filled with water (i.e. over pier P2). All these added loads of soil/mud/water should be removed from inside the box girder.

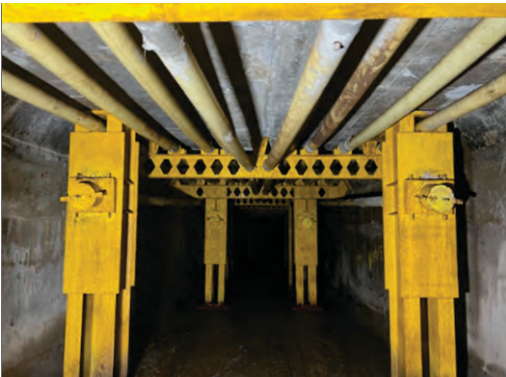
(Photo 5)

- (ii) External prestressing cables, introduced during the rehabilitation process which was carried out during 2012 appears to be functional. No cables were found broken in the two inspected arms. It is noted that the external prestressing cables are supported on steel framing at regular intervals. These steel framing structures would have increased the dead load on the structure, the account of which was not considered in the original design. Photos 5 show the external cables and the steel frames.

Photo 5 : External Cables & Supporting Steel Frames

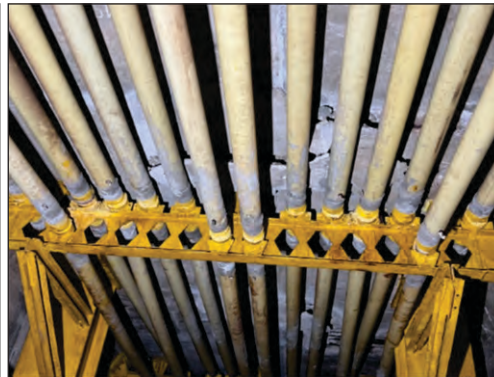
(Photo 6)

- (iii) At a few locations, the cover portion of the deck slab has separated and has fallen. Highly corroded reinforcement is exposed in these areas. Photos 6 & 7 show the details.

Photo 6 : Spalled Concrete from deck slab; **Photo 7 :** Spalled Concrete with exposed corroded reinforcement

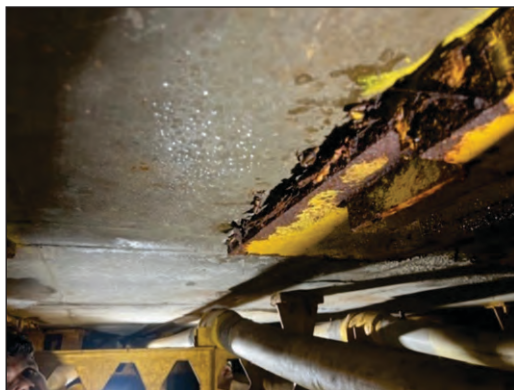
(Photo 8)

Photo 8 : Excessively corroded steel frame inside Box Girder; **Photo 9 :** Leakage of Water from connections

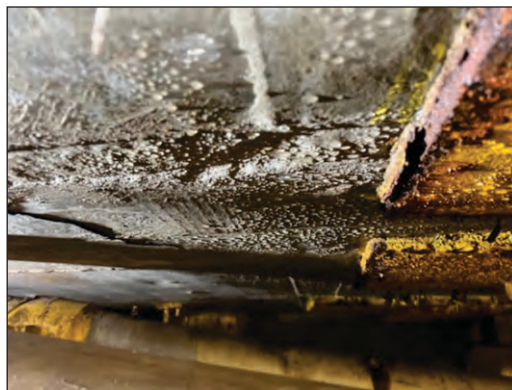
(Photo 9)

(iv) Water is found to be trickling inside the box girder from deck top (as it was raining outside), particularly at locations where the steel frame is attached to deck (Refer Photo 8 & 9). The inside of box is fully wet and is impacting the durability of the structure.

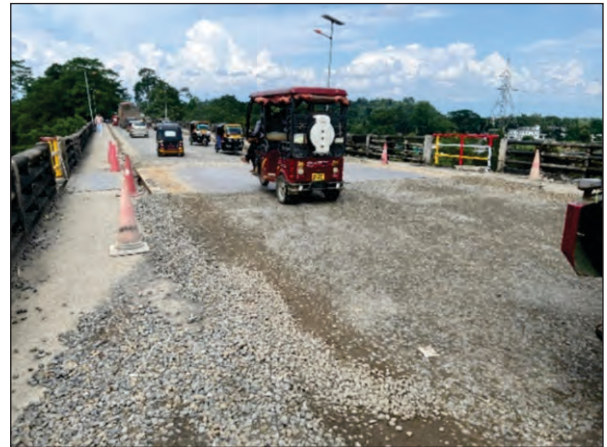
(a) Suspended span between Pier P1 and P2 was reportedly in extremely bad condition. Flange plate and web plate were broken at the bearing location. Before my visit, authorities, very rightly introduced a separate bridging span bypassing the suspended span. Though this solution helped to avoid a catastrophe, the solution adopted involved adding load over the distressed bridge. A rough estimate shows that additional load imparted at the middle of span is around 40 tonnes on this count. Proposed solution as adopted in shown in Photo-10.

Photo 10 : Bridging Span created at middle of P1-P2 to bypass Suspended Span

- c) A short steel deck was added recently at the location of the suspended span between pier P1 and P2, since the suspended span was reportedly in failure condition. The steel deck is supported on the tip of the cantilever box girder and is about 250mm to 300mm above the deck

level. Ramps are created for a length of about 9m on either side of the steel deck to facilitate easy passage of traffic. However, in the process, an additional load of about 30t to 40t is added. It is suggested that this ramp length be reduced to about 5m on each side so that at least this added load can be reduced to a minimum.

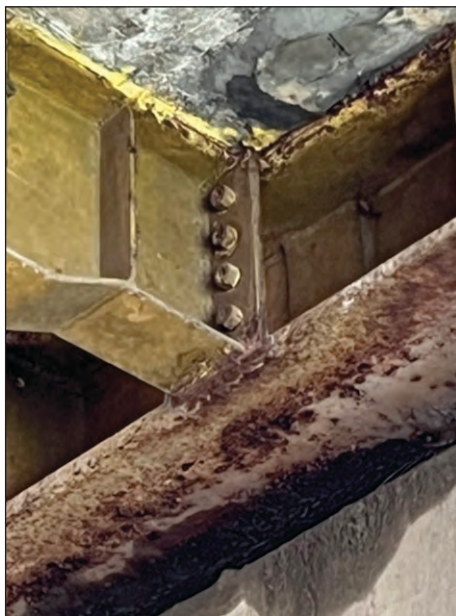
(Photo 11)

(b) Inspection of suspended spans and floating spans from deck top indicates that they have failed from serviceability considerations. It was not possible to inspect the suspended spans from below (where actually the problem lies), due to lack of adequate arrangement for underside inspection at site. However it was possible to inspect the floating span towards P4 (Badarpur side) from the land towards railway line. It is clear that the structural components of floating span is in failed state. Bearings transferring load of floating span to substructure has also failed apparently. Expansion joints have failed. These spans are hazardous for the running traffic and should be replaced at the earliest. Photo 11 & 12 shows the position of floating span at P4.

Photo 11 : View of longitudinal girders of floating span at P4 showing extent of corrosion in girders

- a) It is proposed to eventually replace all the existing suspended spans and floating spans and expansion joints at the earliest.
- b) The present condition of these elements clearly indicates that they are short-lived and sooner rather than later, these components will give way. Therefore, it is proposed to replace the suspended spans and floating spans with prefabricated steel decks, which should be simply placed at the location after demolishing the existing suspended spans.

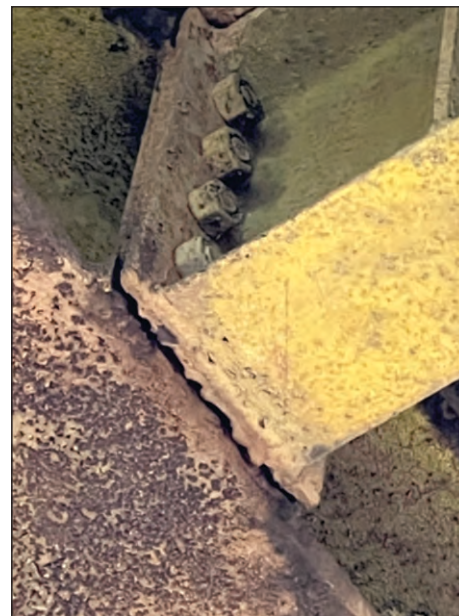
(Photo 12)

Photo 12 : Longitudinal girder cracked at support – the girder is precariously positioned and can loose support any moment

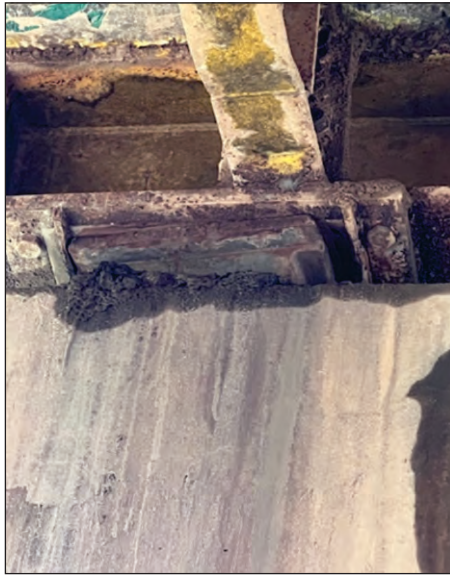
(Photo 13)

- (a) All bearings supporting suspended spans and floating spans have failed. Also all expansion joints have failed. Photo 13 & 14 shows a typical failed bearing and an expansion joint which has failed.

Photo 13 : Suspended Span Bearings displaced and rotated at P4 ; **Photo 14** : Failed Expansion Joint, Floating Span at P4
