# Confidential Reporting Of Structural Failures And Lessons Learnt

## NEWSLETTER

A PUBLICATION OF INDIAN ASSOCIATION OF STRUCTURAL ENGINEERS

July – September, 2022

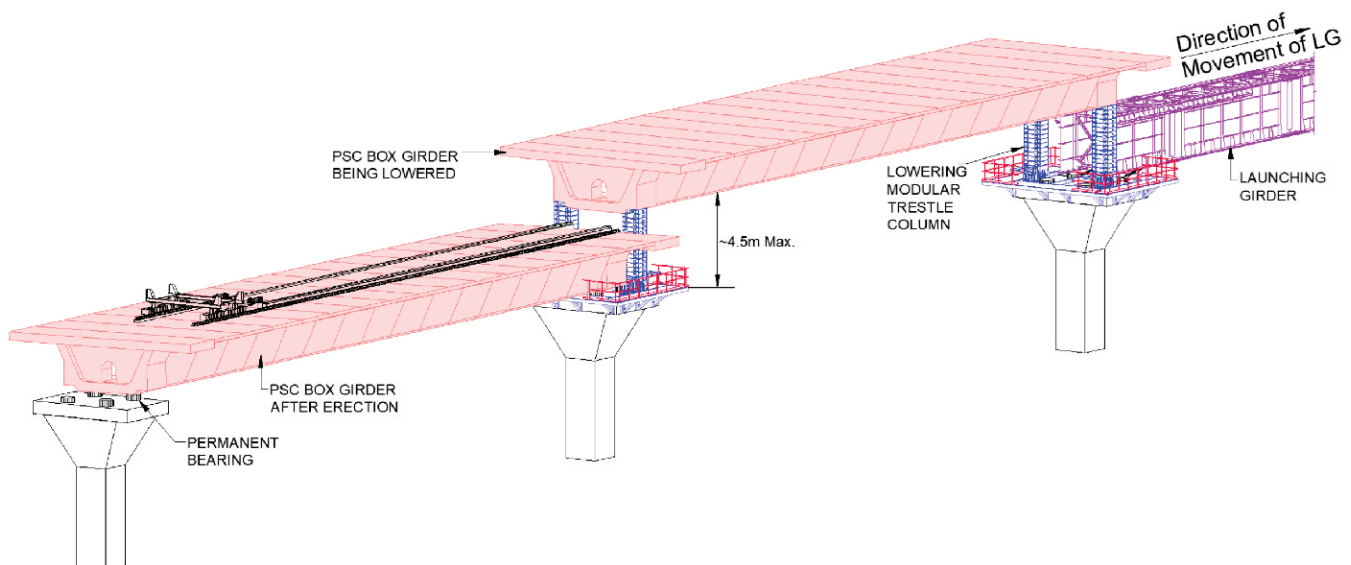
TYPICAL SKETCH SHOWING LOWERING ARRANGEMENT OF PSC BOX GIRDER

After the successful erection of a couple of spans in this bridge, failure occurred when one of the spans was being lowered. The incident occurred in the middle of the night when the lowering operation was being undertaken by the executing agency. It was reported that while lowering the span, one of the hydraulic jacks failed which triggered the failure of other adjacent jacks resulting in instability and fall.

The reporter found that the launching/lowering operation adopted in this project is NOT commonly in practice for highway bridge construction. The lowering scheme was found to be highly vulnerable to any jerks or mechanical failure of hydraulic jacks. The modular trestle used for lowering the span was neither connected at the top nor at the base and was not braced in any direction. The reporter could not find the checks for the stability of the trestles for the safety aspect during lowering.

- a) The scheme of lowering of PSC girder provided in this project was not a commonly used launching system. All stakeholders (i.e, the executing agency, the design consultant and the approving agency) should have exercised extra diligence in finalizing the scheme of erection. Stability checks for the temporary works during construction must be performed. The performance of any erection scheme and structural adequacy of the proposal should be ascertained prior to its finalization.

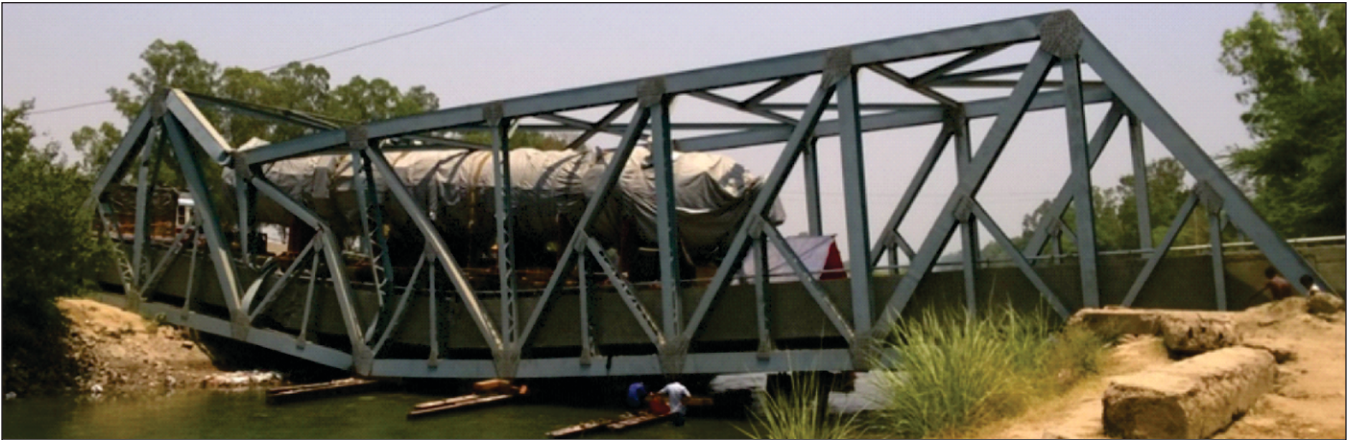
Fig. 1 : View of the Collapsed Bridge Over Canal

In this case, the transporter tried to deviate from the allotted route as he could not pass the vehicle with 6.0 m height through a ROB with 5.5 m clearance and moved the vehicle carrying GVW of 305 MT over this affected bridge designed for IRC Class 70 R/ Class-A loadings. The bridge failed instantly with the vehicle on it and settled by more than about 2m at the 3/8th nodal point from one end of the bridge. Due to the shallow depth of the canal bed from the soffit of the bridge, the bridge did not collapse completely and stood in its position with the consignment trapped inside.

The failure has occurred apparently due to the buckling of compression members, which was caused due to the passage of the OWC vehicle carrying GVW of 305 MT having axle configuration shown in Fig 3 on the bridge designed for IRC Class A/70R.

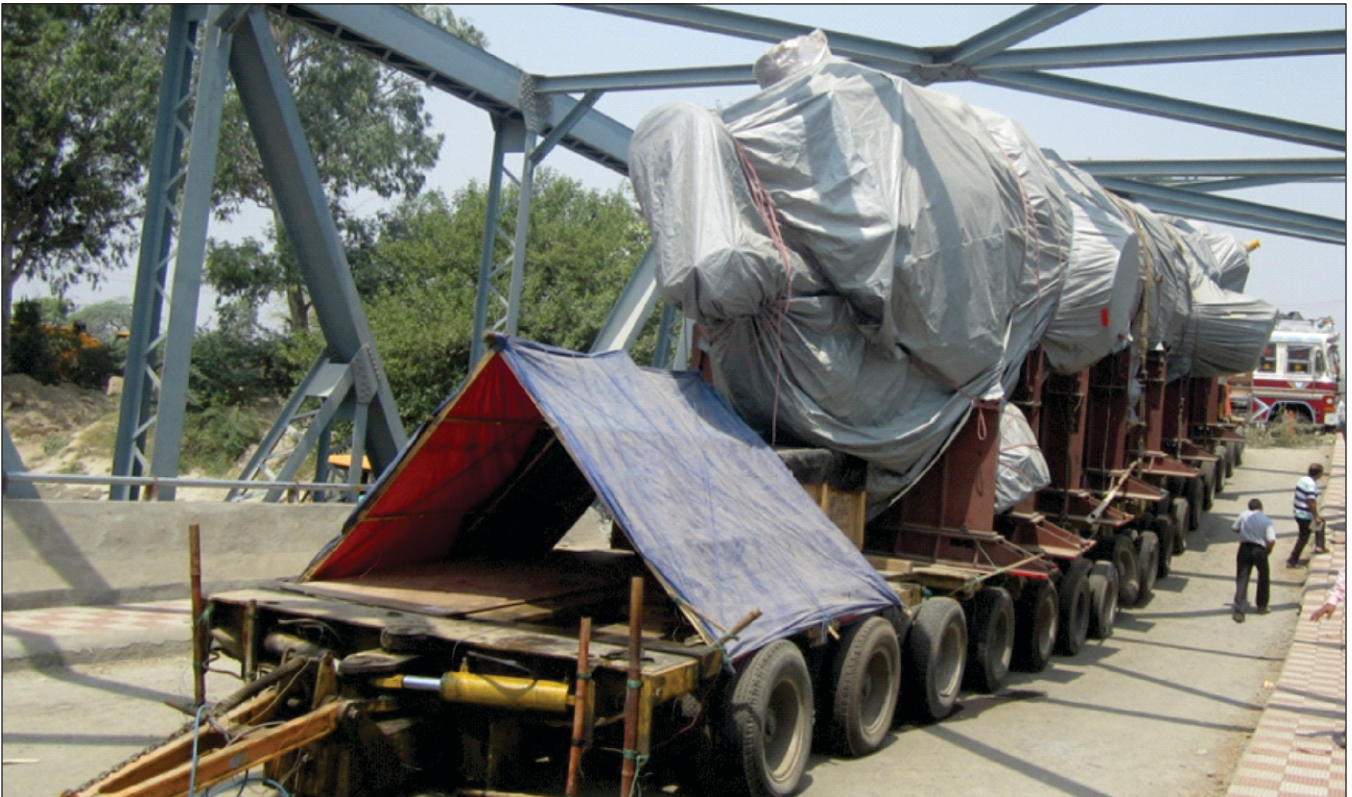
Fig. 2 : View of the OWC/ODC Vehicle on Collapsed Bridge

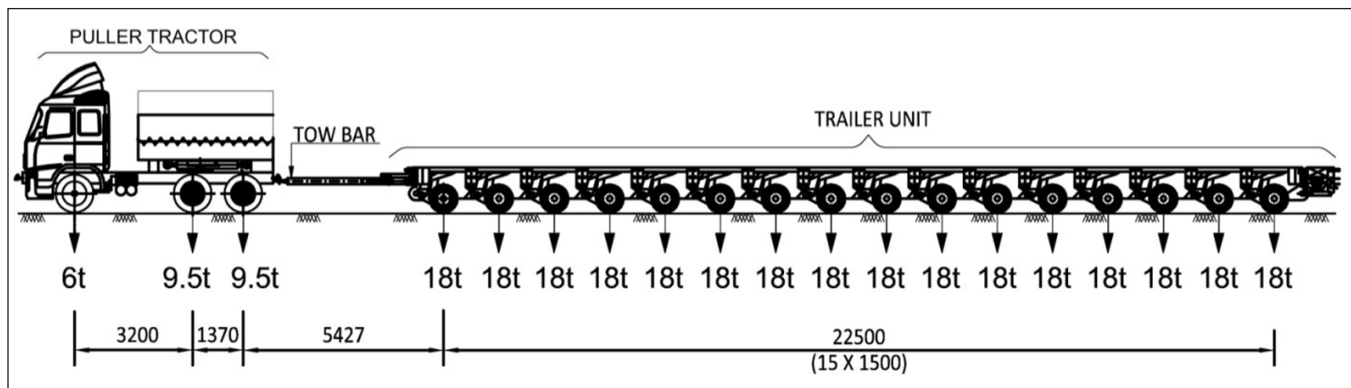
Fig. 3 : Axle Load Configuration of OWC/ODC Vehicle

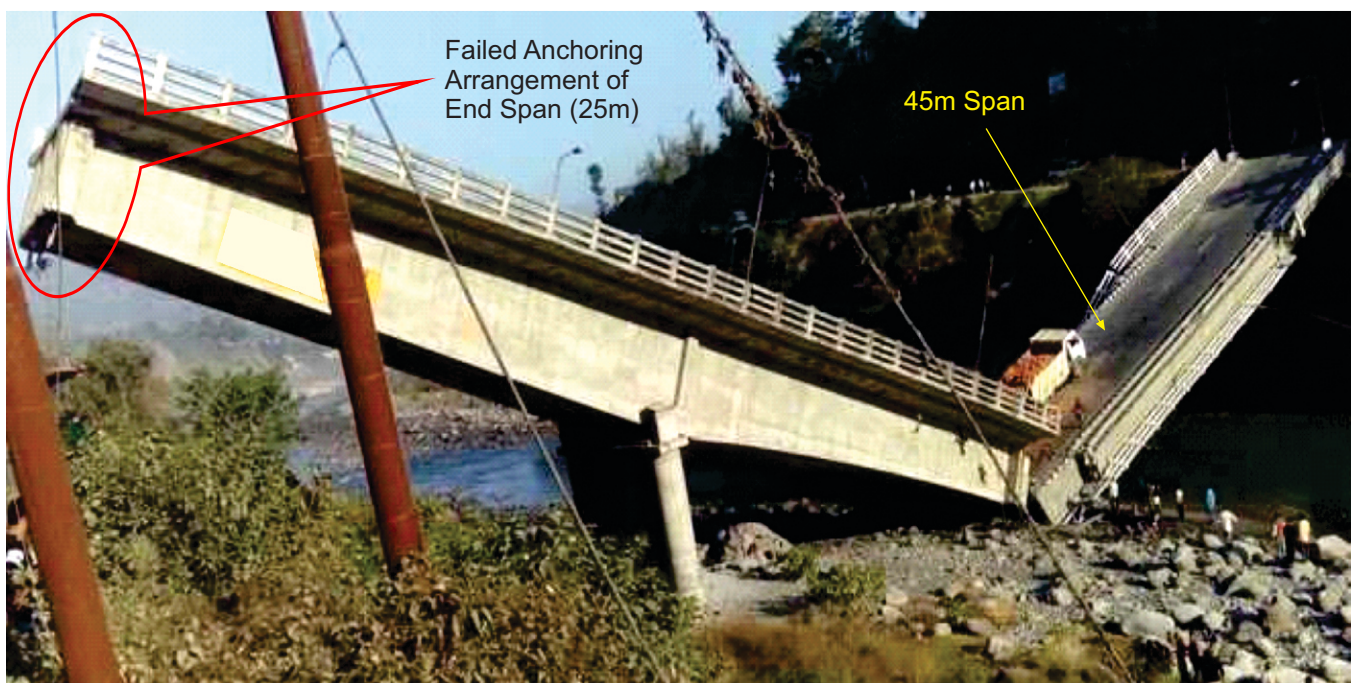
It is obvious by looking at the structural scheme that the abutment at the end supporting the 25m end span is subjected to an upward reaction from the anchor span, unlike a conventional deck which gives a downward reaction. It is understood that the deck was anchored to the abutment by using prestressing cables, which were provided between the abutment and deck, to carry this upward reaction force.

The reporter informed CROSFALL that scrutiny of the GFC drawings post-failure revealed that there was a mismatch between the design requirement as given in the design calculation and the GFC drawing regarding details of prestressed anchor cables which is the root cause of the failure of this bridge. As per the design requirement, 6 Nos U-shaped 6T13 cables were needed. However, the draughtsman noted the requirement as 6 Nos 6T13 cables and showed only 3 U-shaped cables of 6T13 in the drawing interpreting one U-shaped cable as two cables. It is clear that the actual stress in the prestressing cables was double the design value. Probably there was enough margin in the stress due to which the bridge survived for 12 years. However, with time, due to stress corrosion, coupled with high relaxation losses in prestressing steel and lack of maintenance, this sudden failure occurred, in which the whole bridge was lost.

- Also structural conceptualisation where the stability is entirely dependent upon the uplift anchors, which are permanently subjected to tension, should be avoided in the first place to the extent possible. In a box girder, there is scope to add counter dead weight inside the box, which could be used to nullify the tensile reaction.
