REPORT No. CF - 05

Failure Case Studies of Mechanically Stabilised Earth (MSE) Retaining Structures (Highlighting Importance of Connection Design in Performance)

REPORT No. CF - 06

Distress in three apartments in a multistoried building

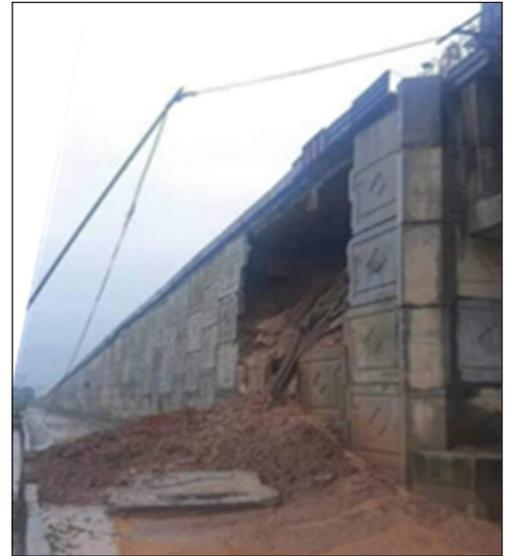
2.1. Case Study No.1: (Ref. Fig.1)

- Primary Cause:
- Connection failure, poor connection system and design
- Other added factors
- inadequate detailing
- Drainage criteria not examined
- Poor construction quality

Fig. 1 : Failure of MSE Wall for Case Study

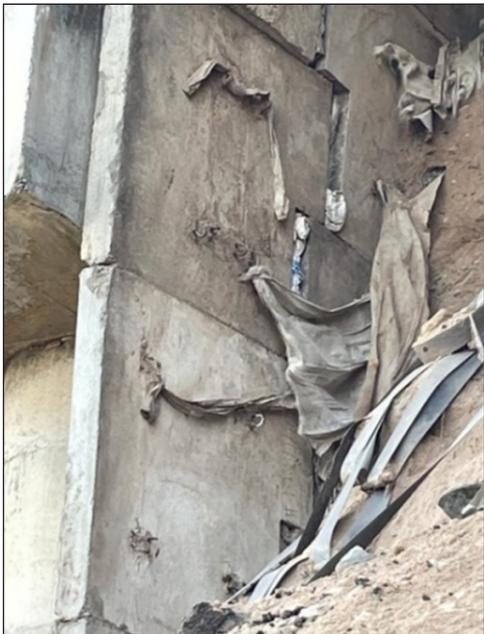
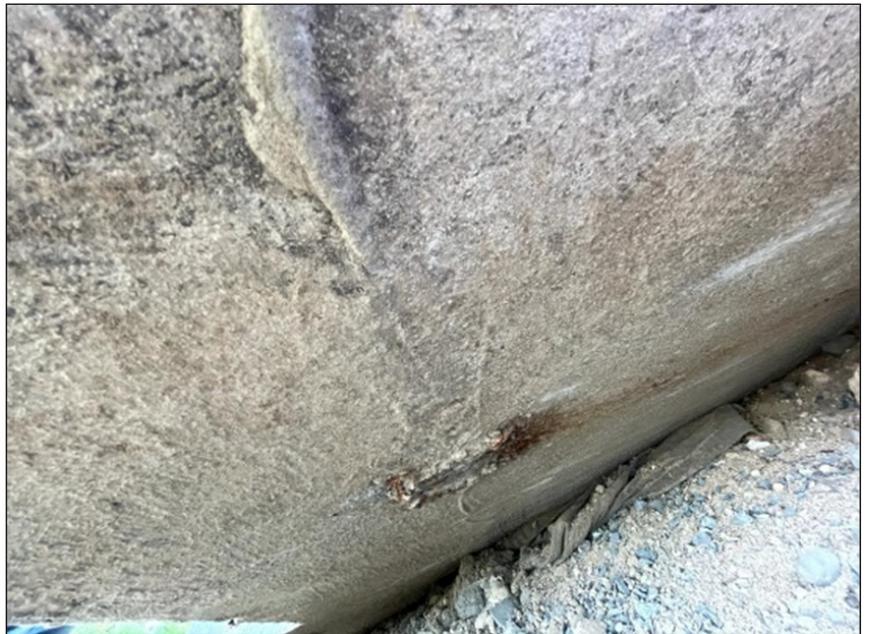
2.2. Case Study No.2: (Refer Fig. 2)

- Connection failure
- Corrosion at connection
- Can be either poor quality of galvanization or aggressive backfill
- Collapsed after 15 years- Long term durability issue

Fig. 2 : Connection failure at closing wall and collapse of panel

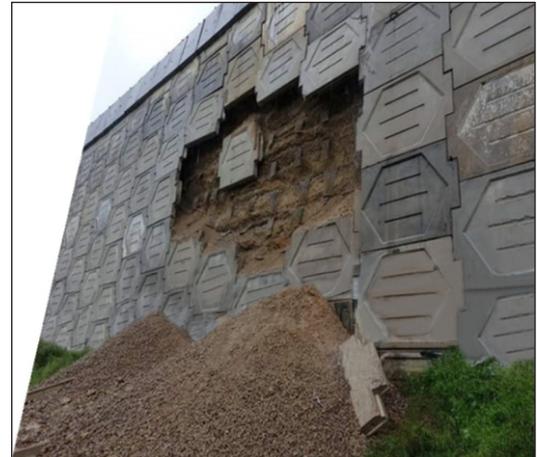
2.3. Case Study No. 3: (Refer Fig. 3)

- Connection Failure
- The intact reinforced fill is noteworthy.

Fig. 3 : Failure of MSE Wall due to connection

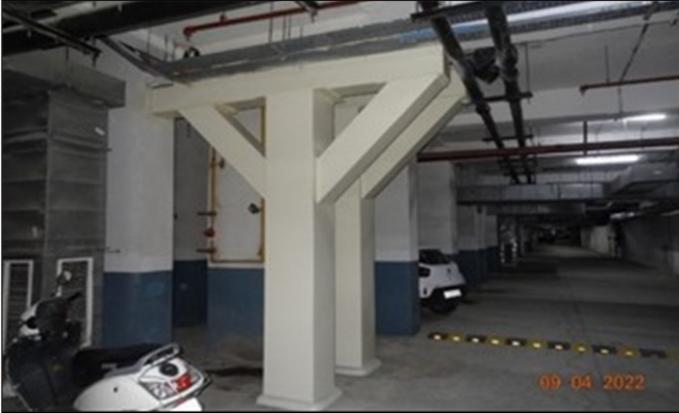
- (a) There has evidence of some basement roof beams being supported by fabricated steel supports to have been installed post-construction of the concrete members. As per the owners these steel supports existed in the building since the day, they occupied the building.
- (b) There is evidence of a concrete core-cut sample to have been taken from one beam, probably for testing the concrete strength of the beam. The date when this concrete core-cut sample has been extracted could not be ascertained.

Fig. 1 : Some basement beams are supported by fabricated steel columns.

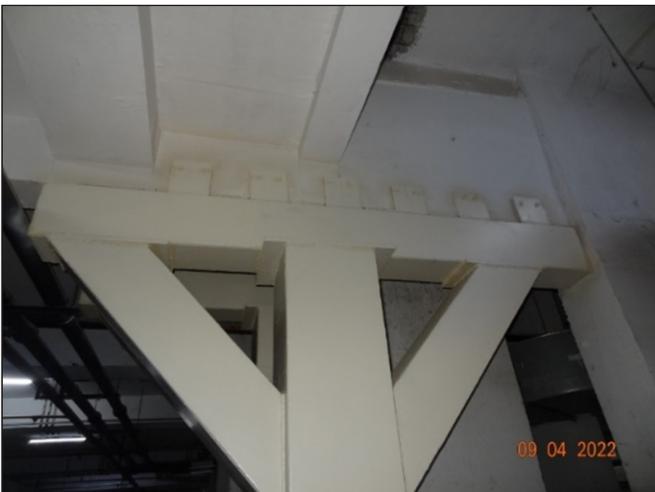
Fig. 2 : Side view of the steel column supporting the basement beam.

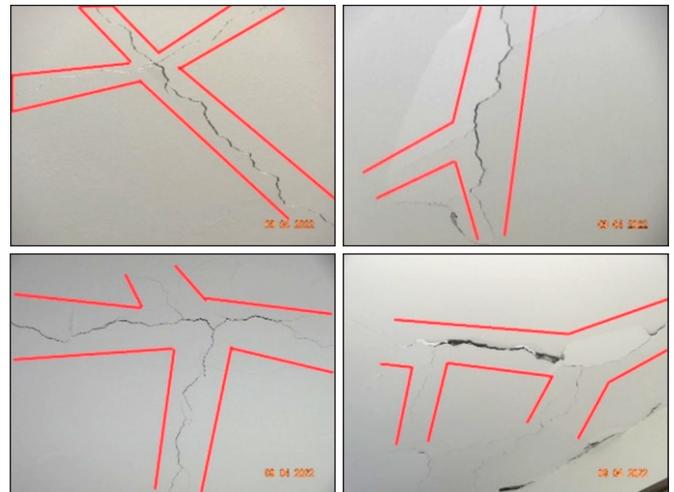
- (a) The roof slab of the flat had extensive cracks in multiple rooms. These cracks in the roof slab were serious and needed immediate attention and further urgent action.

- (b) The roof slab cracks were photographed for the record.
- (c) There was clear evidence of the concrete getting severely degraded in strength, and also corrosion in the reinforcing steel was observed. Corrosion of reinforcing steel had caused swelling, leading to cracks in the floor slab concrete.

Fig. 5 : visible cracks on the roof slab

- (a) Urgent and immediate Non-Destructive Test (within one week of issue of this report) for the floor slabs showing structural distress were recommended. The concrete strength of the floor slab should be ascertained by extracting a concrete core-cut cylinder from the floor slab in the area showing structural distress (cracks) and testing the same in presence of witnesses representing the residents in an NABL accredited laboratory.

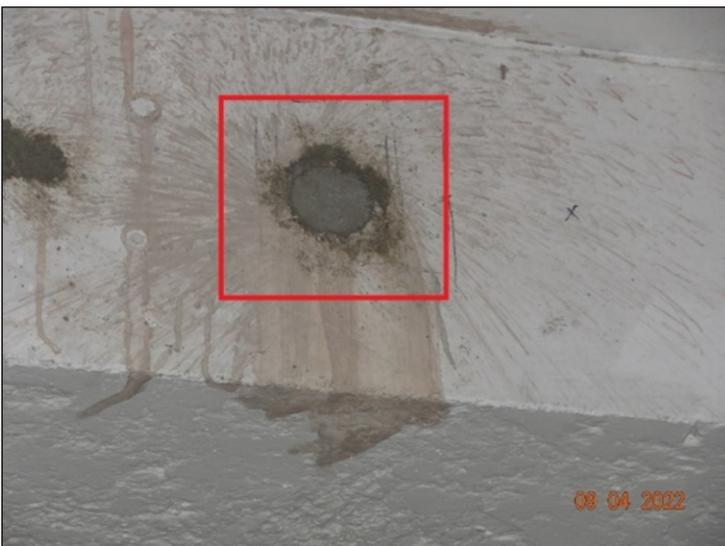
Fig. 3 : Concrete Core cut sample has been taken from basement beam.

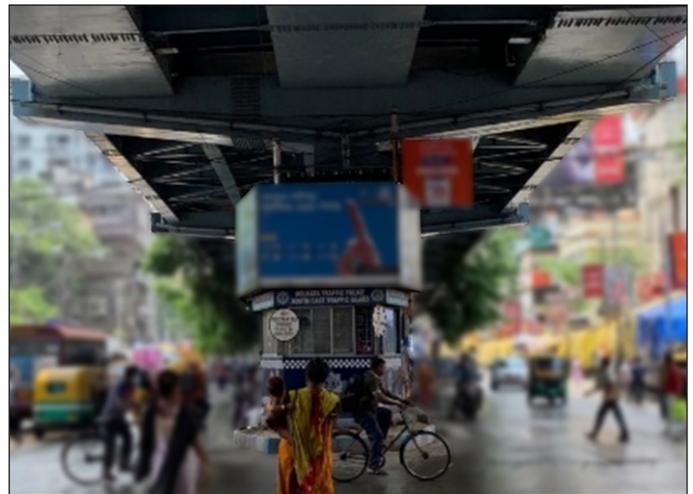
Fig. 1 : View of the distressed Flyover from surface road level

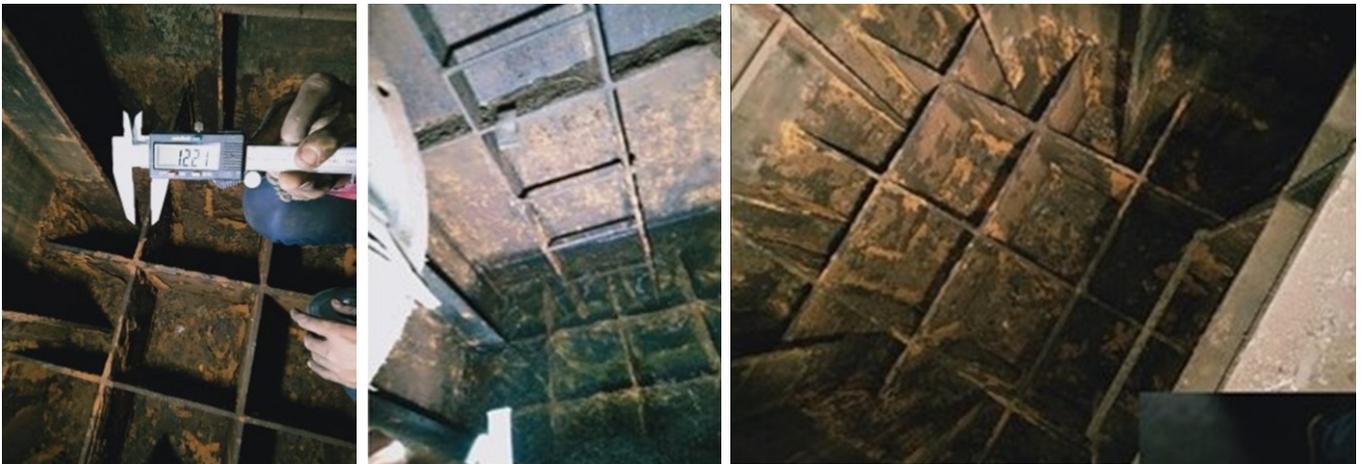
It is a case of a serious level of corrosion in the gridded Base Plate of steel box type pier. The probable cause of corrosion is the poor detailing of the steel pier. There was no provision kept for drainage of any seepage water from inside the box-type steel piers. Fig. 2 below shows some photographs from inside the pier.

Fig. 2 : View of the corroded steel pier box from inside

Faulty detailing in the gridded portion in the base plate is the cause that leads to retention of the water that percolated inside the pier box section through gaps at the end of the different splice joints. It is obvious that while fabricating pier base using steel plates to form grids, a number of separated compartments will form. Unless some drainage slots/openings are left at the bottom corner of each plate and also in the main plates (4 sides), percolated water will automatically get accumulated inside the pier box.

- b. Non-Shrink Grout Concrete to be filled up after installation of the base plate stiffeners (grillages) to a height about 75mm above the stiffener plate top level. After filling of Non-shrink grout concrete, like done earlier, stainless steel drain pipes are to be installed on all the four sides of the pier plates after making holes of diameter 10 mm. Such holes are to be at the level on the top surface of the finished concrete.

- c. Anti-corrosive paint inside the piers and closed box section should be made mandatory. Manual cleaning using Steel Brushes & Steel Scrapers and then followed by the application of 2 coats of Zinc-Rich Epoxy of 20 micron (total), which is as per Table D-2 of Annex-D of IRC:24 - 2010 should be followed in such cases.

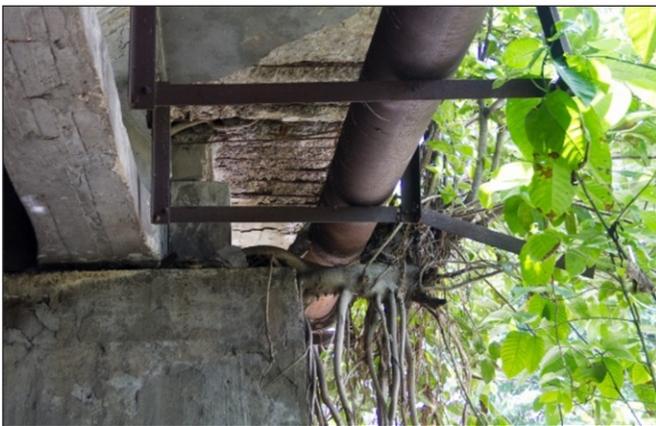
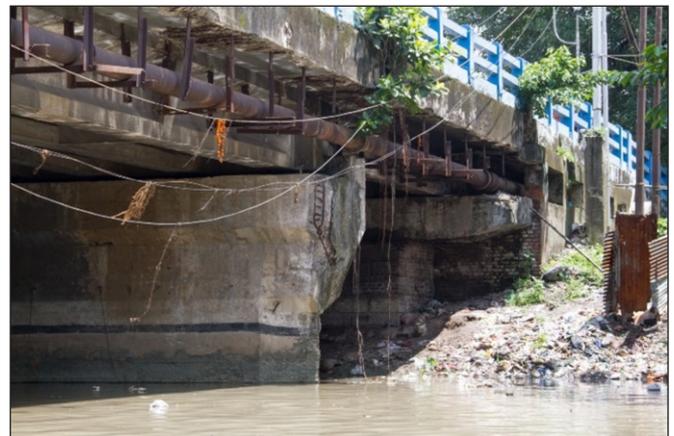
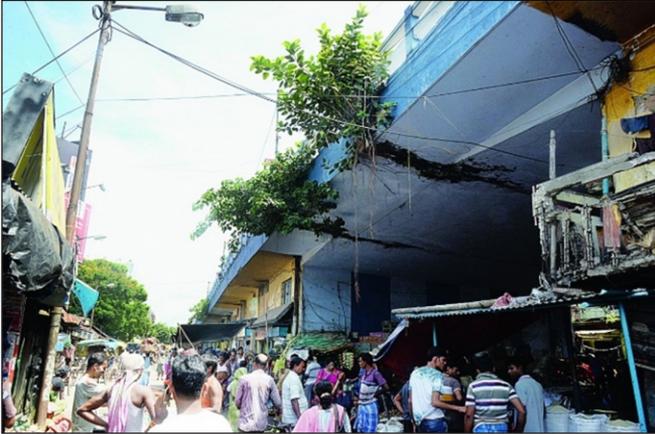
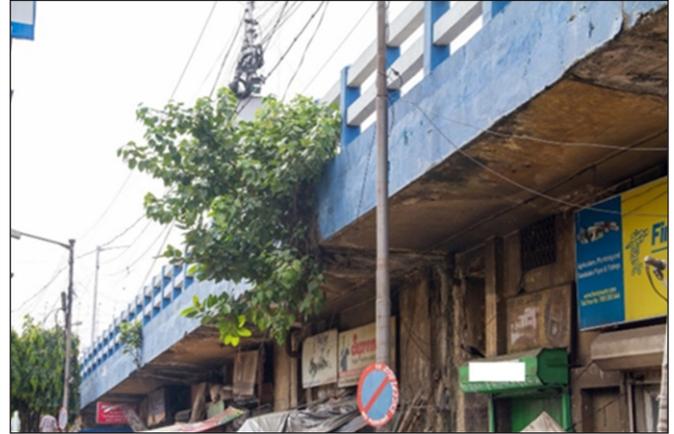
- a. instances of damage caused due to the growth of greens on the structure, (Fig. 1 to 4)
 - b. informal settlers using the underside of the bridge as their habitat unimpeded, (Fig. 5 & 6)
 - c. use of the underside of the structure for residential, commercial and industrial purposes, officially sanctioned by the authorities, (Fig. 7 to 9)
 - d. instances where the design and detailing of structure does not permit essential maintenance work to be done because of a lack of access to such location. (Fig. 10 to 14)
- A. Instances of damage caused due to the growth of greens on the structure-plants have caused corrosion and spalling of concrete cover.

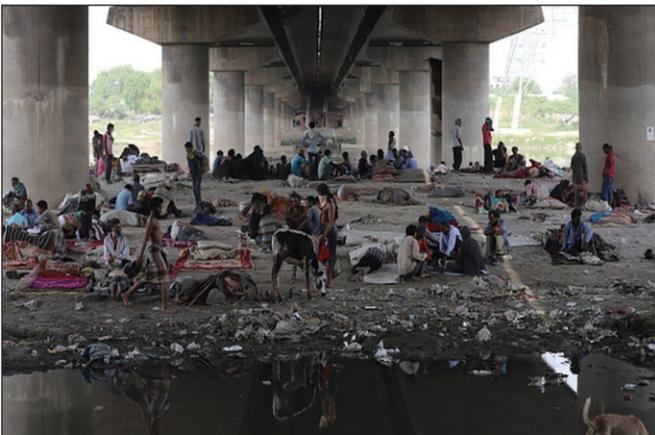
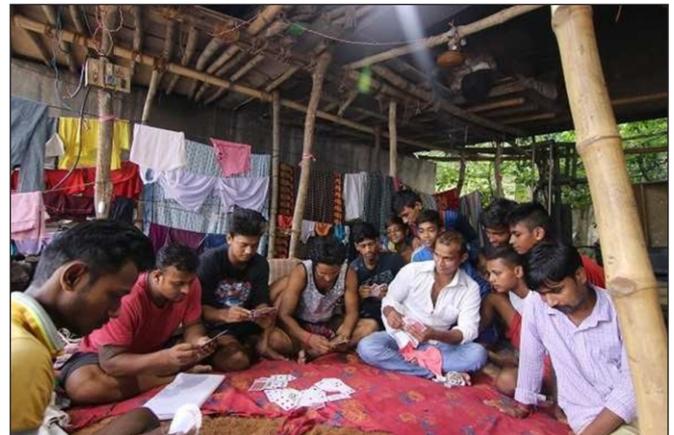
B. Informal settler used the underside of the bridge without any interference - leading to severe damages

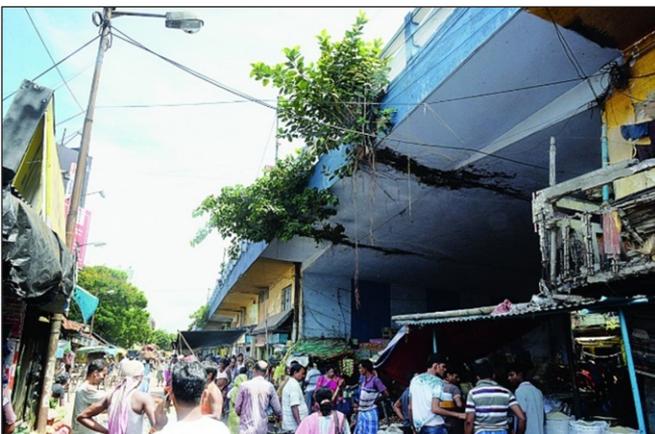
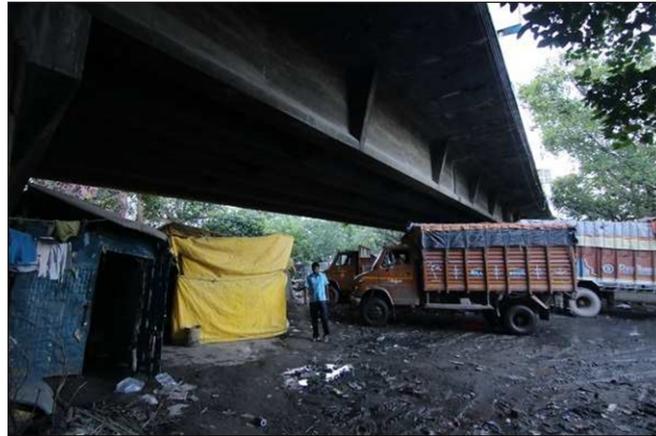
C. Use the underside of the structure for residential, commercial and industrial purposes, with official sanction - leading to permanent damage

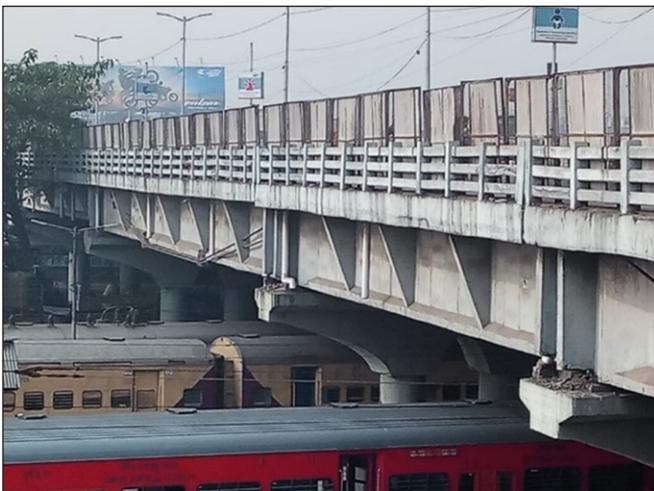
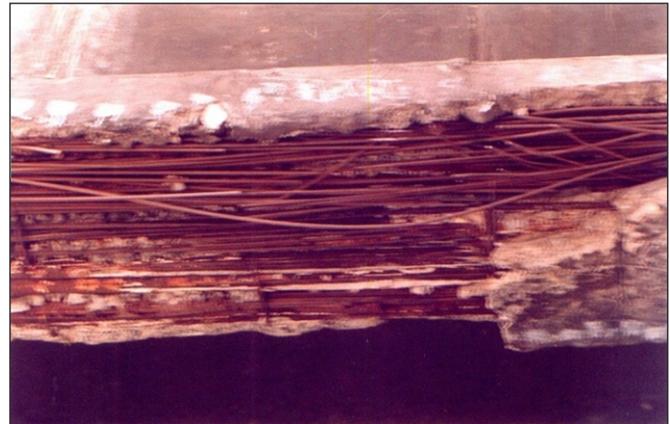
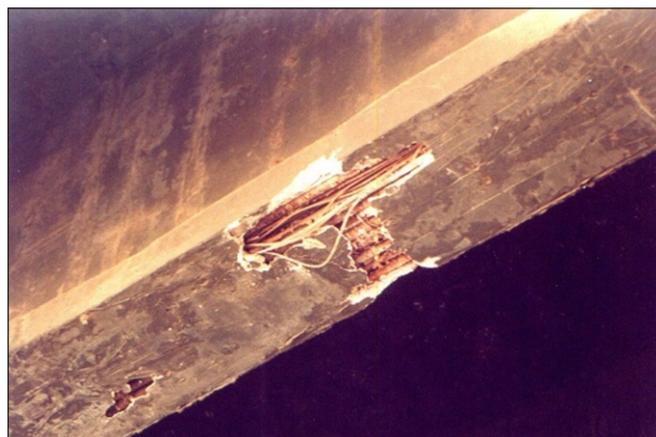
Case 1 : Bridge across electrified railway tracks does not permit any inspection & maintenance work to be done- corrosion started due to lack of concrete flow due to congestion of Rods/PSC wires

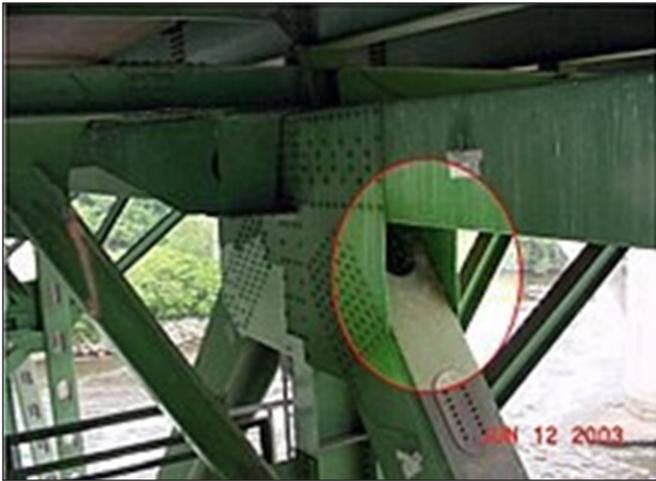
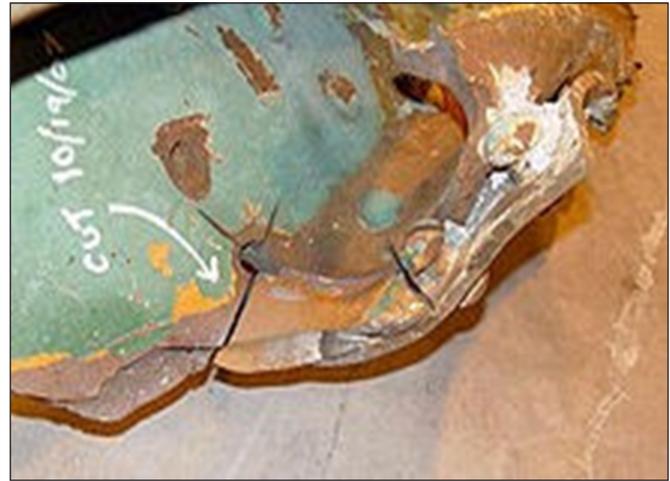
Case 2 : No access to underside of bridge left damages unnoticed leading to catastrophic failure of poorly designed gussets.
