REPORT No. CF-19

Failure/Distress Case Study of Post Tensioned I Girder during Prestress and Lifting operation at Construction Stage

REPORT No. CF-20

Failure of Steel Bridge with Open Web Girder (OWG) during cantilever launching

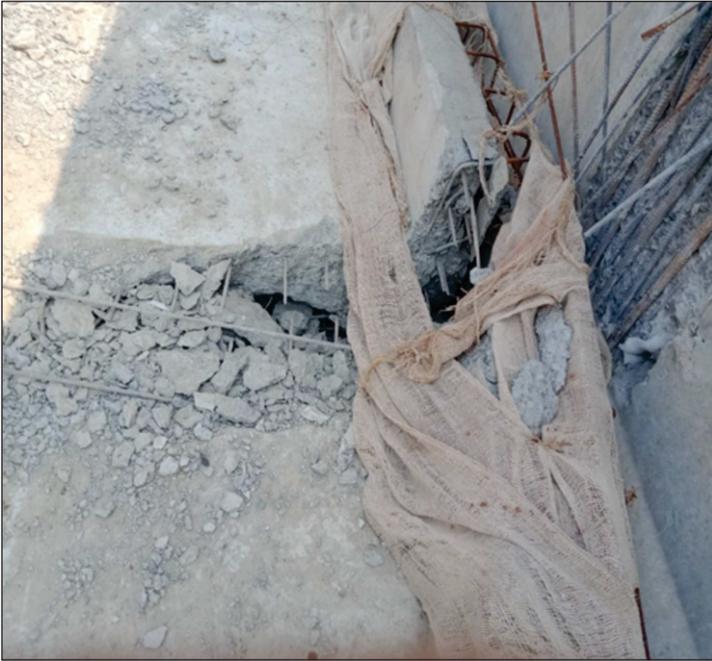
After prestressing of outer girder, lateral deflection was observed as 27mm, which, although higher than calculated deflection but not alarming. During lifting of girder from casting yard, there was sudden increase of lateral deflection (up to 300mm) with rotation about the axis of the girder (Photo 2). The construction team had kept the girder at original support without shifting due to excessive rotation. After sometimes, girder had been lifted again for shifting, girder rotated about 70 degrees to its axis and suddenly broke @ 3L/8 location (Photo 1). Fortunately, no casualty happened during this operation.

- Geometrical imperfection during placing of Tendon at site: Tendon placed eccentric w.r.t position shown in approved drawings (in plan).
- Excessive horizontal buckling about Minor axis: Girder buckled much more than anticipated during design due to slender behavior.
- Improper lifting arrangement: Centre of gravity of lifting hook didn't coincide with centre of gravity of self-weight of girder.

- Unsymmetrical girder section - Led to buckling in minor axis.
- Buckling Check during erection of girders, was not considered by the designer during detail design.
- Slenderness check of I Girder might not have been carried out properly, refer calculation below.

As per clause 11.4.2 of IRC 112 (Slenderness limits of Beams), it is stated that "To ensure lateral stability, a simply supported or continuous beam should be so proportionated that the clear distance between lateral restraints does not exceed $60b$ or $250b^2/h$, whichever is the lesser, where 'h' is the effective depth to tension reinforcement; and 'b' is the breadth of the compression face of the beam midway between restraints."

In this case, $h = 1890\text{mm}$; $b = 425\text{mm}$ (considering bottom flange since compression flange during construction will be bottom flange)

$$60b = 60 \times 425 = 25200\text{mm}; 250b^2/h = 250 \times 425^2 / 1890 = 23893\text{mm}.$$

Lesser is 23893mm < 34800mm.

Designer might have considered this check for top flange considering top flange as compression during service stage.

Photo 1: Girder Break at 3L/8 Location during Lifting

In the revised design, girder sections had been modified with symmetrical girder & increased bottom flange width to solve the issues in all future girders.

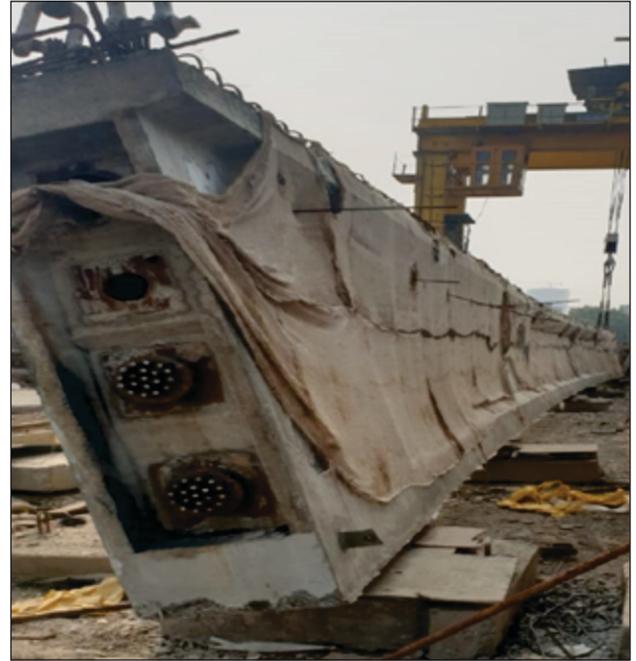
Photo 2: Plan Bending after shifting of girder from Casting Yard

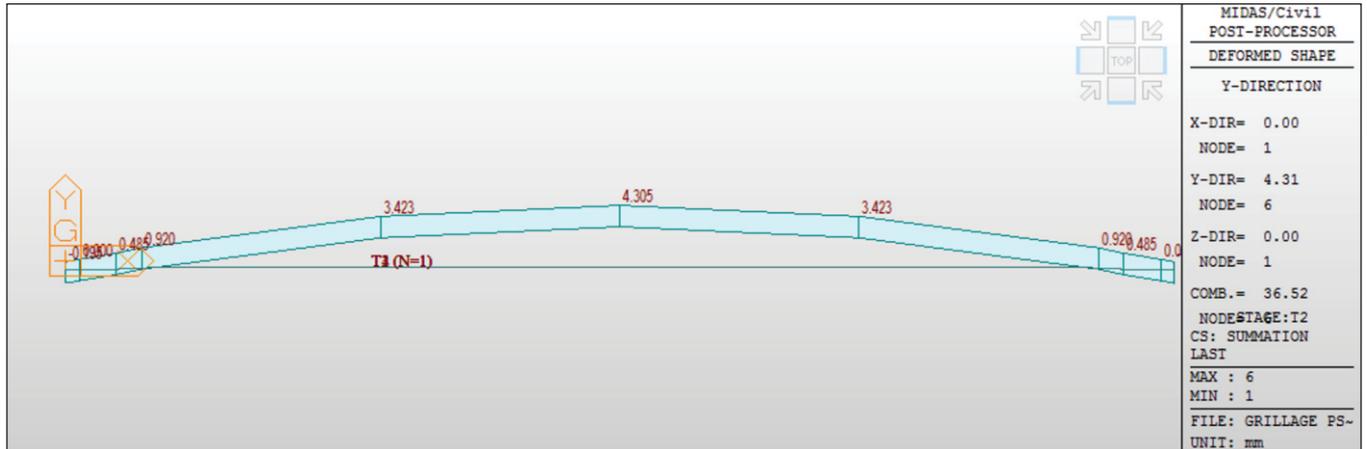
The outer girders have been proposed as unsymmetrical w.r.t c/l of web (as shown in Fig 1, 2 & Fig 3 below) for functional/aesthetic reasons. The length of girder is about 34.8m to be placed for 35m overall span of the superstructure. The prestressing layout is proposed symmetrical to vertical axis of the girder and plan deflection of girder has been checked in model during design, which is nominal. (Refer Fig 4).

Fig. 4: Lateral Deflection of Girder as per Midas Analysis (only 4 to 5mm) lateral Bending

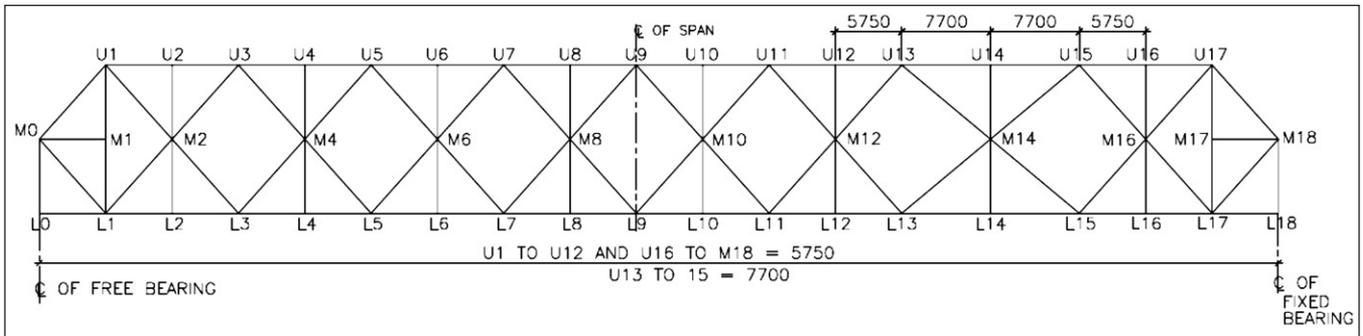
The anchor span of 103.5m was originally designed for cantilever launching with respect to another 103.5m span. There were total 18 numbers of panels (L0-L1 to L17-L18) of 5.75m length each in each span. However, during the erection of the anchor span, the contractor modified the anchor span connection detail in order to keep one node point of the truss on pier P1 which was not any essential criteria. In the process the two panels (L13-L14 and L14-L15) of the OWG had length of 7.7m. Fig. 3 shows the original span configuration and Fig. 4 shows the revised span configuration of the anchor span fabricated during cantilever launching.

Fig. 4 : Revised span configuration of the anchor span fabricated during cantilever launching

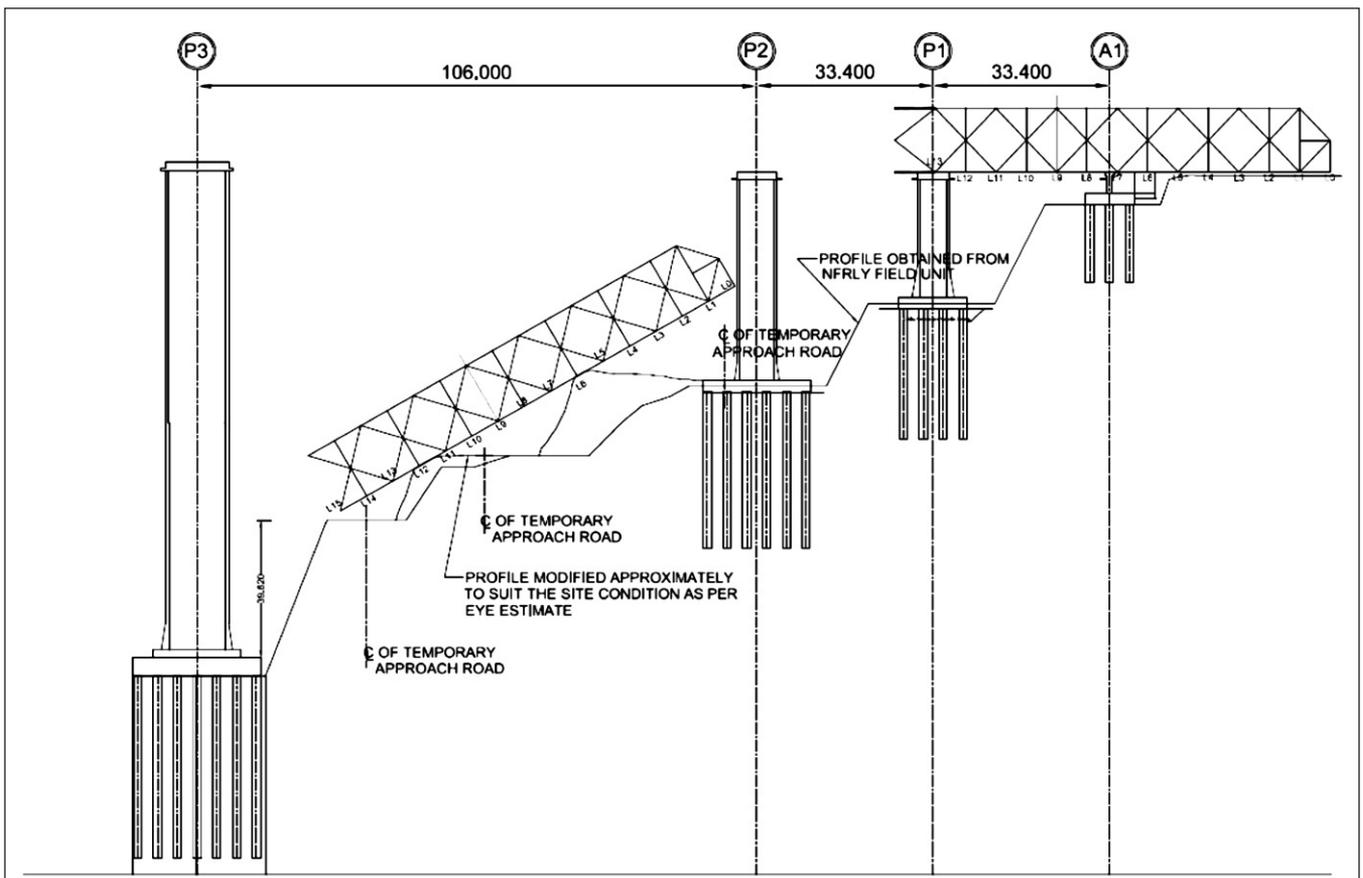
These new panels were of same section which was originally designed. The failure occurred when cantilever launching was progressed between P2 and P3 span up to the node point L15. There was a sudden snap occurred at U14 joint and as a result the entire cantilever span along with part of the anchor span between node L14 and L18 was separated from the anchor span and fell on the hill slope (Refer Fig. 5).

Fig. 5 : Fallen cantilever span

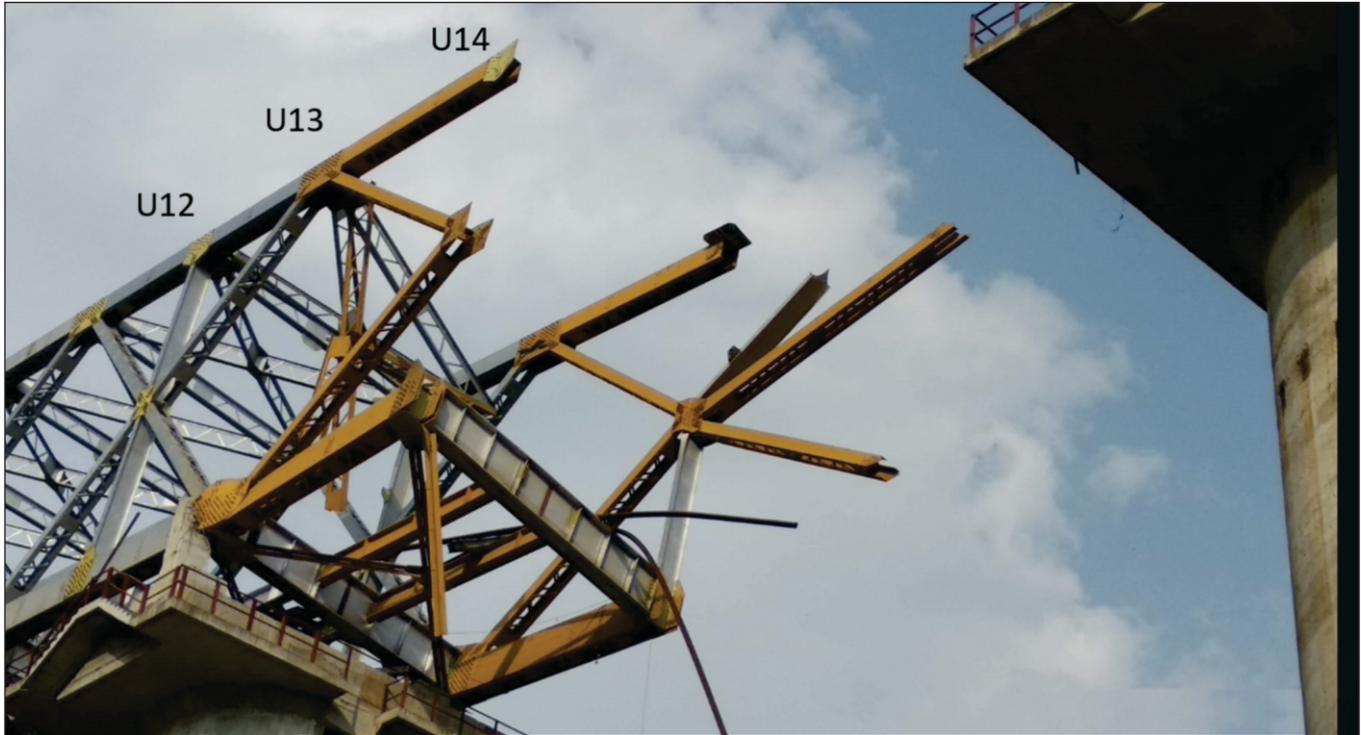
Fig. 6 shows the failure point in truss. It is observed that the panel U13-U14 and U14-U15 provided are of 7.7m length each and they are not connected by a full strength splice. The splice provided at the joint is found to be adequate to cater for the connection forces of vertical members but it was found grossly inadequate to transfer the tension force from U13-U14 to U14-U15 (Refer Fig. 4).

Fig. 6 : The snapped anchor span – the snapping joint at U14 shows no full-strength splice

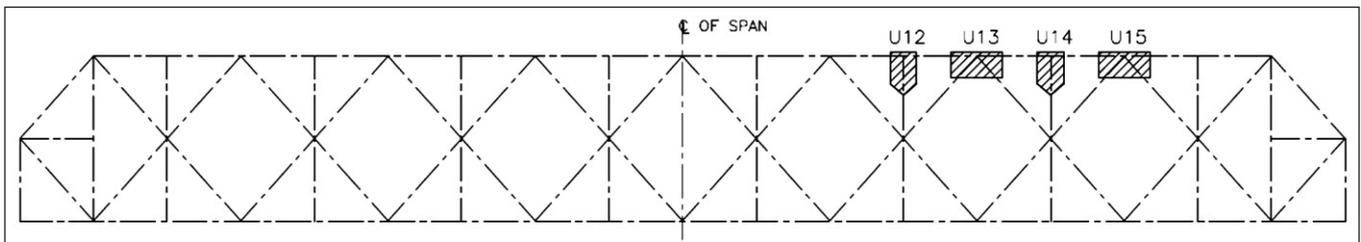
Fig. 7 shows the splice details of the U13, U14 joints for the originally designed span. Under the revised condition, the splice at U14 should have been similar to the splice at U13, which is a full-strength splice capable of transferring tension force from U12-U13 to U13-U14. However, the failed splice is kept similar to that of splice at U12 joint where the panel U11-U12 and U12-U13 are single member of $5.75 \times 2 = 11.5\text{m}$ length and the corresponding splice is only to transfer load from the vertical member to the joint. Had there been a single member between U13-U14 and U14-U15 of total length of $7.7 \times 2 = 15.4\text{m}$, the requirement of full-strength splice to transfer the tension force from one panel to the other could have been avoided. However, due to non-availability of the plate of 15.4m length this was not done and at the same time the full strength splice was also missing which caused the failure

Fig. 7 : Splice at U13 and U14 joint in the original span designed for cantilever launching

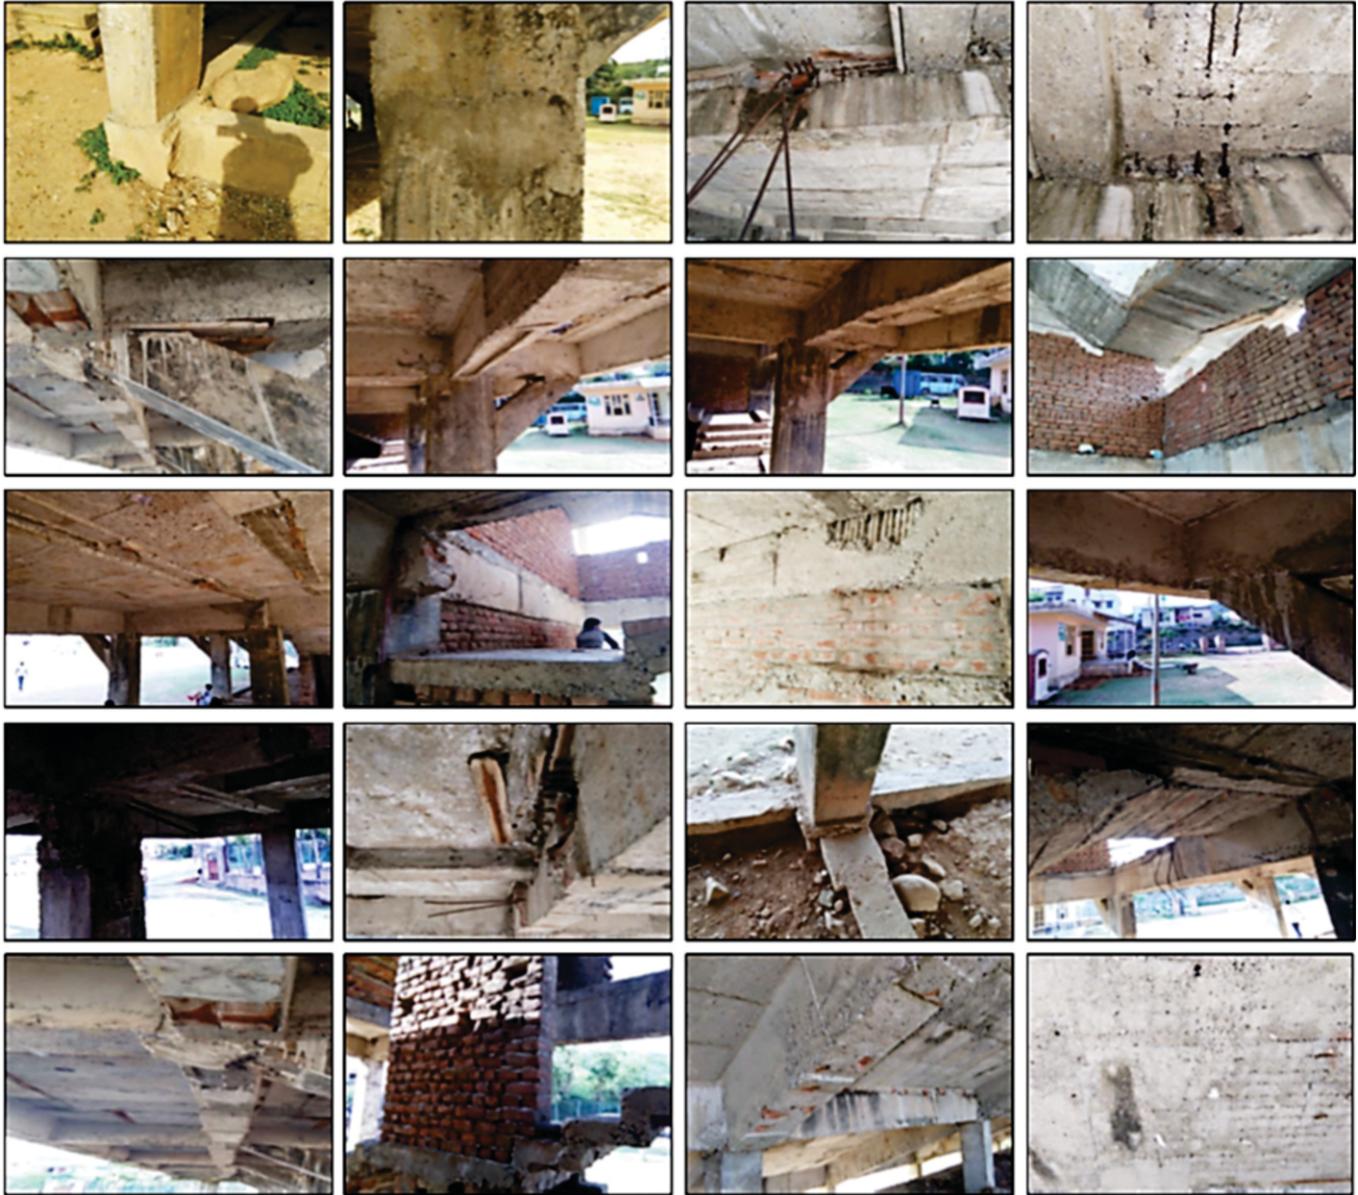
The signs of structural deterioration in the building are elaborated as listed below, and can be visualized from Fig. 3.

- Plinth beam not properly cast.

- Signs of cosmetic finishing and repairs over possible underlying cracks in concrete.
- Poor finishing surface of concrete at many places.
- Signs of using kuccha (unrefined) shuttering in some areas.

- Casting work carried out without proper placement of chairs for reinforcement which resulted in improper concrete cover, exposing reinforcement to the atmosphere and is causing corrosion.
- Bond between concrete and steel bars compromised.

Fig. 3: Signs of deterioration

- Irregular shape and size of reinforced concrete beams observed.
- Exposure of reinforcement bars in beams, leading to corrosion.
- Plinth beam improperly casted with non-uniform cross-section.
