# Confidential Reporting Of Structural Failures And Lessons Learnt

## NEWSLETTER

April-June, 2023

# Few Cases of Wrong Installation of Bridge Bearings

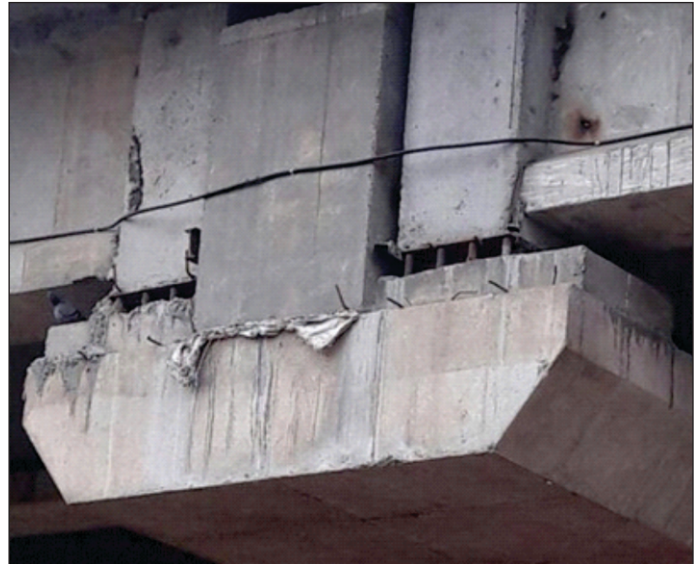
The elastomeric bearings provided in this case are of Type H (Bearings with sliding interface). During a site visit, post-construction, the reporter, noted that sleeves of free elastomeric bearings are not embedded into the concrete of the diaphragm. Rather these sleeves are hanging downward from the top plate! Photo-1 shows the observed detail. Fig. 2 shows the arrangement of fixing of the top plate of bearings, 'as per the GFC drawing' and 'as constructed.'

Photo 1 : Hanging Sleeves from Bearing top plate

- Removed hanging sleeves by lifting the superstructure through jacking positions.
- Provided appropriate nut (in accordance with the grade of the bolt) and lower the superstructure to rest on bearings.
- Precaution was taken to lift the entire unit of three spans at the same time.

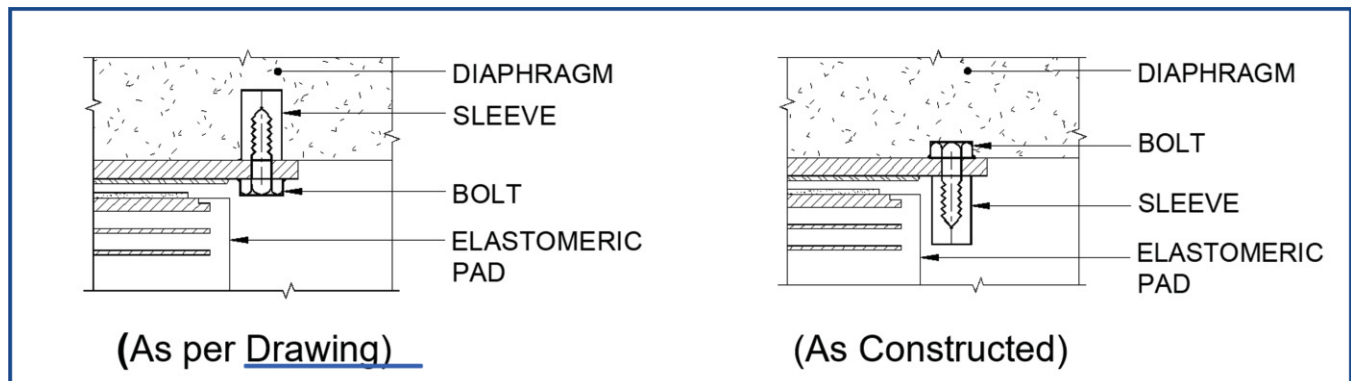
Fig. 2 : Fixing of the Bolt for Top Plate of Bearing

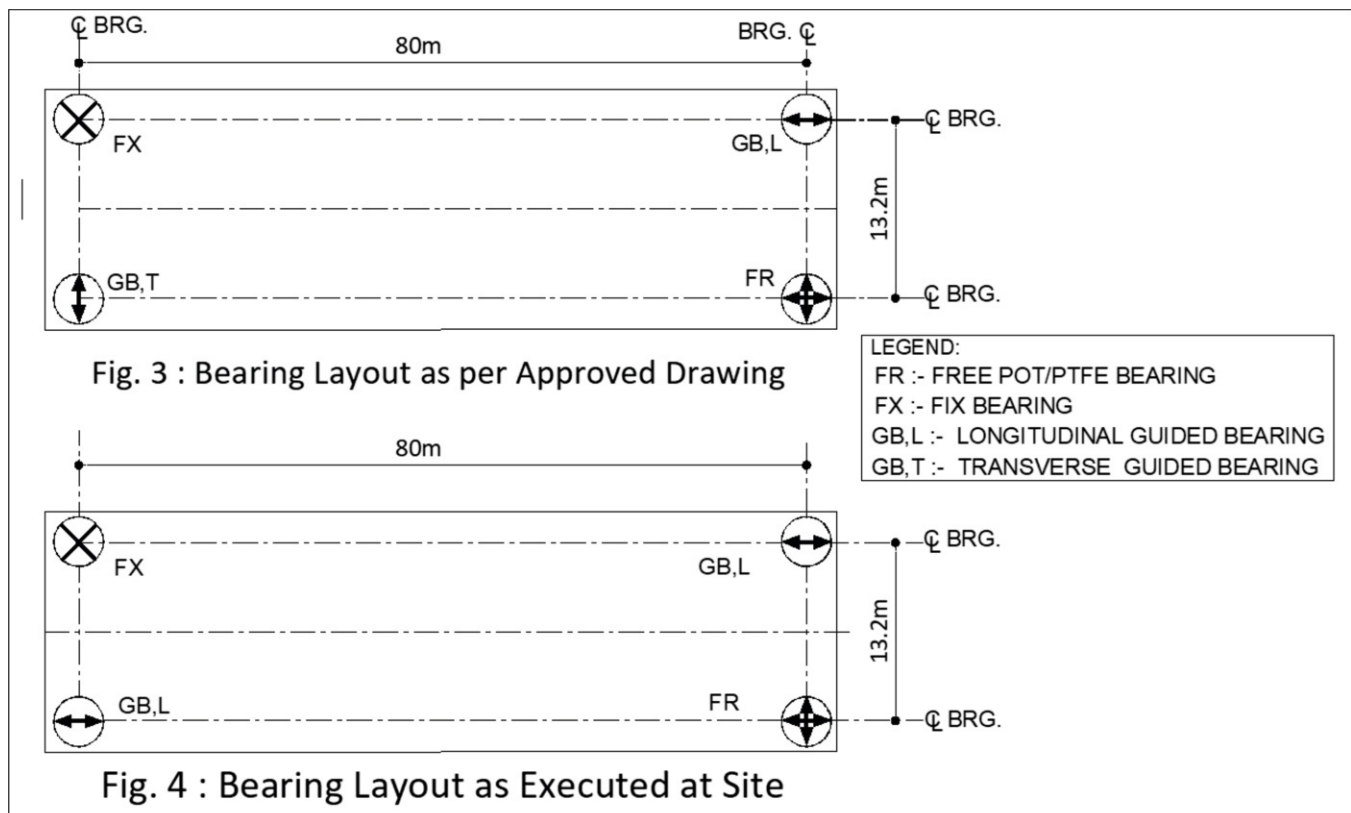
The reporter made a visit to the project site after the completion of the project and found that the bearing layout of the main span, as observed at the site does not match with the bearing layout as per the approved drawings. At one end of the span, the bearing should have been 'transversely' guided, which was found to be wrongly oriented as 'longitudinally' guided. Fig. 3 shows the bearing layout as per the approved drawing while Fig. 4 shows what was executed at the site. At the 'free' end of the bearing system at P5, close inspections of both bearings indicate that the bearings are 'not jammed'. They are functioning normally and there is visible longitudinal movement of the span.

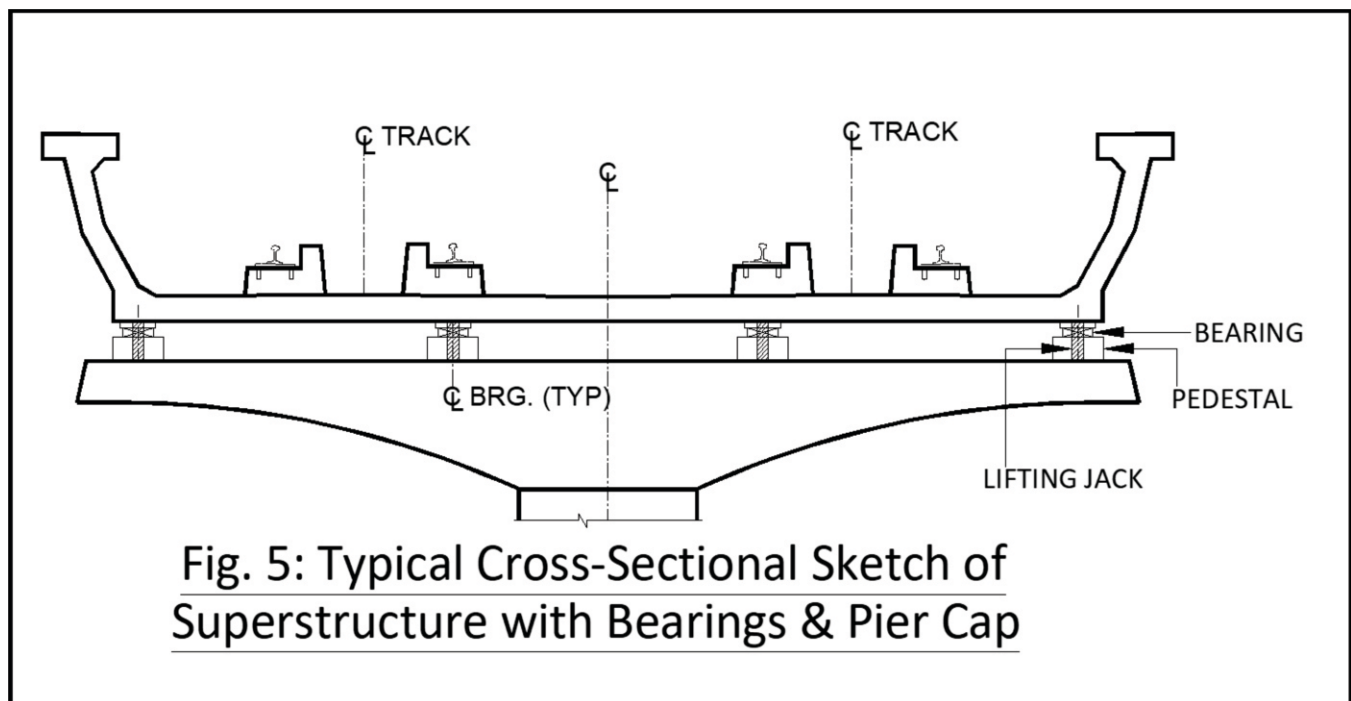
Fig. 5 shows a typical cross-sectional sketch of the metro corridor showing the layout of Bearings and Pier Caps. Photo-2 shows the photograph of a typical bearing before and after replacement.

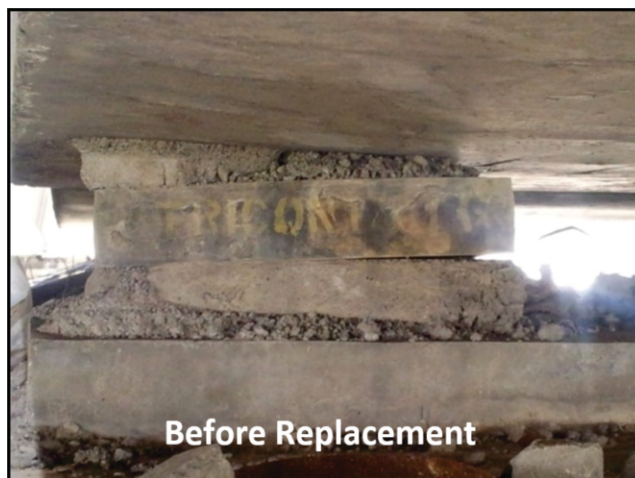
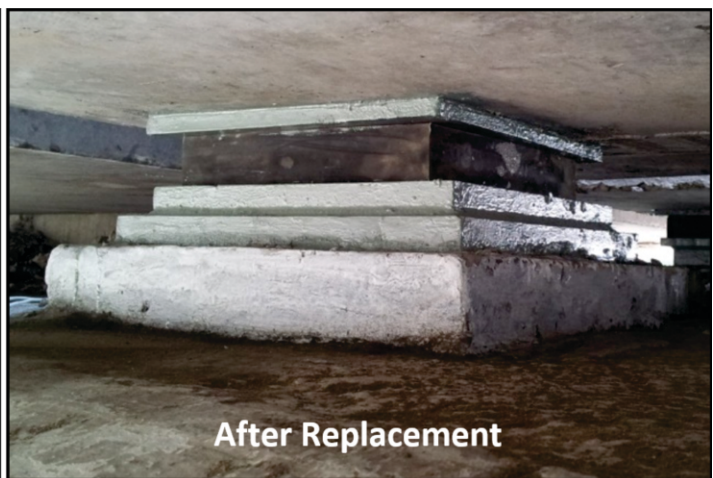
**Photo 2 :** Photograph of a typical bearing before and after replacement.

This is the case of failed elastomeric bearings (caused by poor installation) which reportedly led to the closure of the metro line and the replacement of bearings. Vibrations in a few of the spans in this corridor were noticed by train motormen who brought it to the knowledge of higher authorities. The Metro lane of this section was discontinued for traffic after an inspection of the same was carried out to find the root cause. According to the reporter, proper installation of elastomeric bearing was not done in as many as 86 spans. A total of 688 numbers of bearings had to be replaced.

Whenever elastomer bearings without anchor bolts are installed, there are fitted inside a recess provided in the pedestal and superstructure above. This prevents lateral movement of bearings during installation. Further, if superstructure is on grade, wedges are provided below the superstructure so that contact surface of superstructure is horizontal and bearing surface is in full contact with top & bottom surfaces. The photo 2 shows poor quality of concrete at top and bottom of the bearing which has resulted in uneven load distribution. The bearing installation procedure should be given in drawings explaining step by step installation procedure including Do's and Don'ts.

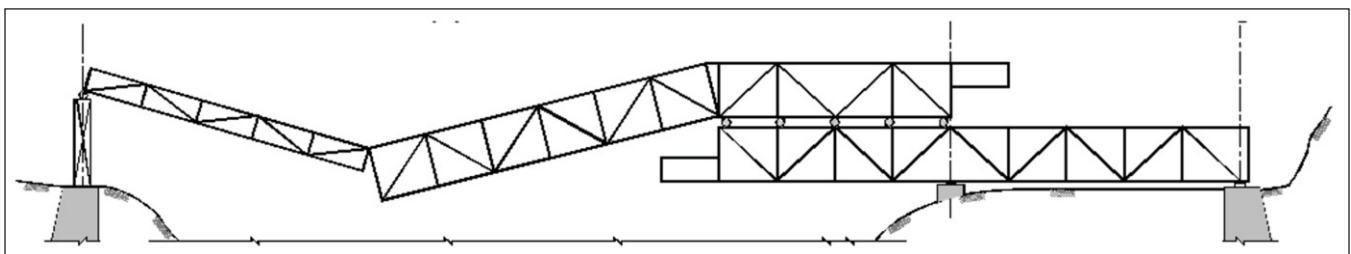
Fig. 9 : General Arrangement of the Bridge

- k) However, when the counter weight was removed, the connection between the main truss and nose failed due to the reversal of forces and the entire top truss with nose collapse into the gorge as shown in Fig. 9.

The Nose was not properly designed for the forces after it became simply supported. During launching, the entire truss and nose were behaving as a cantilever. The top chord of the nose was connected to top chord of the main truss. However, its bottom chord was connected to the vertical member of the main truss. Once it became simply supported after removal of the counterweight at A-2 end, the connection of its lower chord failed since the tension in the bottom chord was not transferred to the bottom member of the main truss. The whole truss collapsed into the gorge and the welding, mainly butt welding in the truss members on P-1 side got damaged.

The truss between P-1 and A-2 side was thoroughly inspected and splice plates were welded to the truss plates which were originally spliced through butt welding. All the welds and splices were tested for quality. Once the damaged truss between P-1 and A-2 was repaired and found to be safe, the 68.25 m long truss was refabricated with a nose fixed to the top and bottom chord for proper transfer of forces once it becomes simply supported.

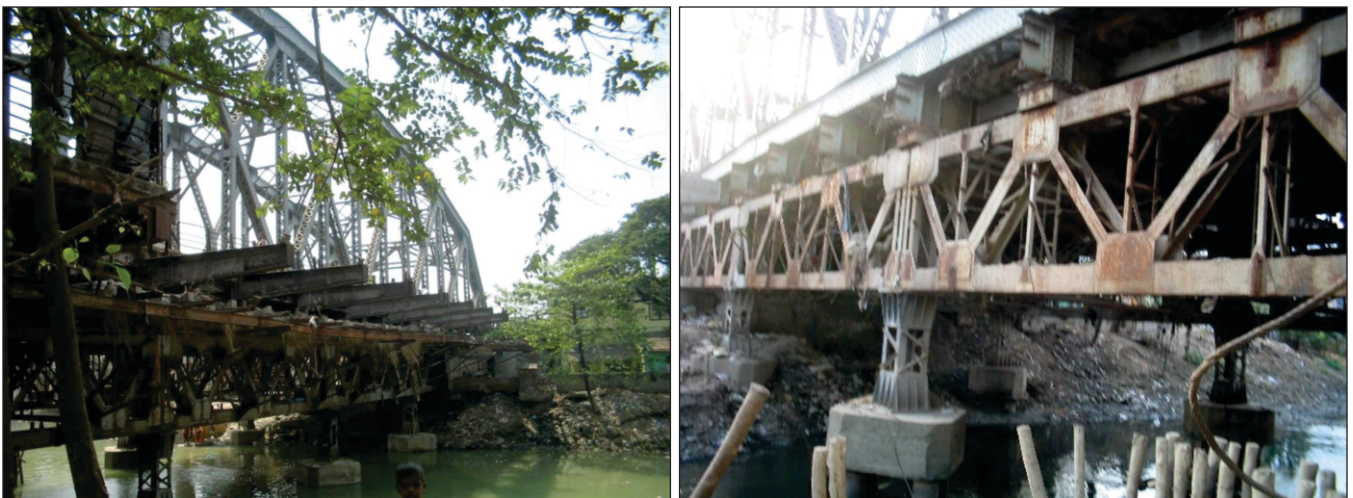
Fig. 10 : Photo of Old Steel Trussed Bridge (YoC : 1920) which was retrofitted in 1980s

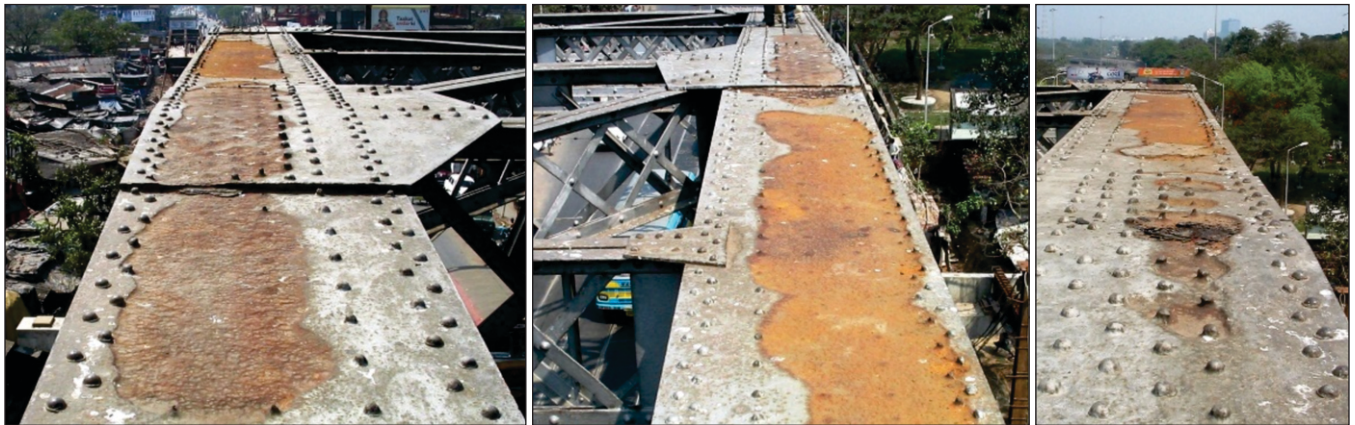
While carrying out detailed investigations, reporter found that a major portions of the upstream and downstream top chords were badly corroded and part of the 20mm thick top plates along with their rivets are totally eroded out. Fig. 12 shows the extent of corrosion noticed in the top flange of the truss. Such heavy corrosion of the top plates was caused by the Caracas of dead cattle picked up and stored on the top chords by the vultures from the drainage canal.

Fig. 12 : Photo showing extent of top-chord corrosion in the bridge

- a. The Tram Services on the bridge was discontinued.
- b. Part by part the major damaged components were replaced by fabricating new members.
- c. This bridge being on a major road connecting the Kolkata Port with the city, this could not be closed for rehabilitation work. Instead, the heavy traffic was diverted to another road closer to bank of Ganges and only the central part of the bridge was kept open for the movement of light vehicles during the rehabilitation work.
- d. Wherever a joints was opened out removing the damaged or highly corroded rivets (fasteners), the rivets for entire joints was replaced by appropriate HSFG Bolts.
- e. The work was carried out day & night under strict supervision of the Consultant's team with supported by the client's supervisors, in ensuring quality work with total safety.

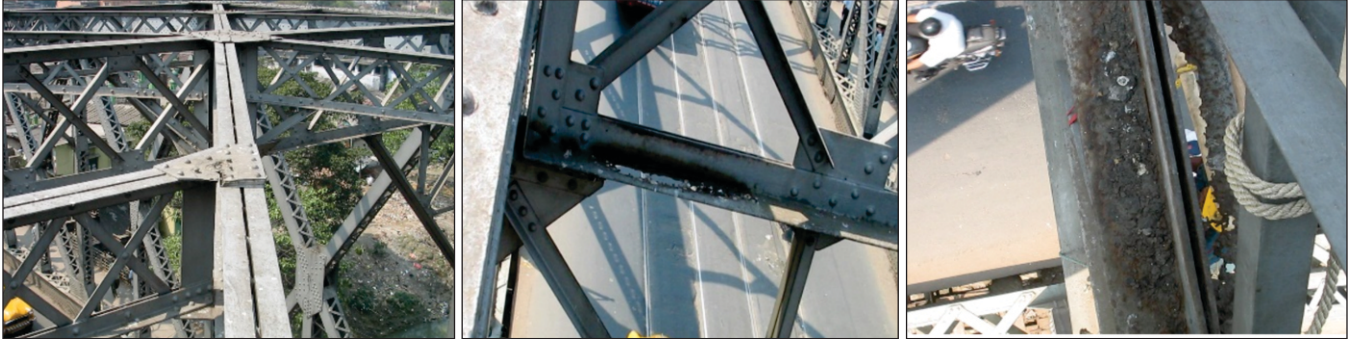
Such corrosion was also observed in many of the lateral bracings as well the Portal Bracing Joints. Vultures found the location of Portal Bracing joints with the gusset plates quite comfortable for nesting and as a result those locations also suffered severe corrosion. Fig. 13 shows the severity of the corrosion in such locations.

Fig. 13 : Photo showing extent corrosion in the Lateral Bracings & Portal Joints
