FROM THE DESK OF THE PRESIDENT

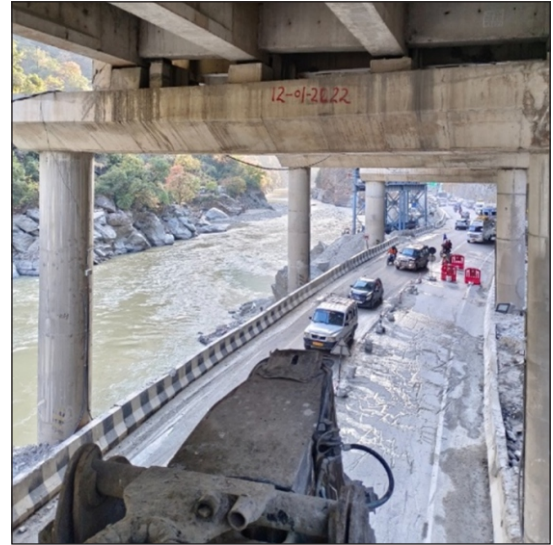
Photo 1 : Elevated bridge supported on portal pier above existing 2 lanes. Existing road winds along the river after elevated road enters tunnel.

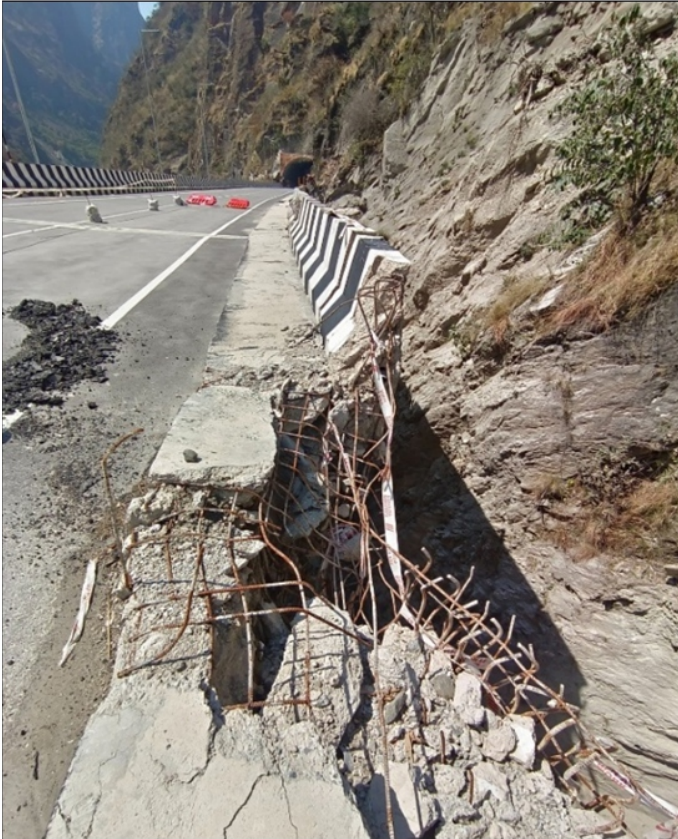
Photo 2 : Damage due to Boulder hitting the deck
 Note : Elevated bridge edge is very close to hill side.
 A big boulder crashed on to the parapet and rolled on to deck slab.

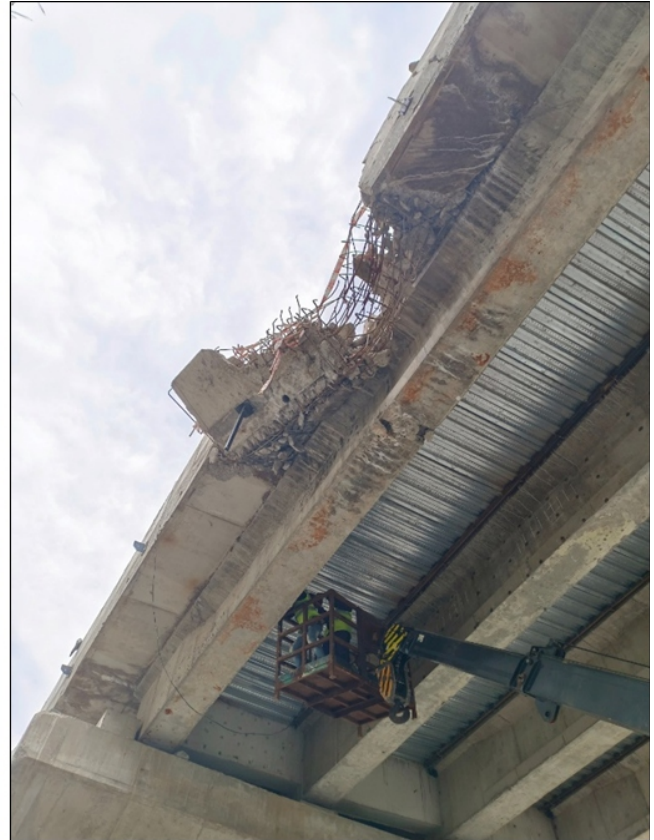
Photo 3 : Damaged PSC girder, deck slab & crash Barrier
 Note : This was repaired by crack sealing and external prestressing of PSC girder.
 Deck concrete was repaired with additional steel and non-shrink concrete.

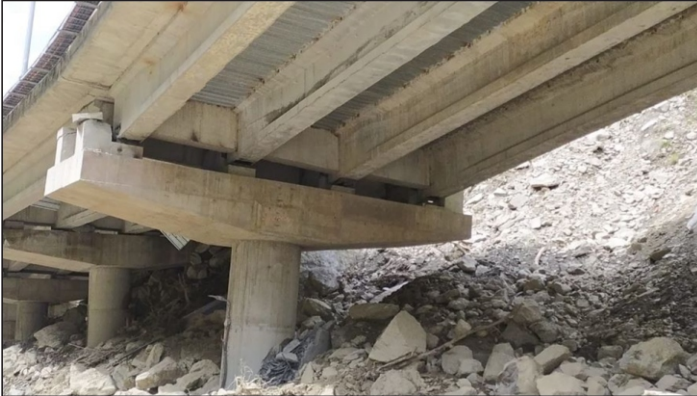
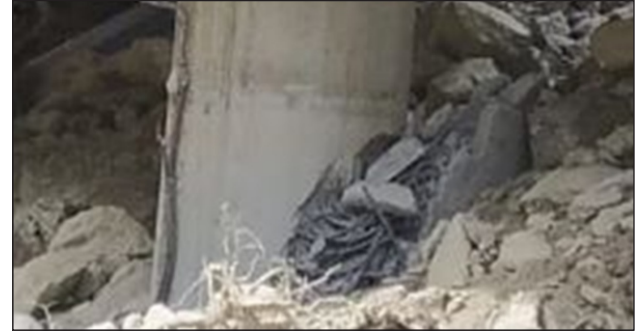
Enlarged view of pier completely broken in two pieces. Removal of debris could trigger further slide.

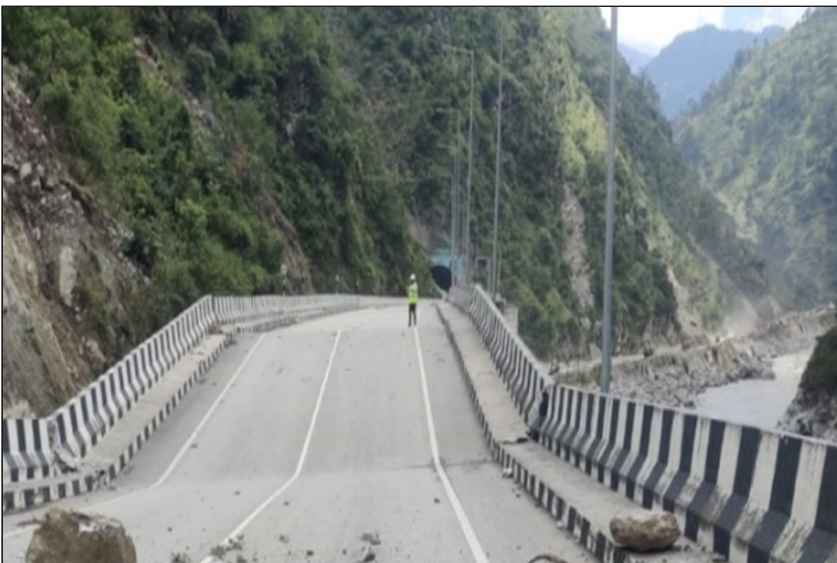
Photo 5 : Superstructure intact but piers settled. A boulder is on the carriageway.

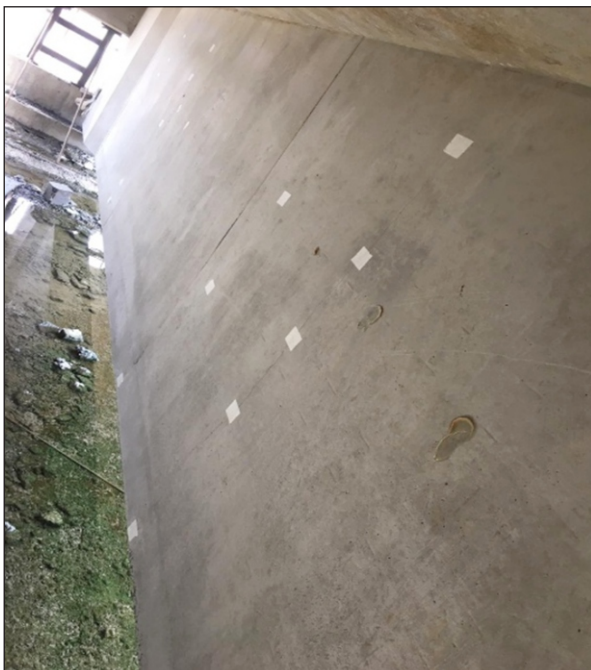
Photo 1: Elevation of Girder showing cracks

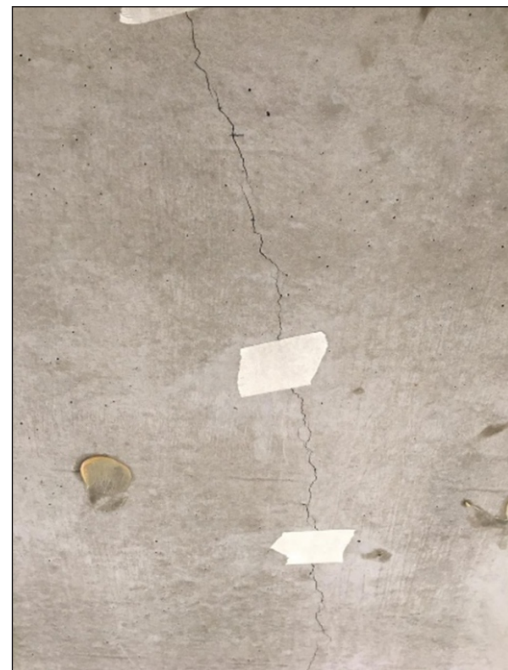
Photo 2: Closed View of Crack

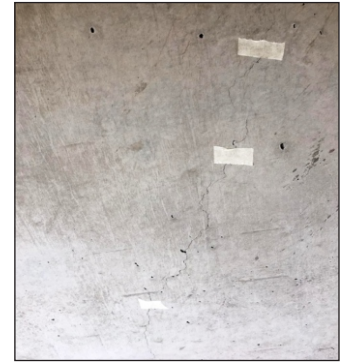
Photo 3: Closed View of Crack

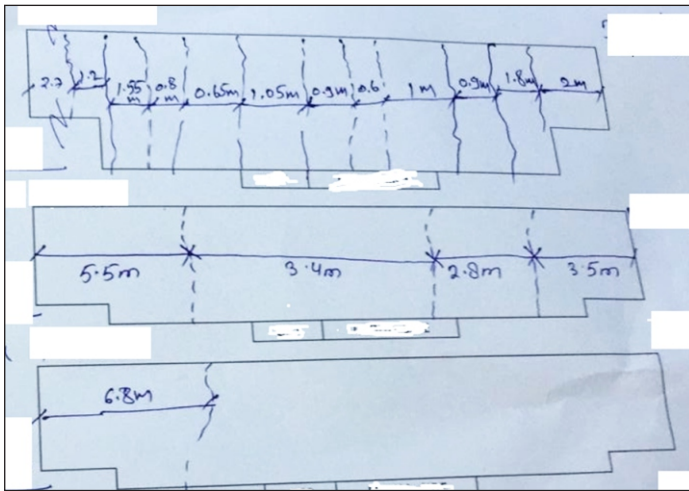
Photo 4: Crack Mapping

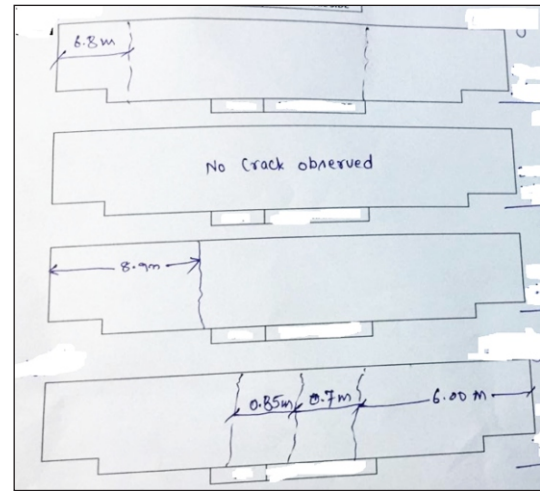
Photo 5: Crack Mapping

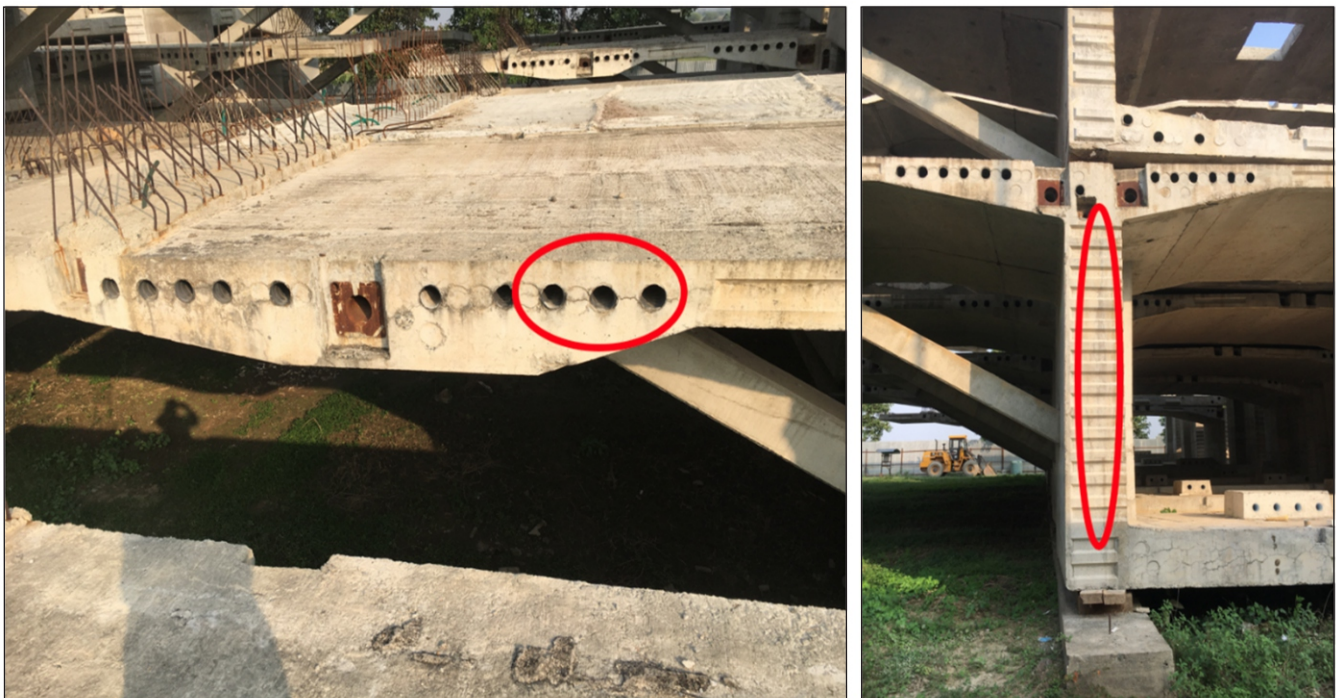
Fig. 4 : Left : Central horizontal cracks in top flange; Right : Central vertical crack in the web

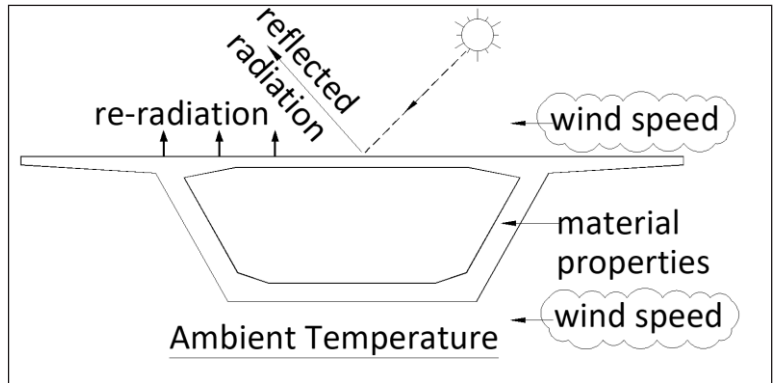
Fig. 5 : Thermal Response Parameters

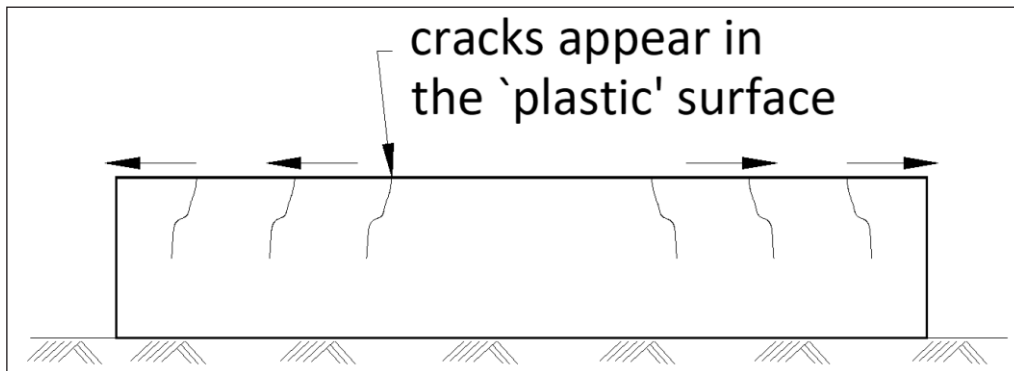
Fig. 6 : Plastic Shrinkage Crack patterns

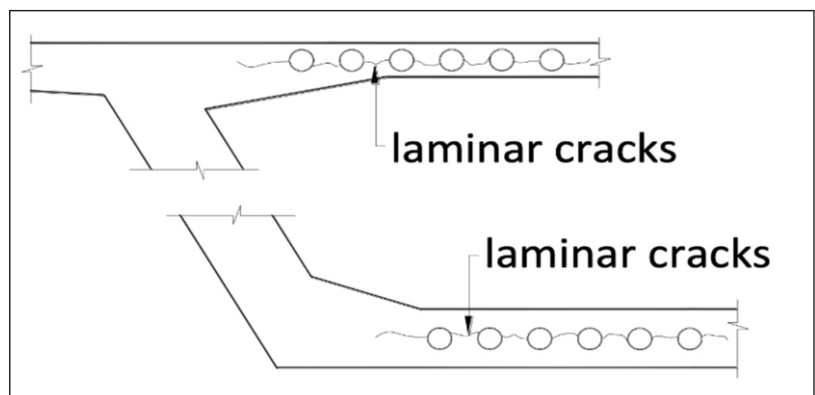
Fig. 7 : Laminar Cracks due to Effects of Plastic Settlement

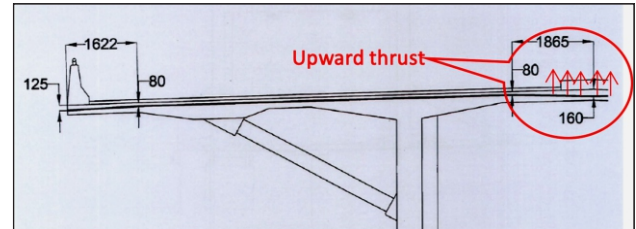
Fig. 8 : Transverse prestressing cable layout providing upward thrust in deck slab at location of laminar cracks

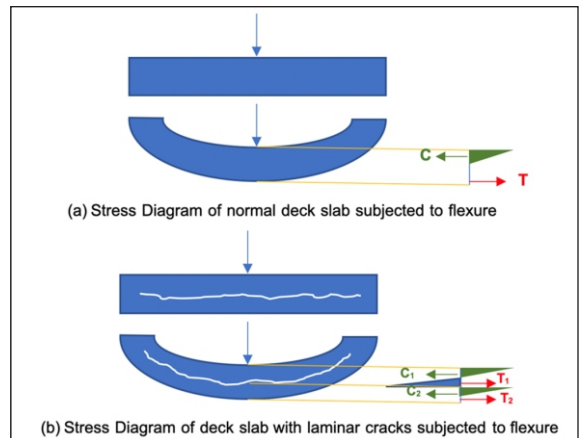
Fig. 9 : Typical Stress Diagram of thin deck slab 'without' and 'with' internal laminar cracks

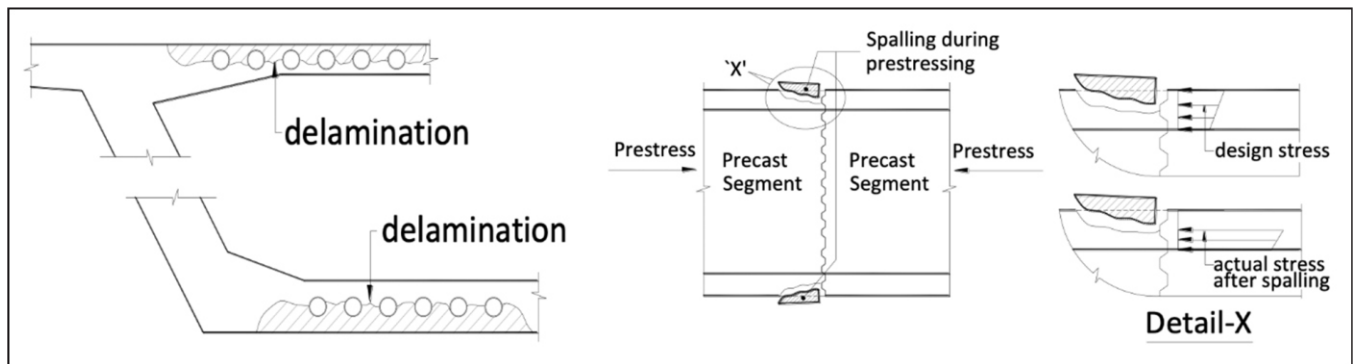
Fig. 10 : Possible failure mode due to delamination in Precast Segments during prestressing
