Confidential Reporting Of Structural Failures And Lessons Learnt NEWSLETTER

A Publication of Indian Association of Structural Engineers

Failure of Modular Expansion Joints of a long Flyover

Failure of Pile Foundation of an Under-Construction Bridge in Coastal Environment

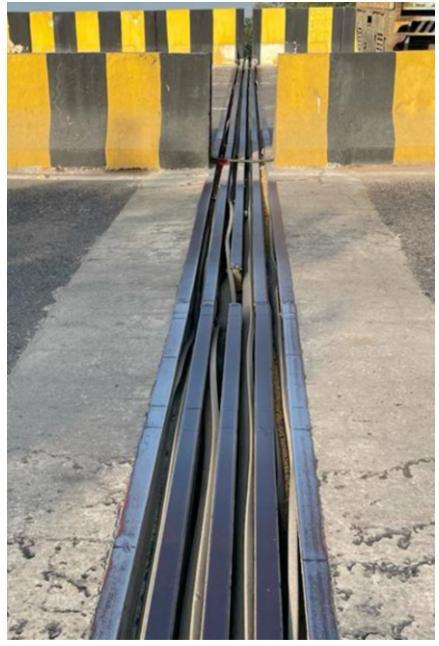
- a) Heavy pounding in most of the joint locations with the passage of vehicles.
- b) breaking of the several centre beams (Refer Fig. 1)
- c) dislodgement of internal support bearings and compression springs
- d) dislodgement of rubber seals

Fig. 1 : Broken Centre Beams

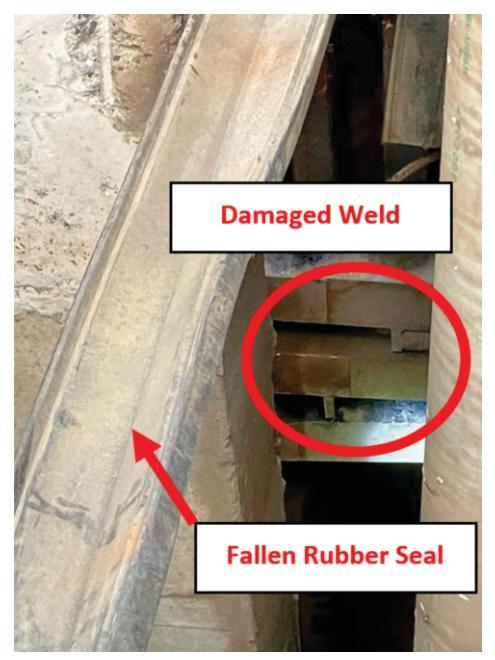
- (ii) Inadequate welding detail: The reporter, on the basis of visual inspection of the welding detail, feels that the strength of connection between the centre beams and the support bars are questionable. Such "girder grid joints" are very sensitive regarding the welding details of the centre beam to support bar connection.
- *(iii) Non-standard Material:* The material used for the compression bearings/springs appears to be of suboptimal quality.

Fig. 2 : Damaged welds and Fallen Rubber Seal

It is also important for the accepting authority to check pre-approved WPS (Welding Procedure Specification) for specialized connections. The weld joint shall pass the Ultra-sonic test for welding. Fatigue test report from a recognized laboratory of butt welded splicing of Centre beams with 2 million load cycles shall be furnished by the manufacturer according to Cl. 8.2.5 of IRC:SP:69-2011. The actual splice welding should have been carried out adopting similar procedure, as adopted for testing.

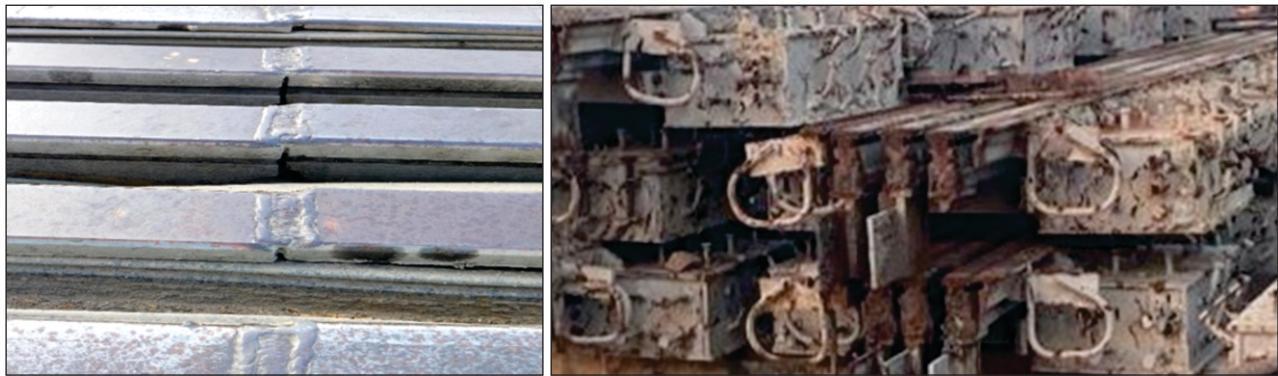
- b. Poor manufacture and workmanship
- *(i) Improper Splice Detail and Welding:* The field splicing of the Expansion joints shows visibly poor connection details and poor workmanship of welding of the parts. From Fig. 3 below, it is evident that a proper groove angle is not formed for effective butt joints, which is required from consideration of high fatigue loads. Only the top part of the beams has been connected leaving gaps in the rest of the portion.
- (*ii*) *Inadequate Corrosion Protection:* The joints removed from the bridge show signs of extensive corrosion indicating inadequate application of Corrosion Protection system (Refer Fig. 4).

Fig. 3 : Improper splice details

Fig. 4 : Extensive Corrosion of the MEJ's taken out from the bridge deck

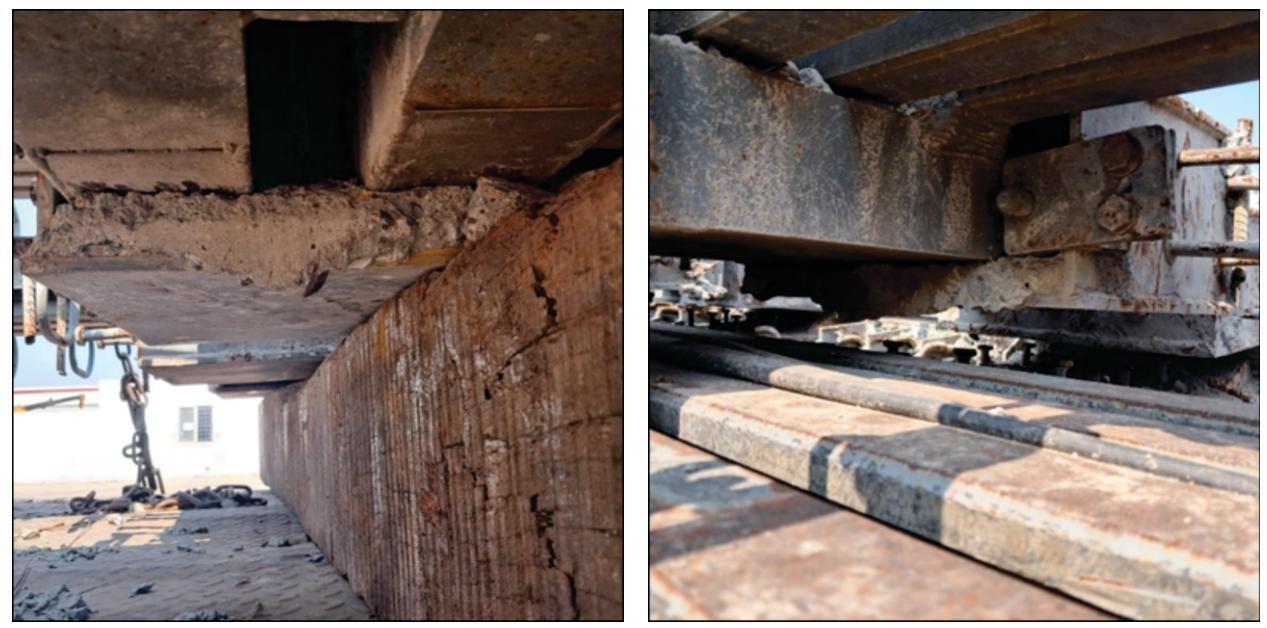
Based on scrutiny of the modular joint boxes, it was found that the concrete had penetrated and filled the modular joint boxes (Refer Fig. 5). This indicates that due care and attention were not given during the installation of the modular joints. However, a well detailed modular expansion joints should have a steel shuttering plate integrated with the joint, as otherwise it would be very difficult to achieve a perfect shuttering at site along the non-linear profile of any modular joint and it would always be prone to concrete intrusion.

Fig. 5 : Concrete intrusion on modular joint boxes, indicating poor installation

An integrated shuttering plate should ideally be provided with modular expansion joints to properly seal the space between the underside of the joint and the vertical face of the recess. Without appropriate shuttering, there is a strong possibility of concrete intrusion within the moving parts of the joints thereby compromising the functionality of the joint.

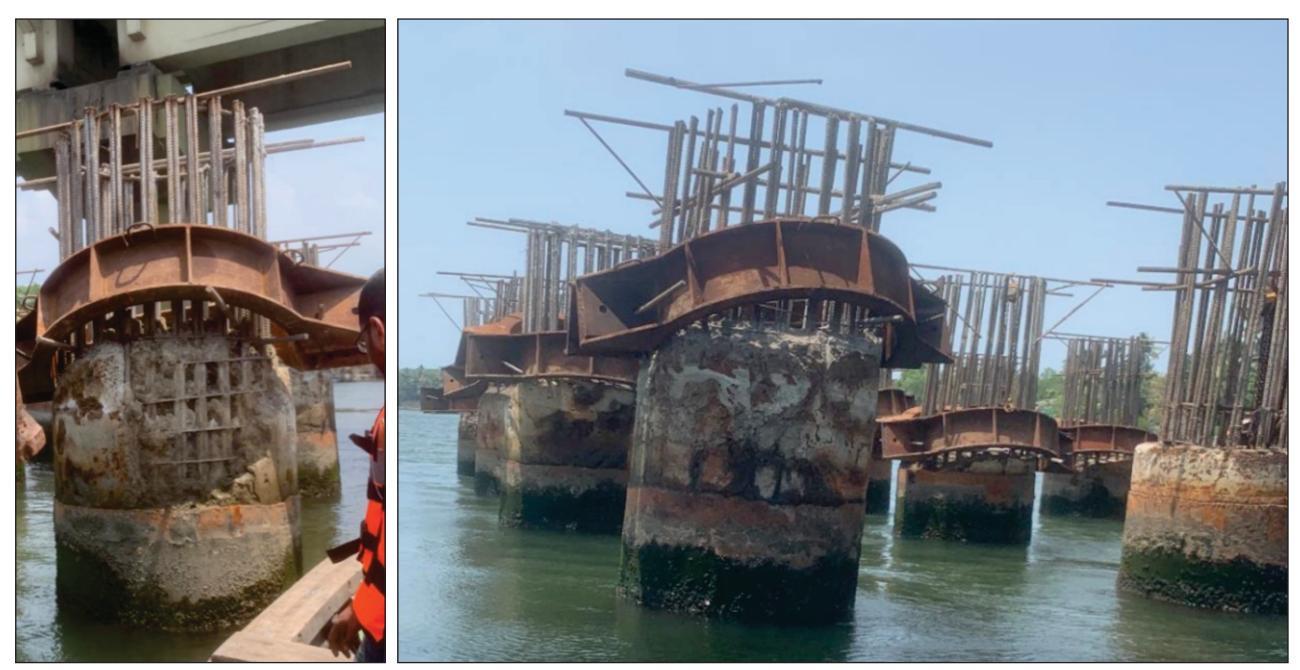
a. The concrete is mixed with bentonite in the top portion of the pile. It appears that the concreting of pile has not been carried out properly. The practice of continuing concreting even after the concrete reaches the top level of pile, so as to push the bentonite mixed concrete out of the pile shaft till good and sound concrete is available at the cut-off level, has not been followed at this case. The result can be seen in Fig.1 below, where it can be seen that the top portion of the pile has exposed reinforcement and very poor concrete.

Fig. 1: Exposed reinforcement and bentonite mixed concrete in top portion of the pile below the cut-off level

- a) Expose all the piles by cutting the liner from the cut-off level downwards till good concrete is seen
- b) Remove the unsound or bentonite contaminated concrete up to the level where visually good and sound concrete is seen.

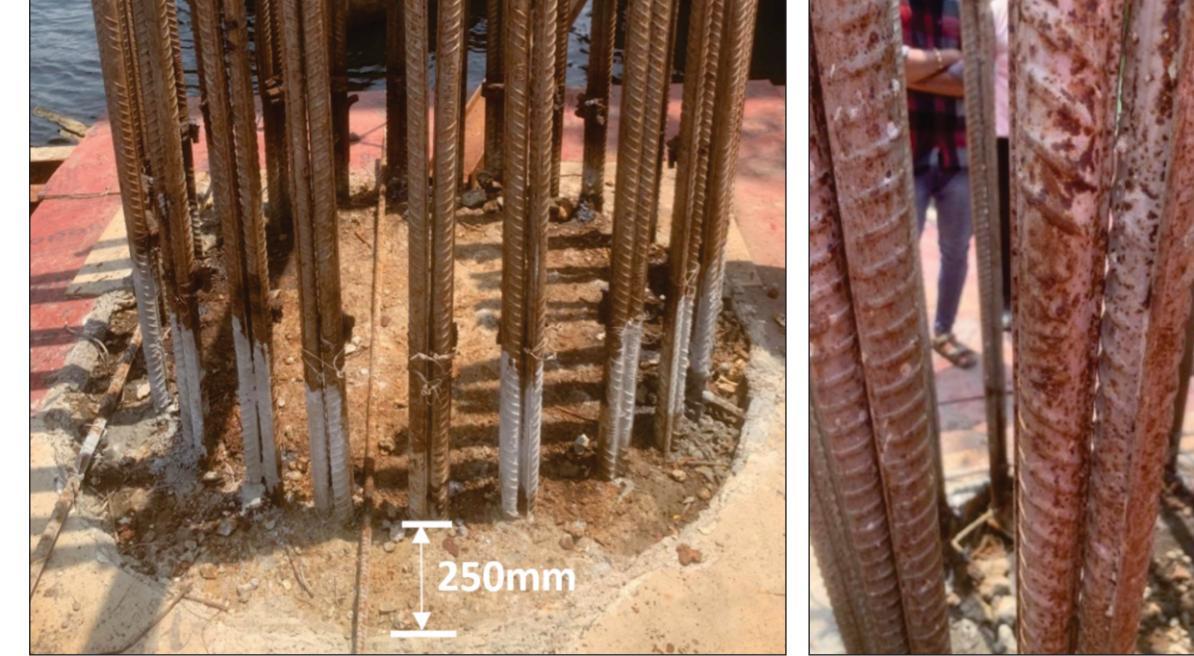
- b. The reporter noted that the reinforcement cage inside the pile bore is totally out of alignment resulting in the concrete cover at one side of the pile of 250 mm and nil on the opposite side as seen in Fig. 2 below. These two values also indicate that in addition to variable cover the circularity of the reinforcement cage was also not maintained and the cage is elliptical.
- c. The stainless-steel reinforcement bars are supposed to have been used in this project for protection against corrosion. However, the dowels from piles as well as the exposed reinforcement in piles without adequate cover are seen as rusted/decoloured, as shown in Fig. 3. This raises doubt about the material quality used.

Fig. 2 : Reinforced cage placed with 250mm cover on one side and NIL gap at the other end. Circularity of cage is also not maintained

Fig. 3 : Reinforcement Bars having signs of corrosion

- c) Confirm the cover to the reinforcement at the level of good/sound concrete. If a deficient cover is found, then continue removing the concrete up to the bed or where the required cover is encountered whichever is earlier. If required, temporary coffer dam or suitable arrangement shall be adopted for dry area for inspection and rectification.

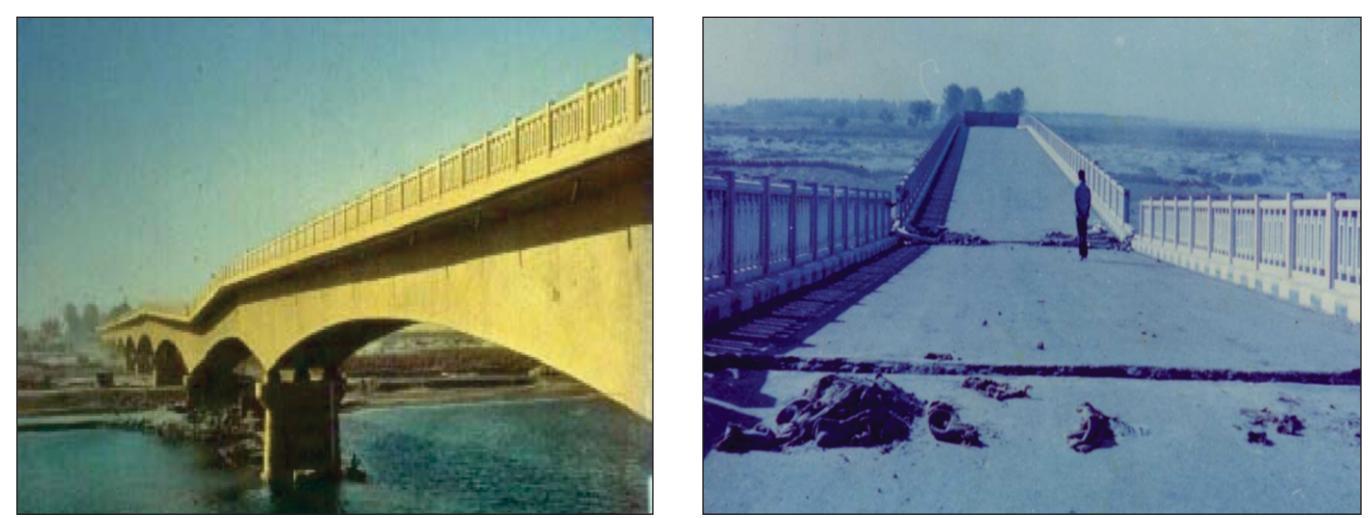
During the unprecedented floods of 1978, one of the pier underwent heavy scouring and eventually tilted longitudinally in the grade of one in 42 and settled by 86 centimeters. There was some additional relative settlement between the upstream and downstream faces of the pier by about 3 centimeters. Consequently, the top of the pier supported on the affected well moved longitudinally by 86 centimeters. Single segmental roller bearings provided on the Pier toppled and box girder fell on collapsed bearing with an impact. Total settlement of box girder over pier was 1.34 meters. Fig. 2 and Fig. 3 show the photo of the bridge after experiencing large settlement on one pier.

Fig. 2 : Settlement of Pier

Fig. 3 : Misaligned Decking

The main reason for settlement of the Pier appears to be extraordinarily heavy floods which occurred first time after the opening of the bridge. As a result, there was excessive scour around the well foundation at the pier which has undergone large settlement, adversely affecting its stability. The well settlement was non-uniform thereby alignment of many bridge components like pier, well cap, cut roller main bearings and suspended span bearings and the suspended span itself was affected severely disabling the bridge to carry the traffic.

- (a) Foundation: In order to prevent deeper scour and thereby ensure required grip around the wells, a flexible garland consisting of cement concrete blocks and boulders in wire crates was provided below normal scour level for the wells. This protection was found very effective and worked well subsequently for more than three decades.
- (b) Well Cap : Well cap of Pier No.3 has gone down below LWL due to settlement of the foundation. A new well cap over old well cap was constructed to accommodate thickening of the pier, placement of steel trestles for

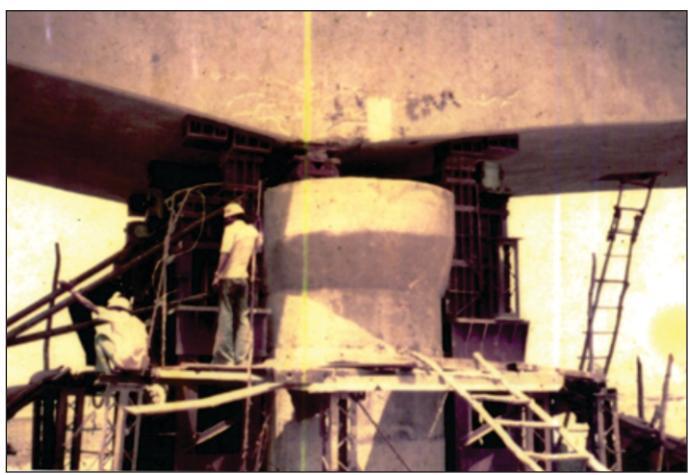
Fig. 4: Span lowered on new bearings

- (C) *Pier and the Cap*: The integrity of the damaged pier and its cracked pier cap was restored by epoxy injection treatment and it was further strengthened by jacketing. New pier and pier cap was designed such that the bearings on the new pier cap could be placed at the position of top bearing plates attached to the superstructure.
- (*d*) *Lifting of the superstructure* : The superstructure was lifted progressively by about 1350 mm in stages to bring it to original line and level by using hydraulic jacks.
- (e) Installation of new bearings and lowering of the span : The span was lifted higher than required to facilitate installation of the new bearings. Finally the span was lowered on these bearings by using the jacks.
