Confidential Reporting Of Structural Failures And Lessons Learnt NEWSLETTER

A Publication of Indian Association of Structural Engineers

JULY-SEPTEMBER, 2024

REPORT No. CF-28

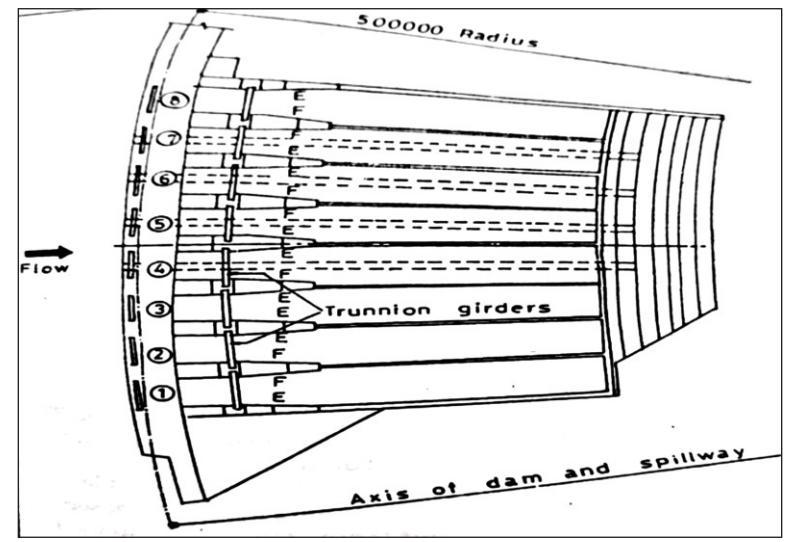
Fig. 2 : Details of Radial Gates

After completion of the dam, during one of the routine inspections prior to commissioning, it was noticed that some prestressed bars were broken and a few bars had yielded. While going through stressing records, it was observed that 45 bars were broken during normal stressing. Some bars were restressed and, in this operation, another 54 bars were found broken. After a few months, a second inspection was carried out which revealed that another 31 bars were broken. Breaking of prestressed bars in course of time and at

intervals indicated a substantial loss of prestress and gave alarming signal. The stability of the gates and related supporting structures of the dam was threatened.

The high tensile bars used for prestressing appear to be not conforming to the specification and standards. A study of actual stressing results maintained by dam engineers indicated that the design elongations of 85mm was supposed to be obtained at a pressure of 997 kg/cm². However, it was achieved at a much lower pressure of about 725 kg/cm². Deviation observed is around 25 to 30% as against five percent normally permitted. Breaking strength of the prestressing steel was lower than specified. It was concluded that poor quality of prestressing bars and lack of quality control on prestressing steel has resulted in failure of anchoring arrangement of the radial gates.

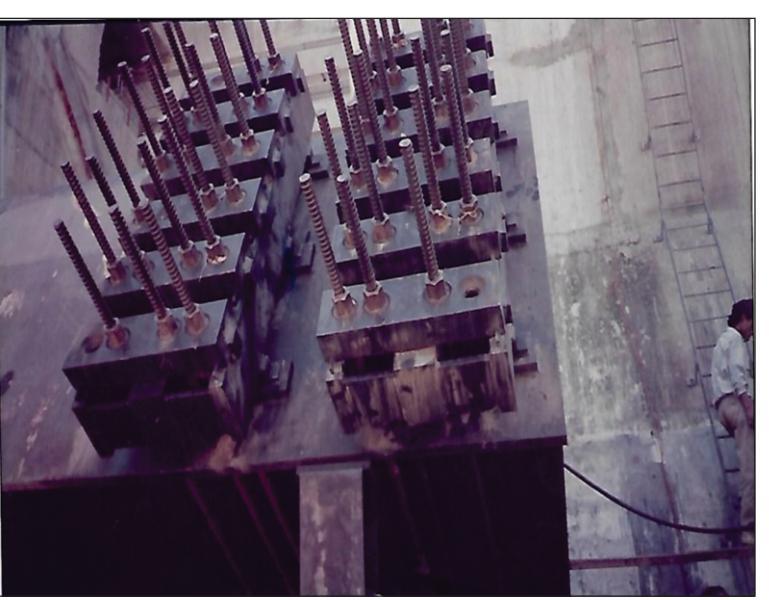
Fig. 3: HT Steel Bar Anchors

Proposal to replace existing bars by cable anchors without changing arrangement of the Trunion Girders, the Radial Gates and related components of the piers was found feasible and was accepted by the dam authorities. Criteria used for design of bars was on the basis of standard specifications and was not changed. (Fig. 3).

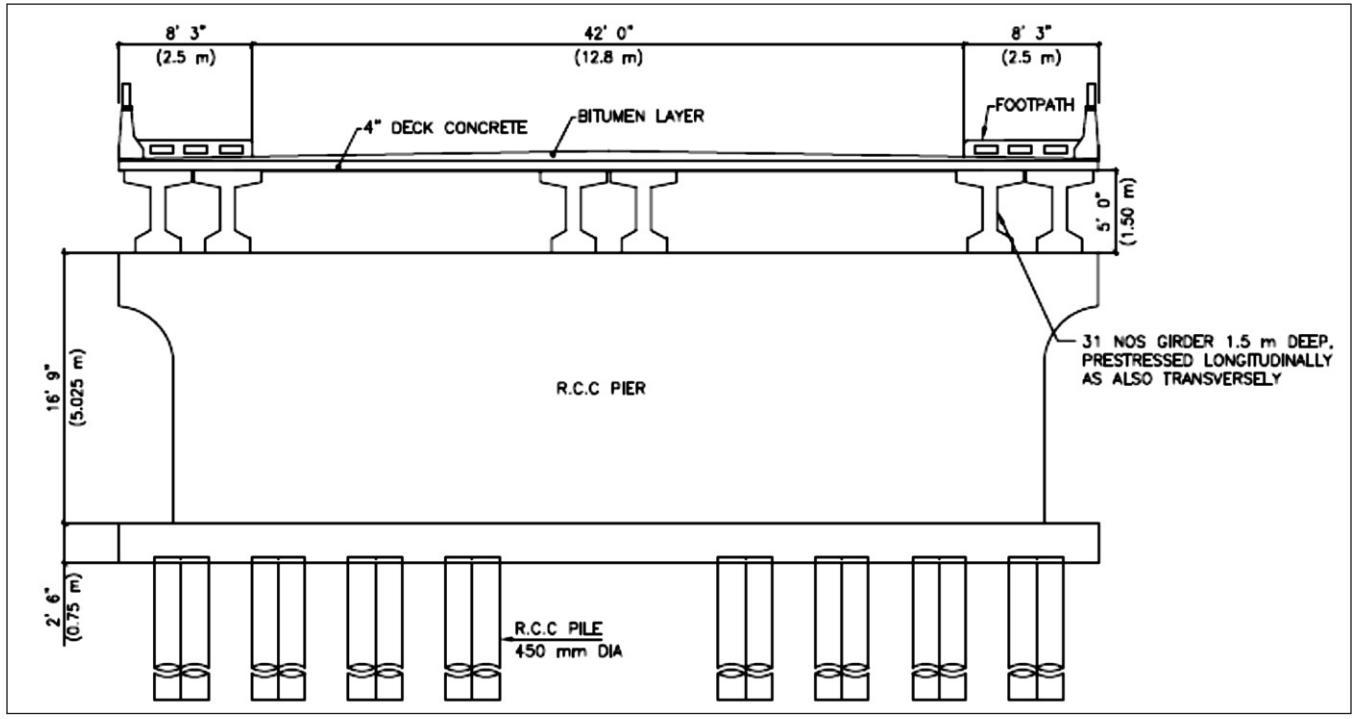
Fig. 1 : Sectional view showing the General Arrangement of the Canal Span Deck & Pier

The bridge, designed for loading standards applicable for National Highways at that time, had served well the ever-increasing traffic loads for the past 54 years (till the bridge collapsed). With the wearing course getting frequently damaged by heavy goods vehicles and intense city traffic spread over day and night, the wearing coats were renewed often, without, perhaps, keeping track of the total thickness initially specified and designed for. Investigations after the collapse have revealed a much larger thickness of Bituminous wearing coat than the original specified 125mm, causing net tensions on the bottom flanges of the girders, which was originally kept at 2.8 kg/cm² compressive stress. This led to cracks in concrete, and progressive corrosion due to the humid atmosphere above the canal area. Frequent travelers across the bridge had complained that of late, the span used to accumulate rainwater at the center, perhaps due to sagging, and the same was rectified by adding more bituminous mix !

The other reason for failure perhaps was the corrosion of the transverse prestressing wires which had been stressed in situ, (after the erection of the girders), from a cantilever staging hung from the girders themselves. The anchorages and the ducts encasing the wires were grouted with cement mortars, which shrunk and got loose and fell off with time, making water ingress easier. Loss of prestressing could have adversely affected the orthotropic behavior and imbalance in the sharing of load carried by individual girders.

the probable collapse of the span including traffic load, for which the bridge was never designed, and which had drastically increased over time, and the increased dead load due to bituminous overlays led to tension at the bottom of the girders. The additional probable causes of failure are failure of the transverse prestressing system due to corrosion and consequent loss of prestress, insufficient maintenance, as access to the soffit of the girders was dangerous, due to presence of high voltage electric lines, the possible lack of co-ordination between three authorities responsible for the asset without any clear division of their responsibilities and accountability. In this case, the collapse of the bridge and loss of lives could have been avoided with proper follow-up of a maintenance regime based upon a maintenance manual, which was non-existent.

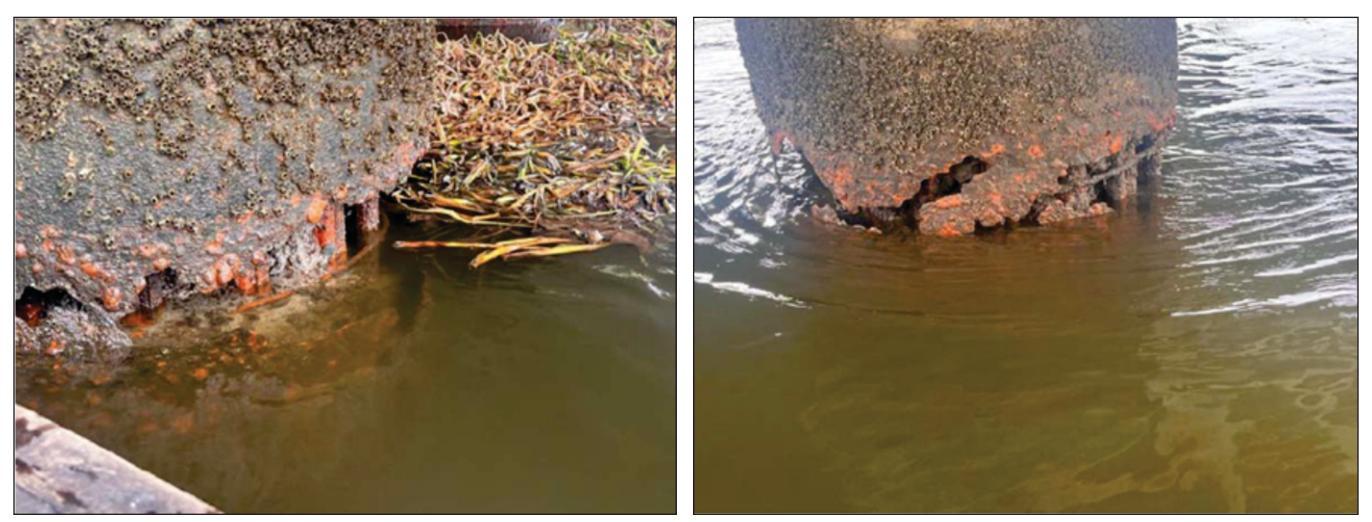
a) The pile foundations in water spans in the two bridges under discussion were found to be critical as steel lining in top portion of free-standing piles was found to be fully corroded and concrete in within almost full diameter and length varying from 2.5m to 0.6m of pile between bed and soffit of pile cap was missing due to its erosion as can be seen in the picture below (Fig. 1).

Fig. 1 : Pile Liner fully corroded and concrete in pile top portion missing or eroded

- a) Few pier foundations in both the bridges were found to be in extreme critical condition. Pile liners fully corroded in these foundations and pile concrete in the top zone fully eroded. The reinforcement bars are exposed and unsupported for substantial length in many cases.

- d) As a short-term solution, to prevent any mishap, it is proposed to repair the affected piles by antiwash out non-shrink, high-strength cementitious micro-concrete for underwater repairs. The concrete shall be of strength M50.

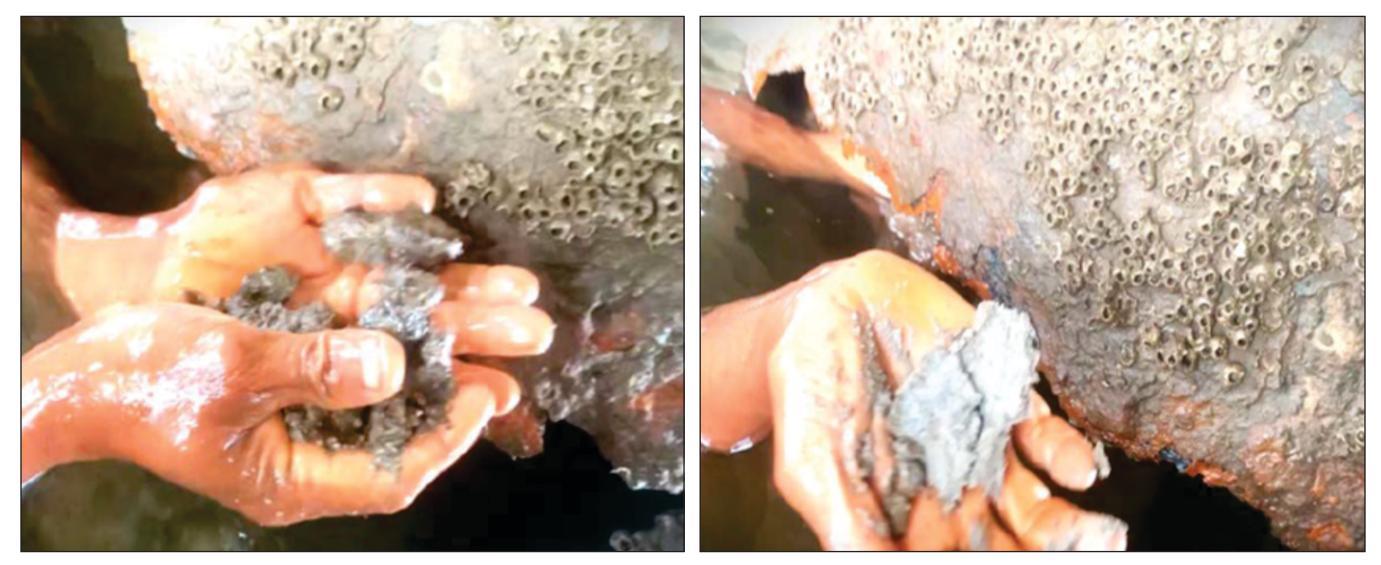
b) With the help of a diver, it was possible to pluck/pinch concrete using bare hands, as can be seen in below pictures (Fig. 2). The concrete grade for the pile as per GFC drawing is M40.

Fig. 2 : Pile Concrete could be Plucked / Pinched using bare hands

- b) The fact that the concrete around reinforcement which are still sticking, are in loose state, which is coming out simply by hand plucking, indicates that the strength of concrete is also far too low.

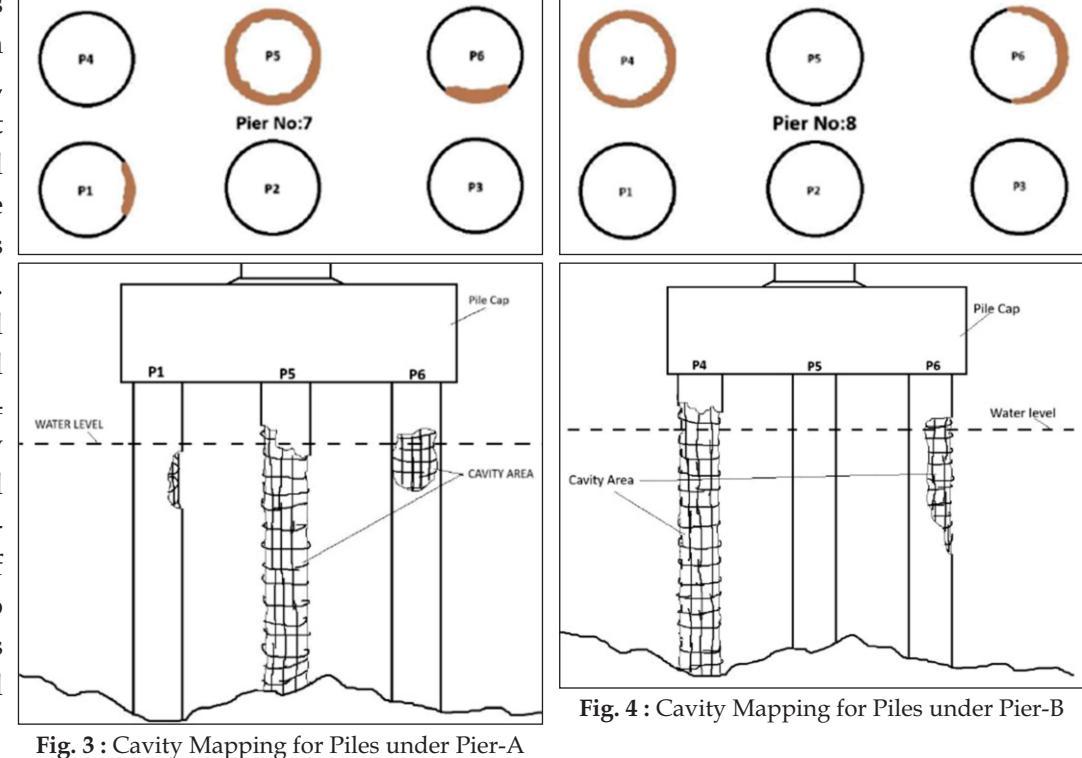
c) The condition of pile foundation is found to be extremely critical due to absence of concrete in 3 out of 6 pile-group, in case of two pier foundations, 4 out of 6 pile-group in one pier foundation. There are two other foundation pile groups where the condition was found to be bad though not as critical as stated above.

Inspection was carried out by a specialist team, under-water but above the river bed level, in areas where the foundations was visually accessible. Hammering, rod piercing was carried out. Fig. 3 & Fig. 4 shows the cavity mapping carried out based on underwater inspection of the piles for two typical Pile Groups (Say Group A and Group B).

- e) As an immediate task, It is essential to check the quality and consistency of pile foundation for all the piles, for their full length. This can be done by using pile integrity test or by other similar available methods.

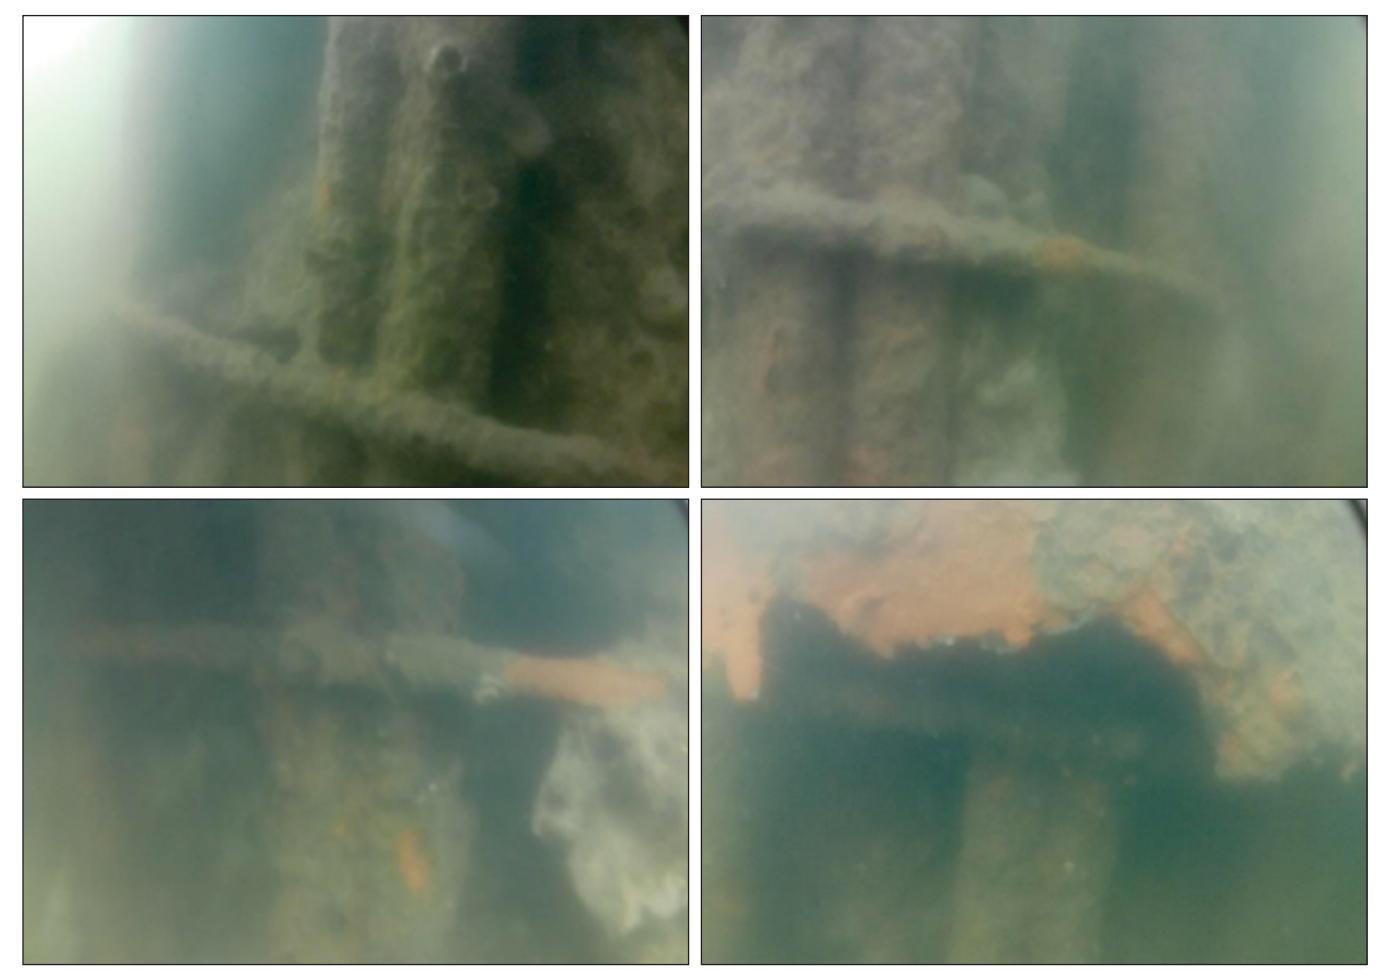
Fig. 5 : Photographs under water showing distress in Pile Foundation

- c) The pile erosion seen above bed level due to substandard concrete may exist below bed also, which can only be ascertained by conducting pile integrity tests. Therefore, it is important to check the quality of concrete in all the piles for establishing safety of the structure.

f) Depending on the results of tests on pile foundation, a long-term solution will have to be adopted for the safety of the bridge. The permanent solution, if necessary, will be either constructing new group of piles around existing piles and integrating them with existing pile caps.
