## FROM THE DESK OF THE PRESIDENT

## REPORT No. CF-46

# Design & Construction Challenges Faced in well Foundation of a Railway Bridge & Remediation

# Failure of False Steining of Well Foundation during sinking Process

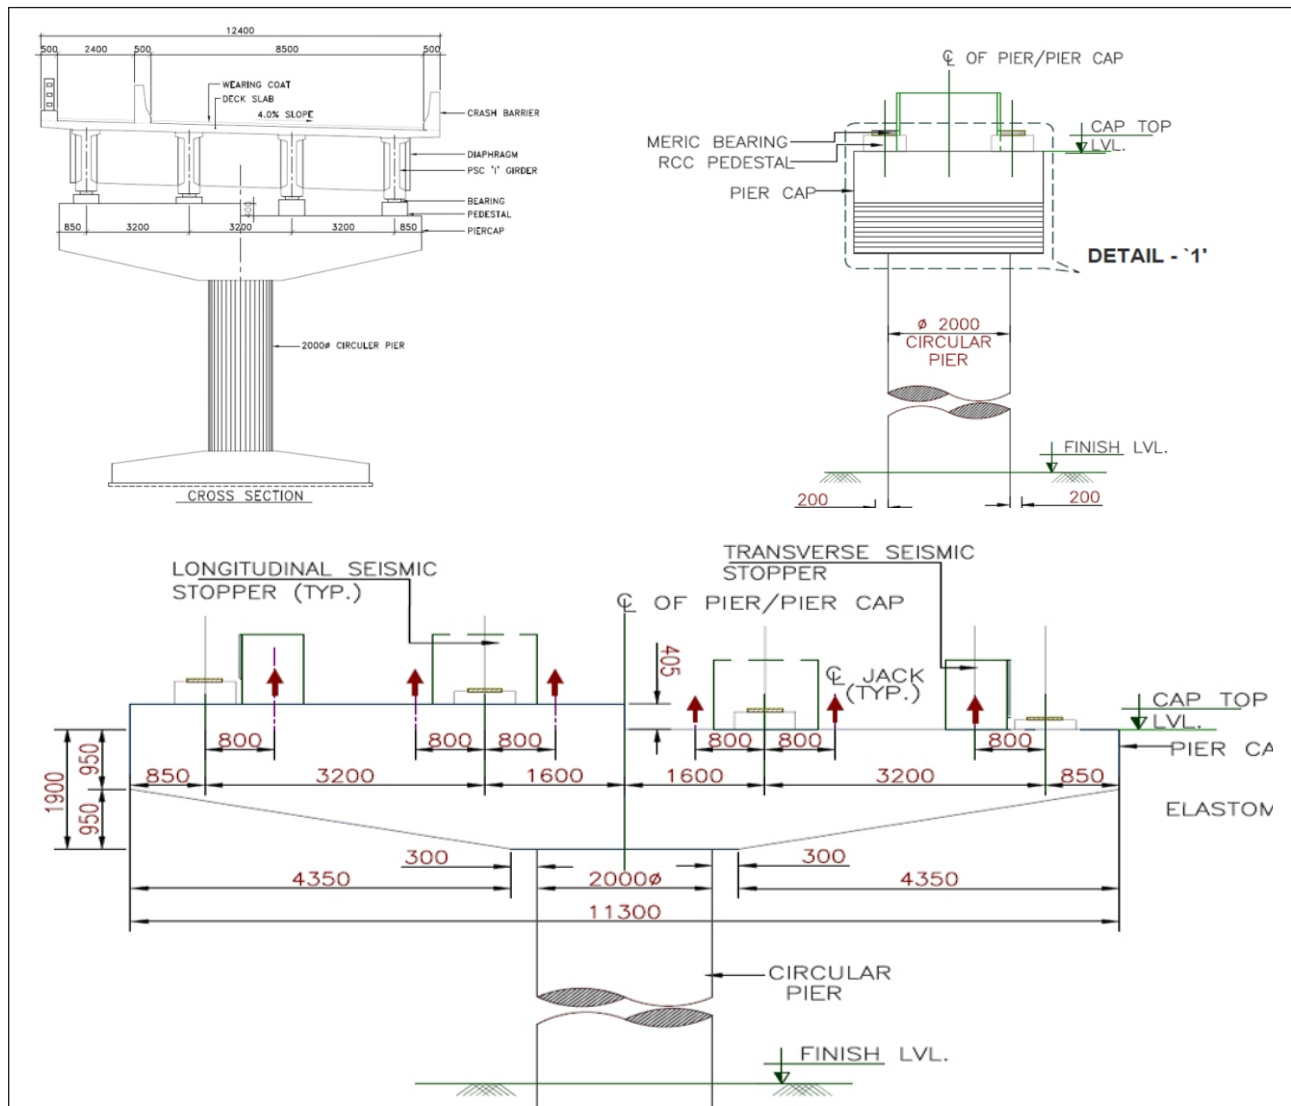
### Sketch 1

This report is on a case study of a 4-lane flyover in a city with two separate carriageways in either direction. Bridge is on a curve. Spans are 35m. Curvature is tackled with straight PSC girders of equal length and adjusting the bearing centerlines with respect to pier centre (see bearing level plan below). Total width of flyover in either direction is 12.5m, including widening for curvature. Superstructure is supported on 4 prestressed precast girders. Each carriageway is supported on an independent RCC pier cap and Pot/PTFE bearings pier and open foundation. Substructure consisted of a single circular pier of 2 m dia with cantilevering RCC pier caps. To avoid large pedestal heights for outer girders, due to 4% super elevation for a vehicle speed of 60 kmph, one side of pier cap supporting two outer girders is provided with additional height of 400 mm. See sketch 1.

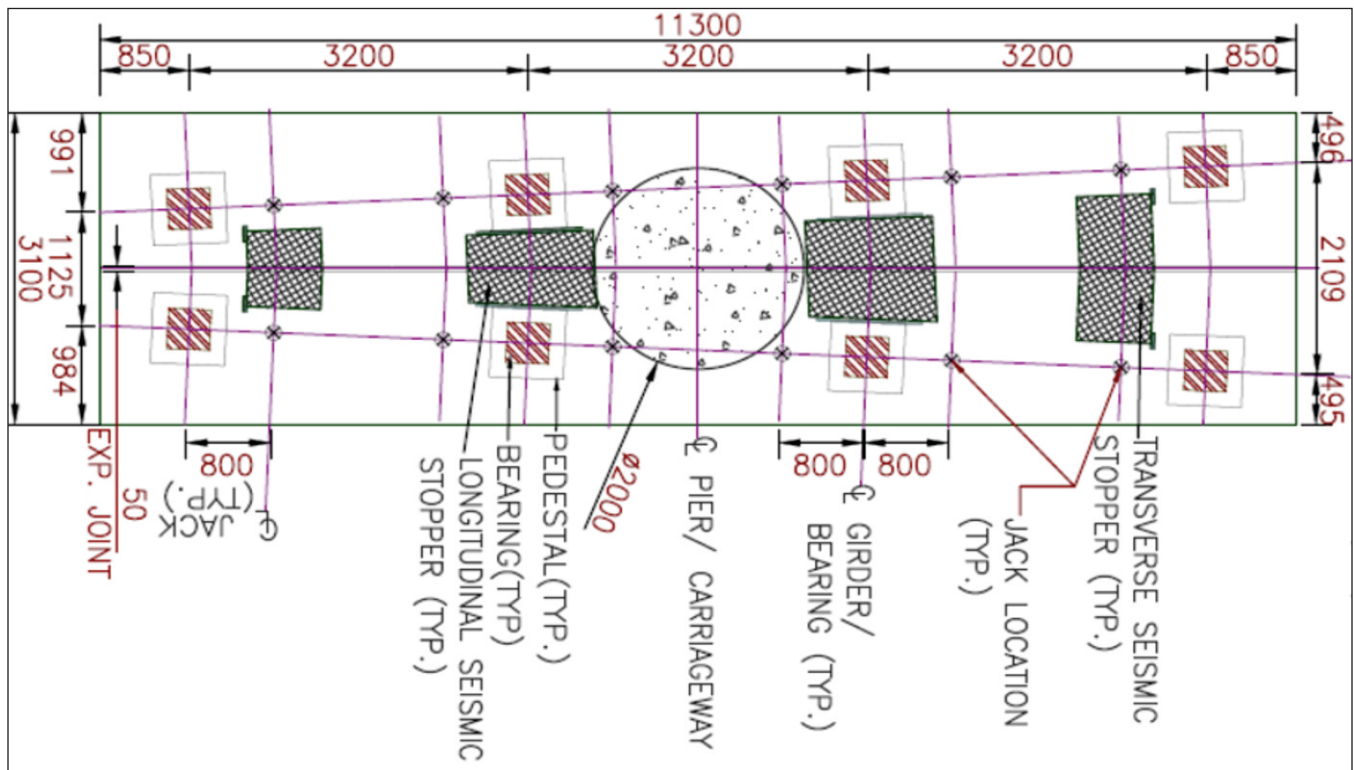
Sketch 2

Assuming girder lengths were maintained same by shifting bearing positions, see sketch 2, the radius of curvature works out to 400m which really is not a very sharp radius.

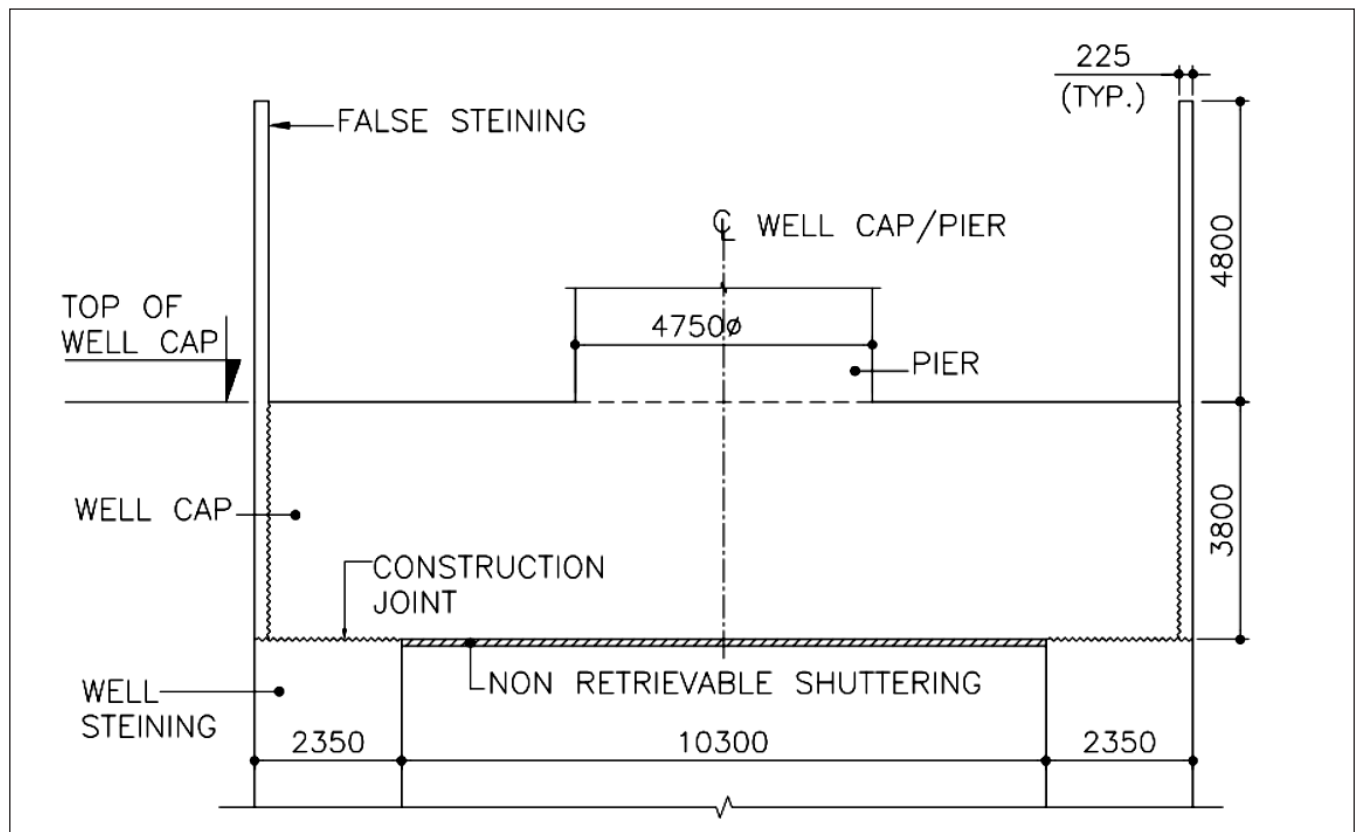
This report is about failure of 225mm thick RCC false steining, in case of a well foundation of a railway bridge across a major river. False Steining is a temporary, additional layer of steining which is built above the permanent well steining. It is used in well sinking to extend the wall height above water level, facilitating further sinking where well cap can be cast in dry state at a level below the prevailing water level.

Fig. 1 : Dimensional details of false steining

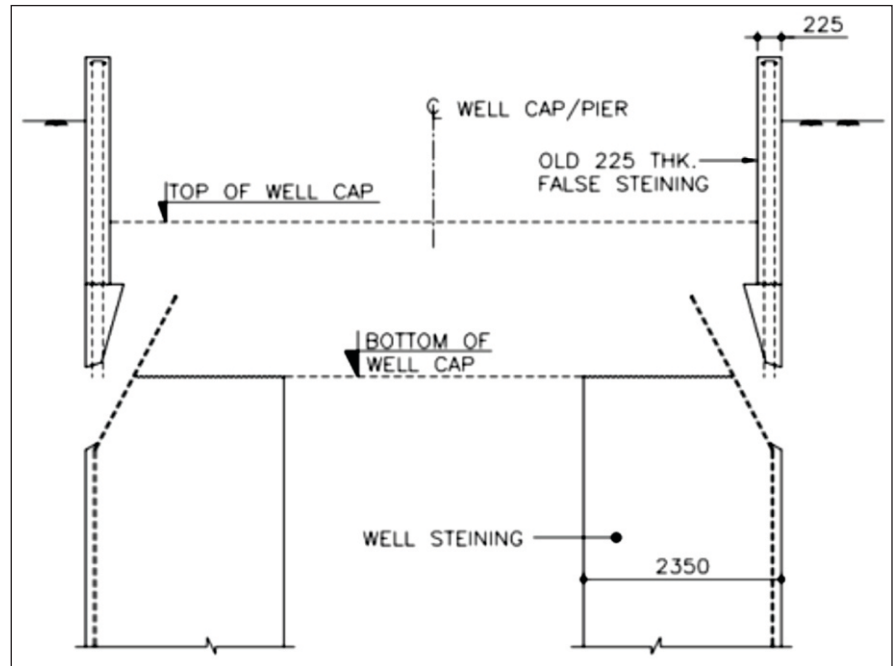
The sinking of well foundation was in progress, when this problem occurred in one of the well foundations. The sinking was started around two years ago i.e. in Feb'2024. As per Geotech report, top 15 to 20 m strata at this location consisted of bouldery deposits comprising cobbles, pebbles, and boulders intermixed with a non-cohesive matrix of soil and sand. Below this layer strata consists of medium to hard rock. The failure occurred at the junction of false steining and well steining after sinking of well for about 24m. Only 3m sinking was balance. Total height of false steining cast was around 7m. Fig. 2 shows the position of well foundation when this failure occurred.

Fig. 2 : Dimensional details of well foundation at the time of False Steining Separation from well
