Confidential Reporting Of Structural Failures And Lessons Learnt

NEWSLETTER

A PUBLICATION OF INDIAN ASSOCIATION OF STRUCTURAL ENGINEERS

JANUARY-MARCH, 2024

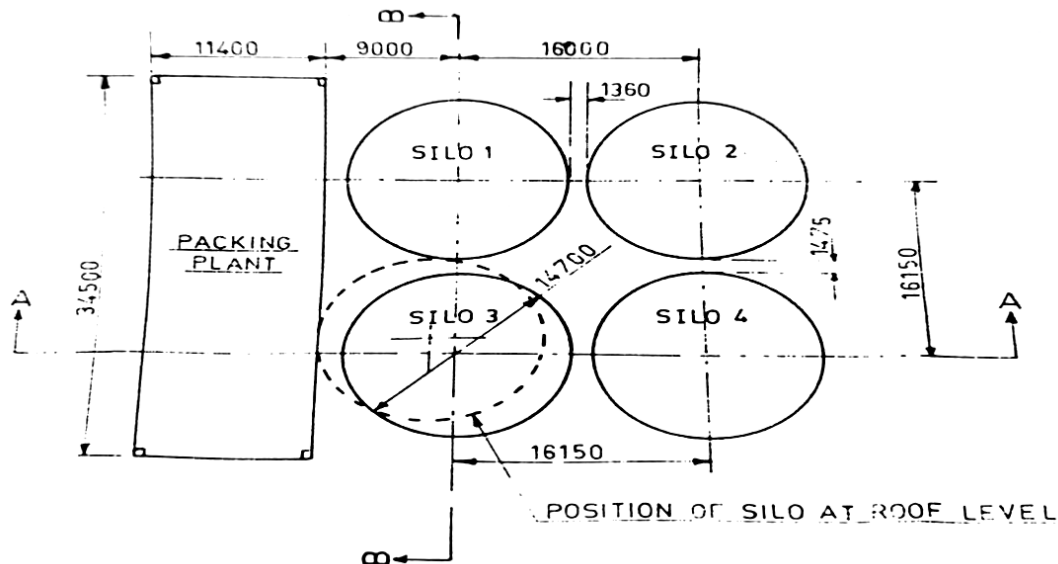
Fig 1 : Key Plan

Group of four cement silos was constructed adjoining to the packing plant as shown (Fig. no. 1 & 2).

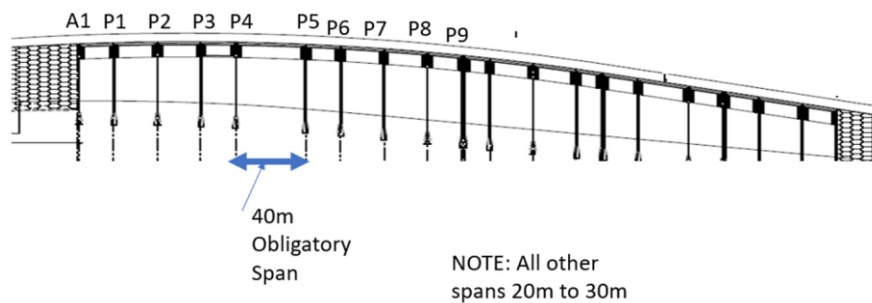
Fig 1 : Flyover Elevation

The flyover, FIG-1, is a fairly long one with an obligatory precast span P4-P5 of 40m of box girder section. The remaining spans constituting the approaches have a length of 20-30m each depending on the location of underground utilities. Two cranes were required to erect the precast Box girder, FIG2, while a single crane was adequate for erecting the I- girders of the approach spans.

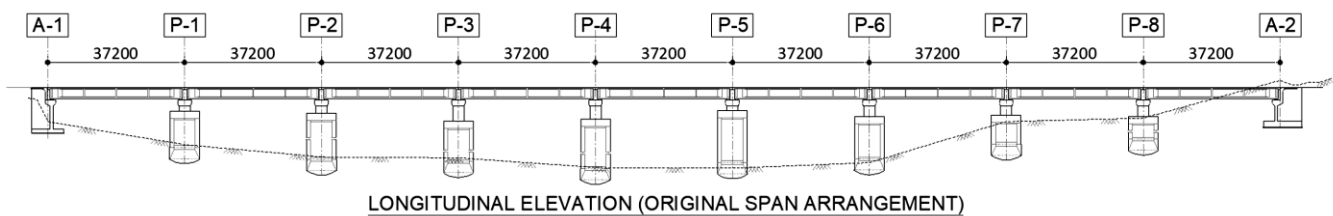
Fig. 1 : Span Arrangement for the Bridge as per Original Design

- This report is about a river bridge, 2 lane wide, 335m long, which is under construction since more than 10 years and has faced rough weathers due to various technical reasons. The original contract was awarded in the year 2012. The original contractor however left the contract in 2016, after completing a part of the work, when a number of well foundation for the bridge got tilted beyond restoration.
- In the original scheme, the bridge had 9 spans of 37.2m (c/c of expansion gap). The foundation proposed was the Well/Caisson foundation (resting on rocky strata) for piers and open foundation for Abutments. The superstructure comprised of PSC T Girder (3 girders per span) with in-situ deck slab over precast girders.
- MOST Standard drawings were adopted for the Superstructure. RCC circular pier with Pier Cap was proposed for the substructure. Fig.1 attached shows the span arrangement

- Out of 8 pier wells, 3 wells reportedly got tilted and shifted beyond restoration (which is at pier number P2, P3 & P4). At the time of termination of the original contract, the status of construction completed is as follows :
