REPORT No. CF-37

Failure/Distress of Post Tensioned I Girder during Prestressing and Lifting Operation

Impact of Ignoring Hydro-morphological Effects of Mighty Rivers in Planning of a Bridge – A Case Study

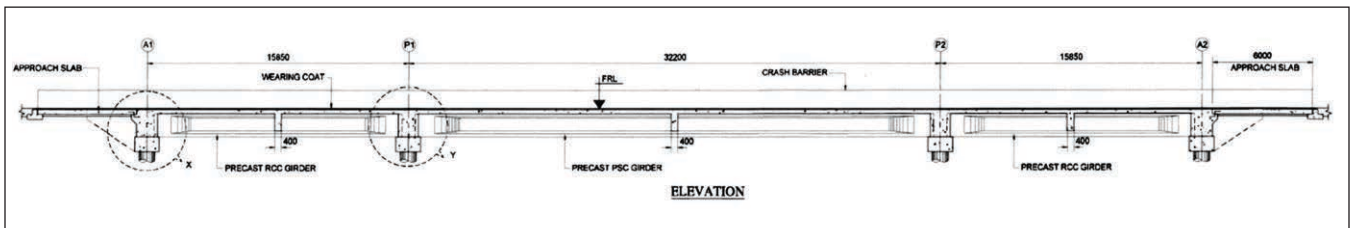
Span Arrangement

The bridge in question consists of three continuous spans (RCC-PSC-RCC) with a total length of 63.9 meters. The PSC girders are cast on the ground and prestressed in a single stage. Similarly, the RCC girders are cast on the ground and erected in place once the desired strength is achieved.

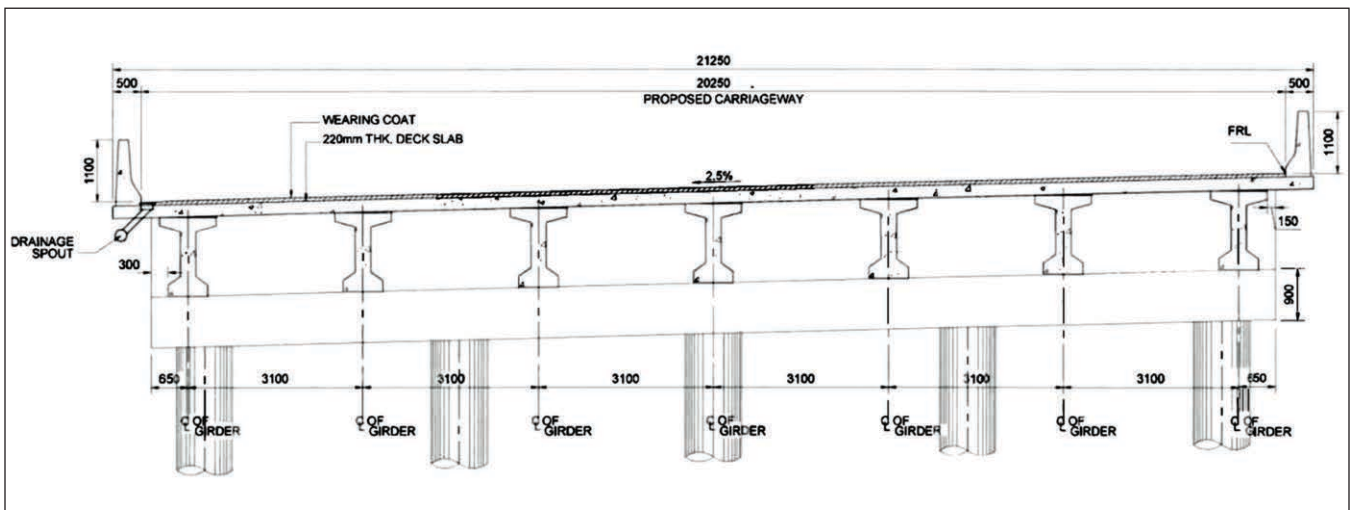
Typical Cross Section at Integral Pier

This report examines the failure of Post-Tensioned Concrete (PSC) I-Girders, which are extensively used in infrastructure projects such as flyovers, underpasses, and viaducts. Typically, I-Girders are supported over bearings, with continuity between adjacent spans established using link slabs. In this specific case, the PSC girders are integrated with the pier-cap.
