It gives me great pleasure to present the July-September 2025 issue of CROSFALL, IAStructE's flagship newsletter dedicated to the confidential reporting of structural failures and the dissemination of lessons learnt.

Report No. CF-40 : Cable Stayed Bridge - Failure during Construction.. **02**

Report No. CF-41 : Failure of Approach Embankment of A Major Bridge on National Highway during Monsoon **05**

Report No. CF-42 : Cantilever Bridges with Short Suspended Spans – A failed experiment of the past : A Case Study..... **11**

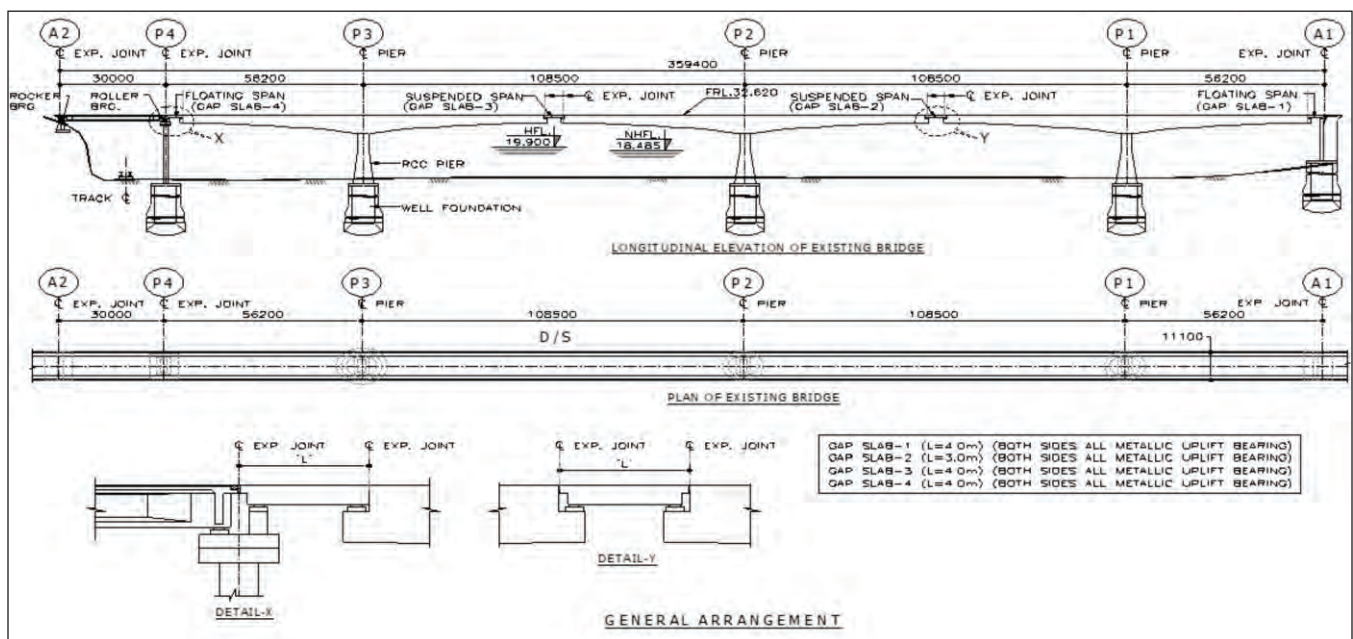
Fig. 1: Structural Scheme of the Bridge : (30m + 56.2m + 108.5m x 2 + 56.2m)

1.1. This report pertains to case study of a long span prestressed concrete variable depth cantilever constructed bridge, with short suspended spans, constructed more than 50 years ago. The reporter in this case is a bridge expert who was engaged by the Owner Client to visit the bridge site when the bridge was reportedly in extreme distress and considered unsafe by the local authorities. It is an important bridge on National Highway in the north-eastern area, is a vital link connecting two states. The bridge was opened to traffic in the year 1974. It is one of the oldest bridges in the area and serves as a landmark. This 360m long bridge has been in distress within a couple of years after its birth in 1974. The cantilever tips at the center of spans drooped severely and also differentially, causing discomfort to passing traffic. Fig. 1 shows the General Arrangement of the Bridge.
