Confidential Reporting Of Structural Failures And Lessons Learnt NEWSLETTER

A Publication of Indian Association of Structural Engineers

Failure of Modular Expansion Joints of a long Flyover

Failure of Pile Foundation of an Under-Construction Bridge in Coastal Environment

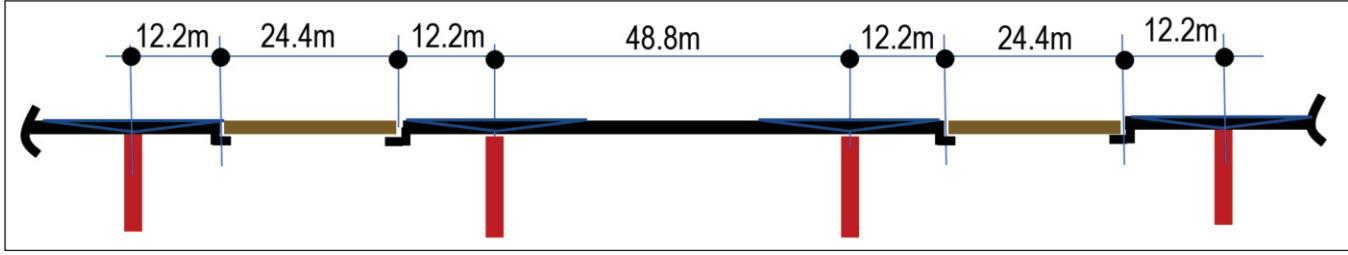
Fig. 1: Typical Span Arrangement for the Bridge (Schematic)

This 2 lane bridge, 478.8m long was constructed in 1970s. The substructure of this bridge comprised of twin hollow reinforced concrete cellular piers which are supported on 6.1-meter diameter single circular masonry well-foundation. Superstructure is made of two cell reinforced concrete box girders of balanced cantilever type with main span of 48.8 meter and 12.2 meter long cantilevers on either side. The suspended spans of 24.4-meter length are supported on cantilever tips. Fig. 1 below shows the span arrangement schematically. Steel rocker bearings at one end and segmental roller bearings at the other end have been provided for the main spans as well as suspended spans.

The suspended spans supported on cantilever tips at either end of the box girder also got tilted, one in downward and the other one in upward direction. Rocker bearings provided at the other adjacent pier (PN+1) were not damaged or dislocated due to span rotation. Some cracks developed in the webs of the box girder as well as pier cap at the location of the impact.

The main reason for settlement of the Pier appears to be extraordinarily heavy floods which occurred first time after the opening of the bridge. As a result, there was excessive scour around the well foundation at the pier which has undergone large settlement, adversely affecting its stability. The well settlement was non-uniform thereby alignment of many bridge components like pier, well cap, cut roller main bearings and suspended span bearings and the suspended span itself was affected severely disabling the bridge to carry the traffic.
