REPORT No. CF-19

Failure/Distress Case Study of Post Tensioned I Girder during Prestress and Lifting operation at Construction Stage

REPORT No. CF-20

Failure of Steel Bridge with Open Web Girder (OWG) during cantilever launching

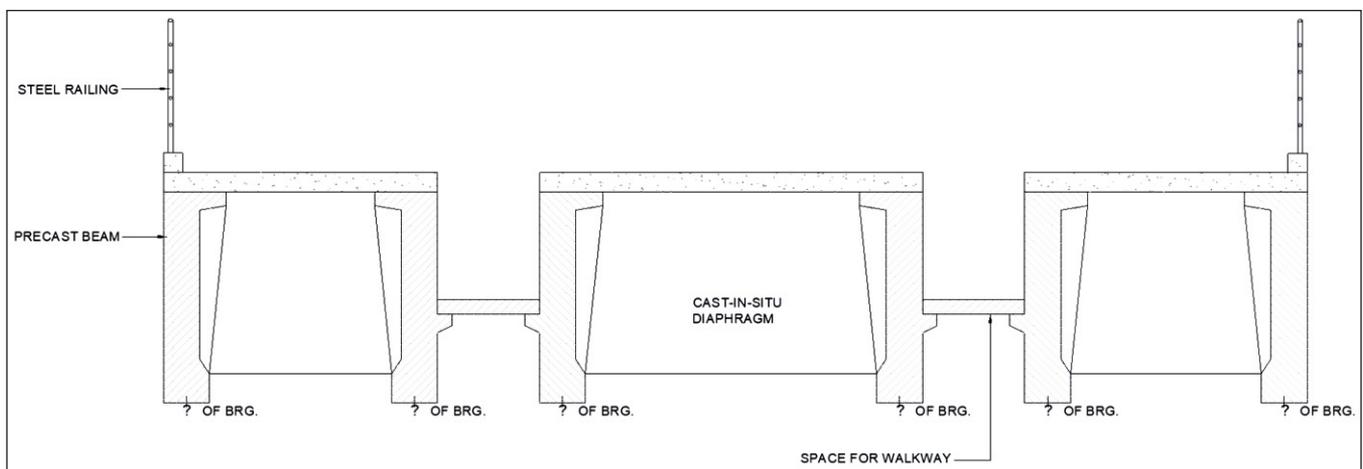
Fig 1: Cross Section of Superstructure

The outer girders have been proposed as unsymmetrical w.r.t c/l of web (as shown in Fig 1, 2 & Fig 3 below) for functional/aesthetic reasons. The length of girder is about 34.8m to be placed for 35m overall span of the superstructure. The prestressing layout is proposed symmetrical to vertical axis of the girder and plan deflection of girder has been checked in model during design, which is nominal. (Refer Fig 4).

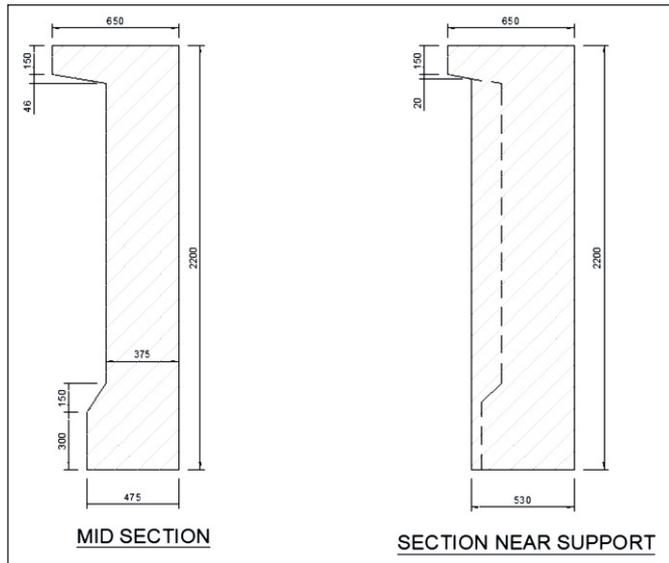
Fig 2: Cross Section of Girder

After prestressing of outer girder, lateral deflection was observed as 27mm, which, although higher than calculated deflection but not alarming. During lifting of girder from casting yard, there was sudden increase of lateral deflection (up to 300mm) with rotation about the axis of the girder (Photo 2). The construction team had kept the girder at original support without shifting due to excessive rotation. After sometimes, girder had been lifted again for shifting, girder rotated about 70 degrees to its axis and suddenly broke @ 3L/8 location (Photo 1). Fortunately, no casualty happened during this operation.

- Geometrical imperfection during placing of Tendon at site: Tendon placed eccentric w.r.t position shown in approved drawings (in plan).
- Excessive horizontal buckling about Minor axis: Girder buckled much more than anticipated during design due to slender behavior.
- Improper lifting arrangement: Centre of gravity of lifting hook didn't coincide with centre of gravity of self-weight of girder.

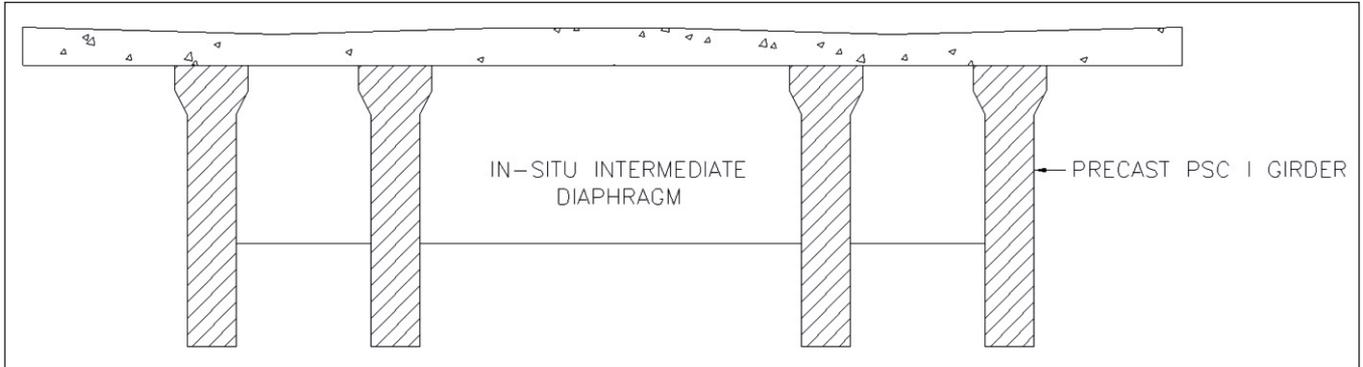
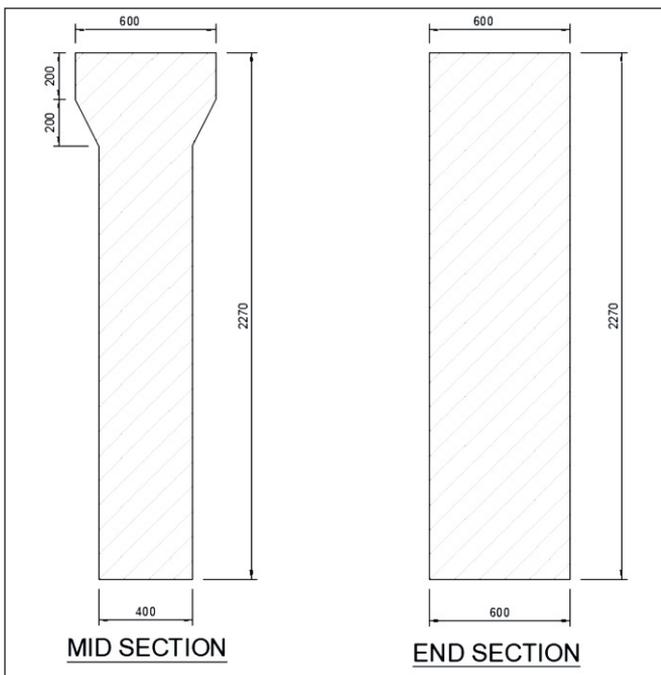
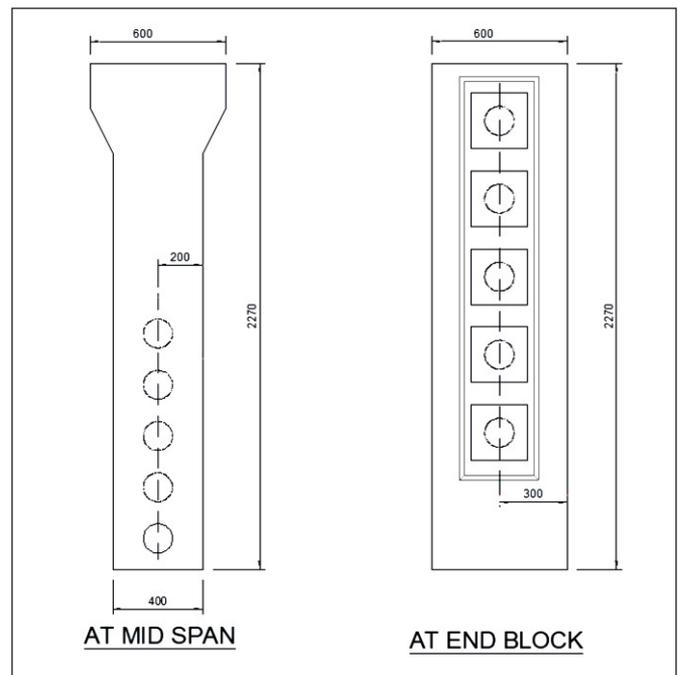
The second case study is related to excessive plan bending of precast girders after prestressing operation at casting yard. The length of girders was about 34.5m to form 35m superstructure span. The cross section of the superstructure and girder including tendon locations, has been shown in sketch (Fig 5 to 7) below.

The prestressing operations had been proposed in two stages in casting yard with symmetrical cable profile and forces. In this case, all the four girders (of the span) had excessive lateral deflection after two stages prestressing and lifting from casting yard to stacking yard. The value of lateral deflection was quite high varying from 100mm to 160mm.

Design had been reviewed with as-built lateral deflection (considering eccentricities of cable due to imperfection) and it had been observed that there will be permanent tension at one corner of the bottom flange of the girder during service stage. A proposal had been submitted with external prestressing

through diaphragm to control the tension in bottom flange. But the proposal had not been executed due to client's reservation. The precast PSC girders have been replaced with new I-girders with modified cross section.

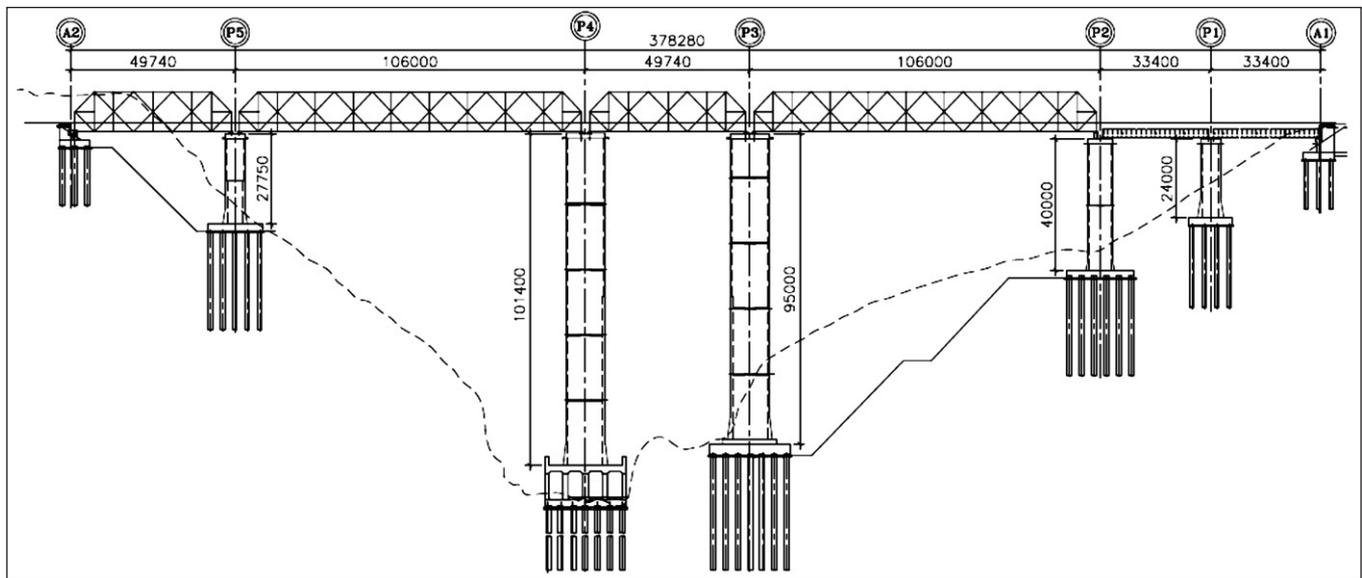
Fig. 1 : Elevation of the bridge

The bridge comprised of multiple spans of varying span length and supported on piers of varying height. The overall span configuration is 2x33.4m steel composite girder + 1x106.0m OWG + 1x 49.74m OWG + 1x106.0m OWG + 1x49.74m OWG.

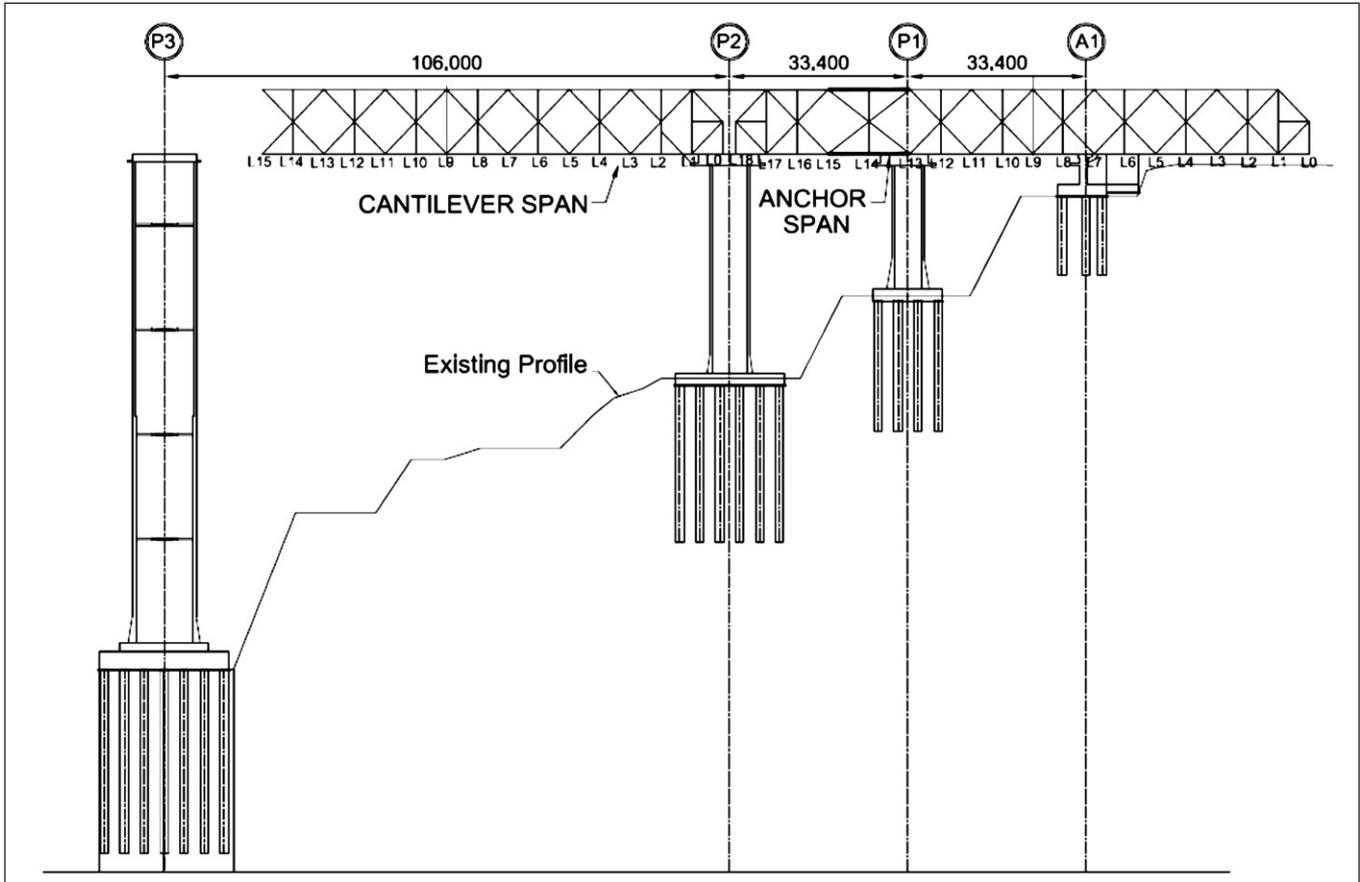
Fig. 2 : Position of cantilever span during launching

The bridge was designed for cantilever launching method of construction for the OWGs. The cantilever launching was started from abutment A1 side. One span of 103.5m was assembled partly on the embankment and partly on the A1-P1 and P1-P2 span. The span between P2 and P3 was supposed to be cantilevered from the anchor span of 103.5m span, erected beyond P2 towards A1. Fig. 1 shows the elevation of the bridge and Fig. 2 shows position of cantilever span during launching.

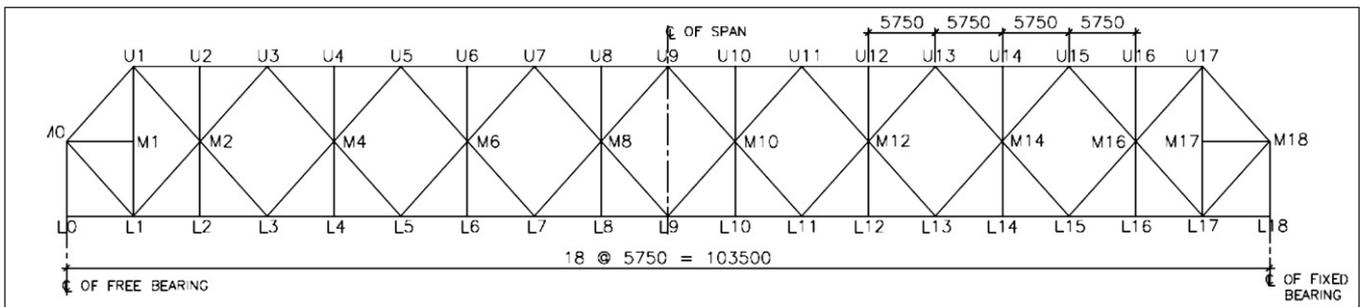
Fig. 3 : Original span configuration

The anchor span of 103.5m was originally designed for cantilever launching with respect to another 103.5m span. There were total 18 numbers of panels (L0-L1 to L17-L18) of 5.75m length each in each span. However, during the erection of the anchor span, the contractor modified the anchor span connection detail in order to keep one node point of the truss on pier P1 which was not any essential criteria. In the process the two panels (L13-L14 and L14-L15) of the OWG had length of 7.7m. Fig. 3 shows the original span configuration and Fig. 4 shows the revised span configuration of the anchor span fabricated during cantilever launching.

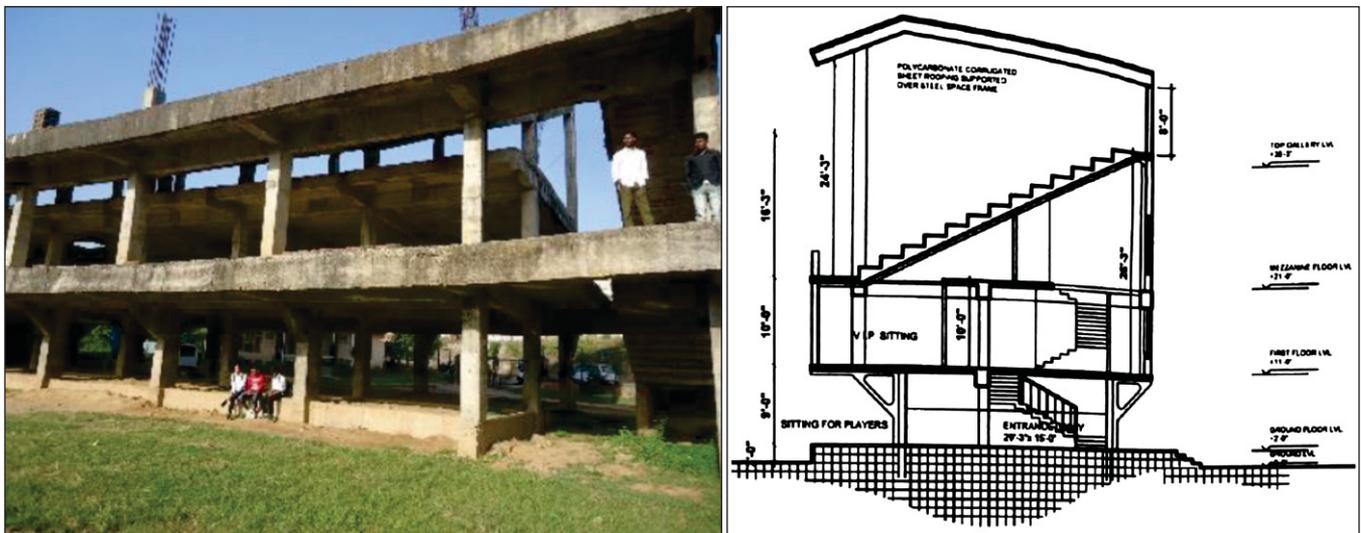
Fig. 2: Different levels of the Stadium

The structure is a RCC frame structure, comprising of beams, columns and slabs. It consists of four levels as seen from Fig. 2: (a) Plinth level (b) First floor level (c) Mezzanine level (d) Pavilion level. The roof is at a level of 43' 3" from the Ground level. It lies in the Zone IV according to the seismic hazard map of India given in IS: 1893-2016 and hence the location is prone to severe seismological activities. In addition, as the stadium is an open structure, the wind load is an important load to be accounted for in the structural analysis.

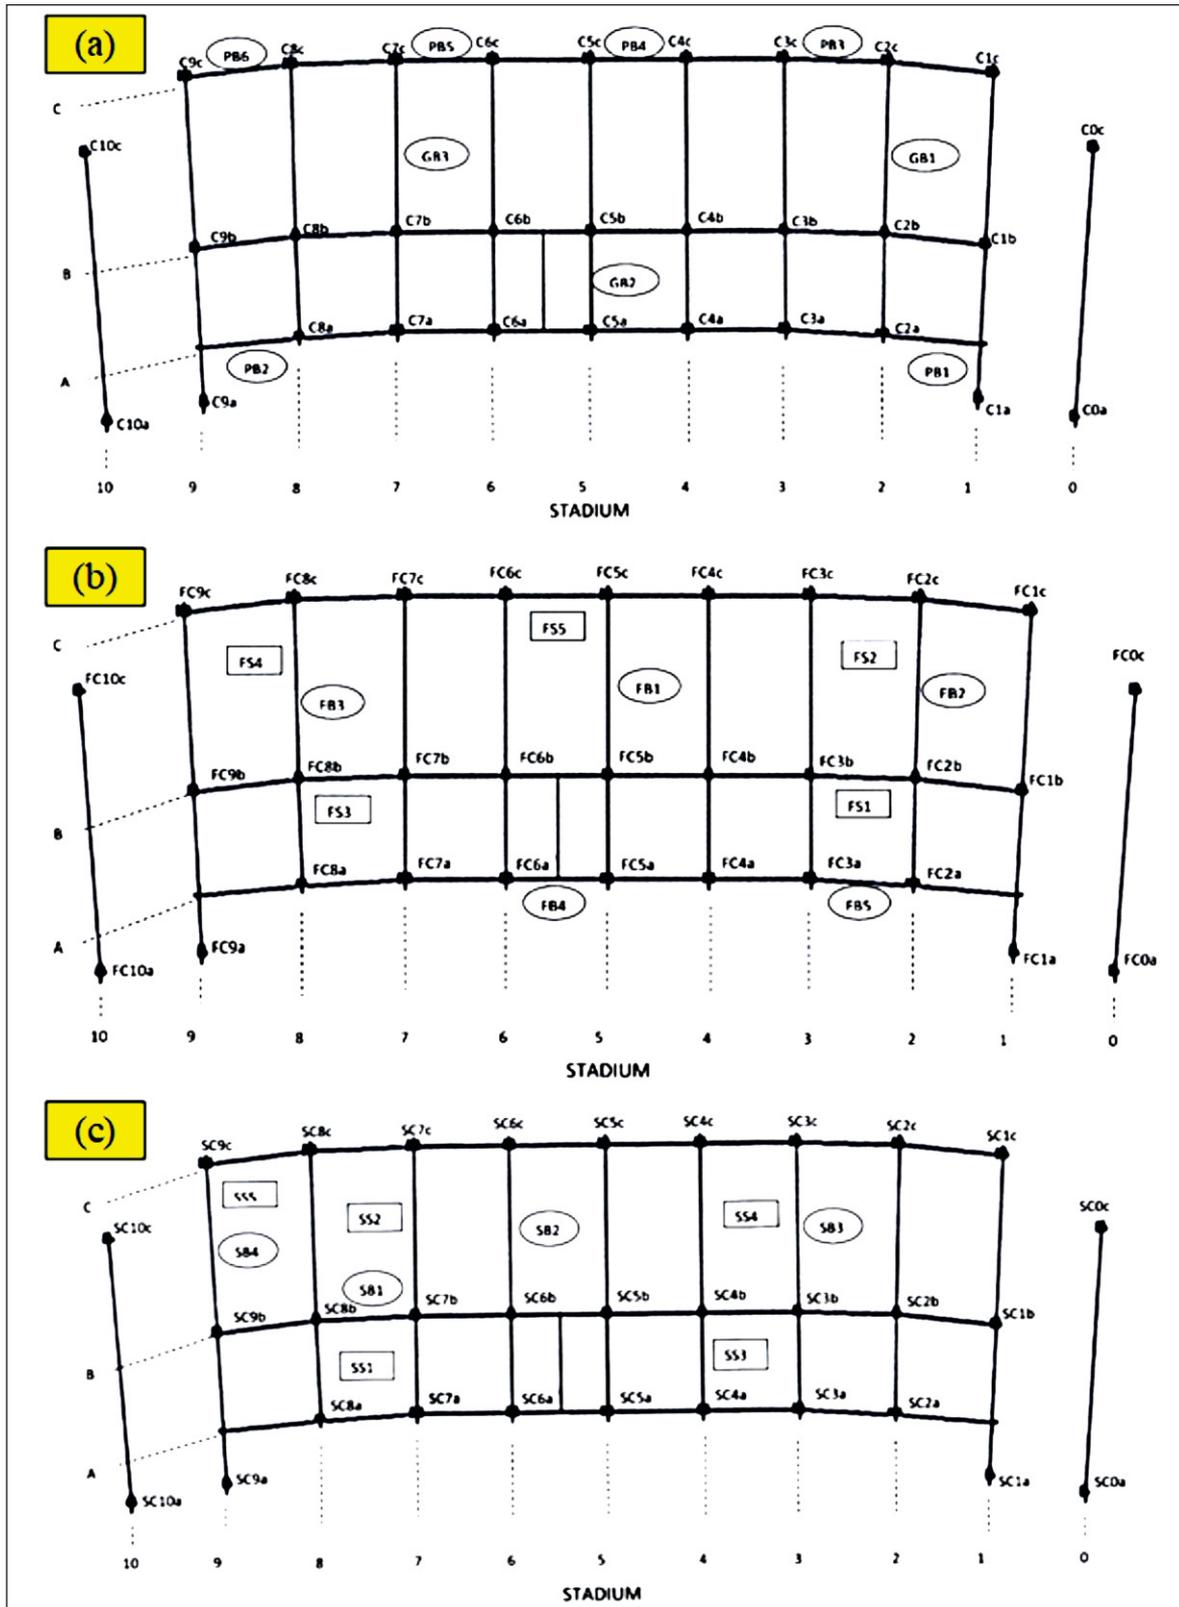
Fig. 4: Plan of (a) Ground, (b) First and (c) second floor plan

The structural design, workmanship and quality of the construction work of stadium building was not observed up to the mark. Further the structural auditor advised that any further over loading, construction activity or movement on the existing structure is not advisable. The risk might be of very high magnitude in the event of any earthquake. It was suggested to redesign the structure strictly as per the latest codal

provisions and recommendations. The consideration of dynamic analysis for resonance is also mandatory considering the importance of the building. The plan of ground first and second floor plan is shown in Fig. 4.
