# Confidential Reporting Of Structural Failures And Lessons Learnt

## NEWSLETTER

April-June, 2023

# Few Cases of Wrong Installation of Bridge Bearings

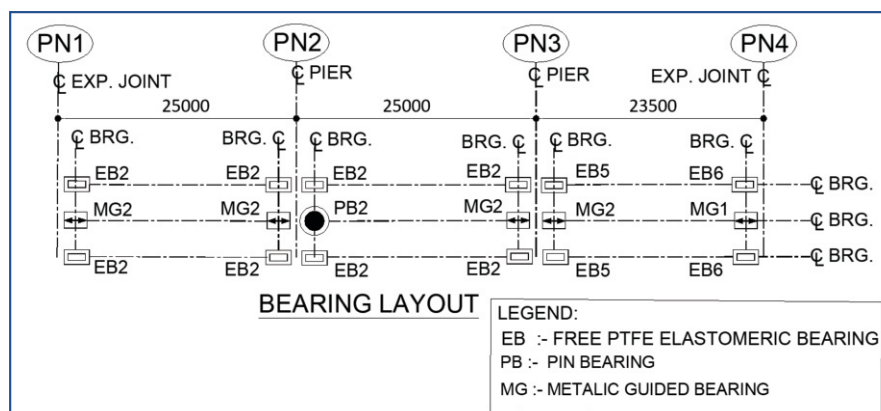
Fig. 1 : Bearing Layout for a typical module

The elastomeric bearings provided in this case are of Type H (Bearings with sliding interface). During a site visit, post-construction, the reporter, noted that sleeves of free elastomeric bearings are not embedded into the concrete of the diaphragm. Rather these sleeves are hanging downward from the top plate! Photo-1 shows the observed detail. Fig. 2 shows the arrangement of fixing of the top plate of bearings, 'as per the GFC drawing' and 'as constructed.'

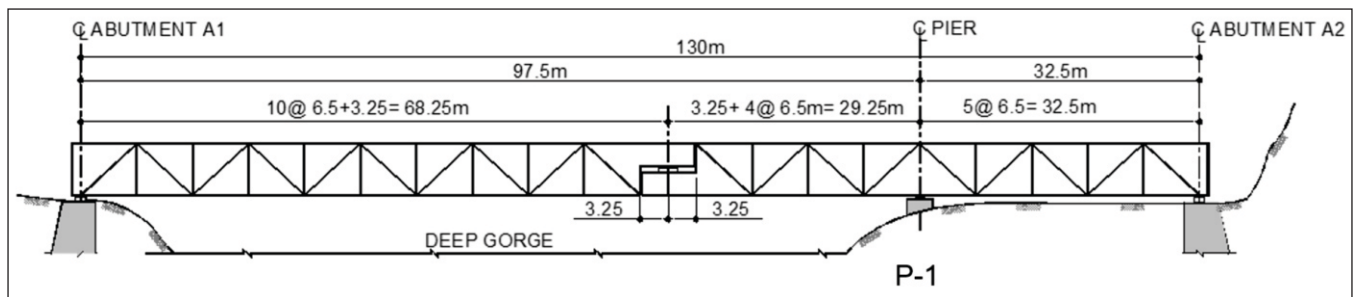
Fig. 6 : Elevation - Completed Bridge

This report presents a failure case of a 68.25 m long steel truss during its launching over a deep gorge in a hilly terrain. The overall length of the steel truss bridge is 130m with the span arrangement of 97.5m + 32.5m as shown Fig. 6.

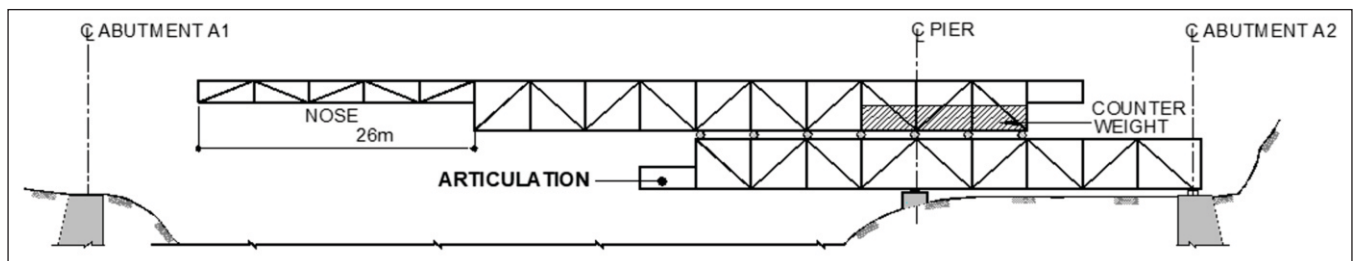
Fig. 7 : Launching of 68.25 m Truss

68.25m truss. To counterbalance the cantilever moments and ensure a factor of safety of 1.5 during construction, counter weights are added at the rear end of the truss during launching as shown below.

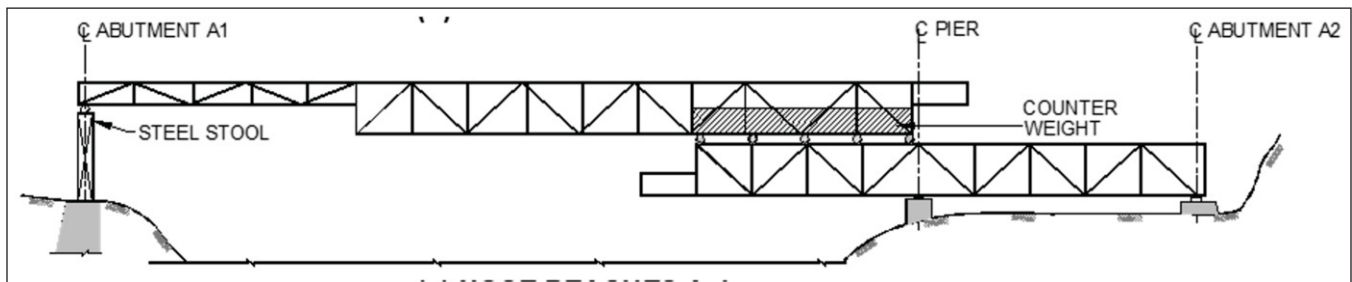
Fig. 8 : Launching Nose reaches Abutment A-1

- j) The scheme envisaged removal of the counterweight at A-2 end once the nose rests over the A-1 end over a steel stool with roller so that the truss with nose is simply supported over A-1 end. The nose was to be dismantled panel by panel once it crossed the A-1 end. This process was to be continued till the entire length of nose is dismantled and front end of the main truss rests over the A-1 side temporary support. The truss end on P-1 also was to be supported over temporary supports over the articulation. In the next operation, 68.25 m long truss which was resting on top of the lower truss and over steel stools on A-1 was to be lowered onto the bearings on articulation and also on A-1 end.

- k) However, when the counter weight was removed, the connection between the main truss and nose failed due to the reversal of forces and the entire top truss with nose collapse into the gorge as shown in Fig. 9.

The Nose was not properly designed for the forces after it became simply supported. During launching, the entire truss and nose were behaving as a cantilever. The top chord of the nose was connected to top chord of the main truss. However, its bottom chord was connected to the vertical member of the main truss. Once it became simply supported after removal of the counterweight at A-2 end, the connection of its lower chord failed since the tension in the bottom chord was not transferred to the bottom member of the main truss. The whole truss collapsed into the gorge and the welding, mainly butt welding in the truss members on P-1 side got damaged.

The truss between P-1 and A-2 side was thoroughly inspected and splice plates were welded to the truss plates which were originally spliced through butt welding. All the welds and splices were tested for quality. Once the damaged truss between P-1 and A-2 was repaired and found to be safe, the 68.25 m long truss was refabricated with a nose fixed to the top and bottom chord for proper transfer of forces once it becomes simply supported.

- b) Articulated joints as provided in this bridge is very risky and cause maintenance problems and should be avoided.
- c) Design and detailing of nose are very important and it should be designed properly for its connection with the main truss and transfer of forces during cantilever and simply supported stages. Top and bottom chord members of the nose should be connected to top and bottom chords of the main truss respectively.
